Case 18-S-0448: In the Matter of the Investigation of a Rupture at Fifth Avenue and 21st Street on July 19, 2018 in the Service Territory of Consolidated Edison Company of New York, Inc.

NEW YORK STATE DEPARTMENT OF PUBLIC SERVICE

CASE 18-S-0448

TECHNICAL REPORT

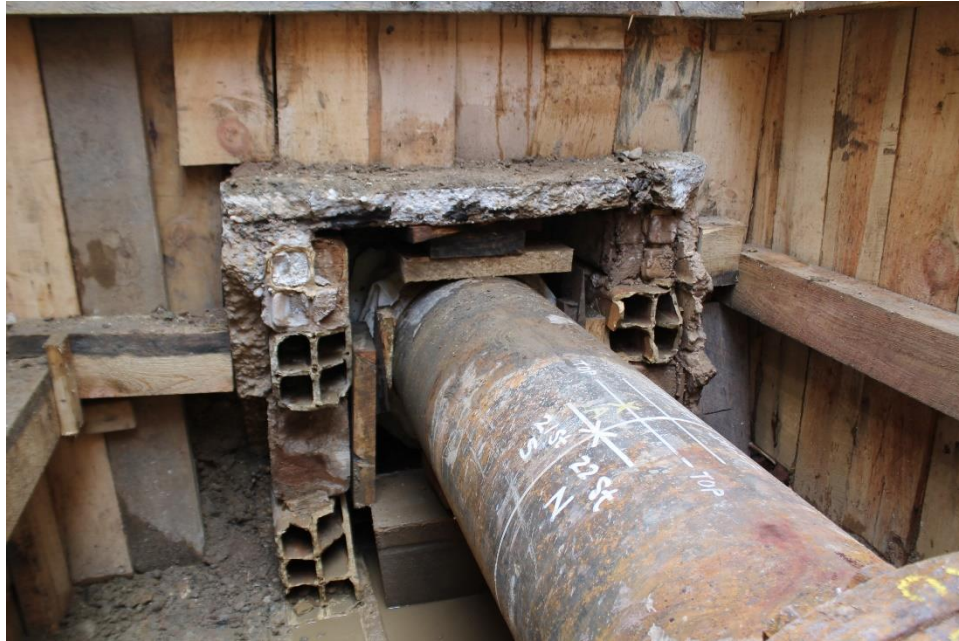
Figure 3 - Photo of Steam Main in Older-Style Housing along Fifth Avenue, between 20th Street and 21st Street. Taken by Staff

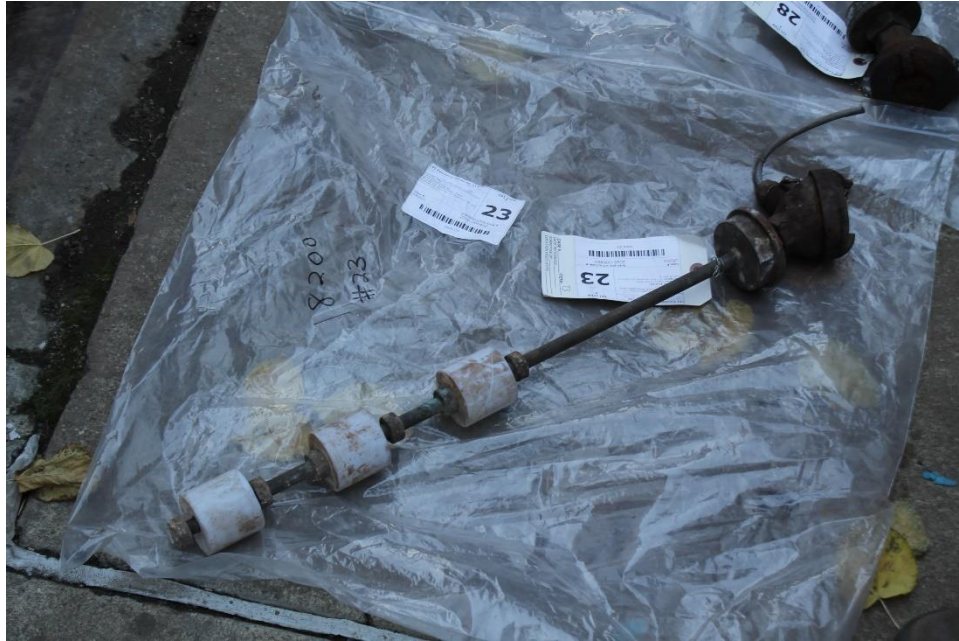
level alarms also indicate that the pump is not working or that the pump is being overwhelmed by water, since there is water building up in the structure.

Figure 14 - Photo of Manhole Float, Taken by Staff

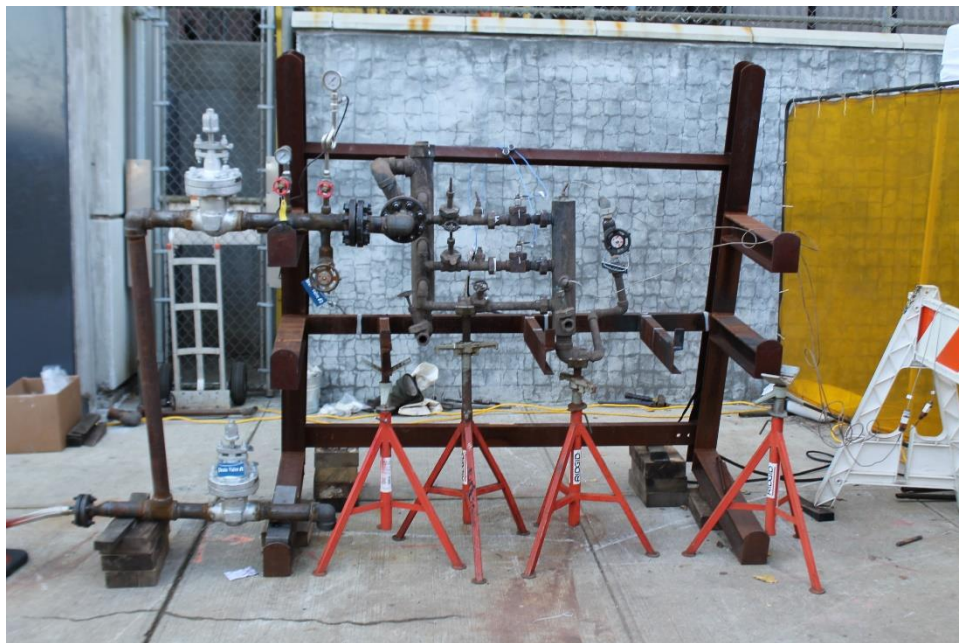
Figure 15 - Photo of Trap Assembly During Testing on November 1st, 2018, Taken by Staff

Traps - Because one of the contributing factors to the 2007 incident were traps that were blocked, trap temperature sensors were installed throughout the RMS system to indicate the functionality of the traps. A trap that has been obstructed will cool down as the trapped steam condenses in the piping (a "cold trap" condition). If the trap temperature drops below 300 degrees, Con Edison will receive an alarm from the trap temperature sensor, since it indicates that the trap may not be functioning.

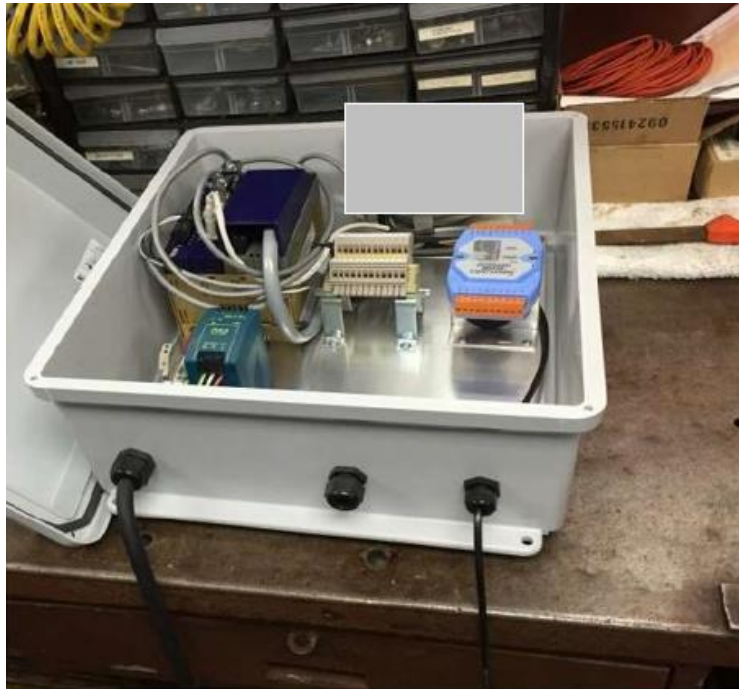
Figure 16 - Photo of Remote Telemetry Unit (RTU) Box

continuous improvements over the years, however, to improve the reliability of its RMS system. Each component has undergone numerous iterations. For example, for the RTU boxes, the Company transitioned from polycarbonate enclosures in 2008 to fiberglass reinforced polyester enclosures in 2015 because the polycarbonate material became brittle to the point of collapse from the heat cycling typically seen within the steam manholes. Similarly, in 2011, the Company moved from wired communications to wireless cellular antennae communications.

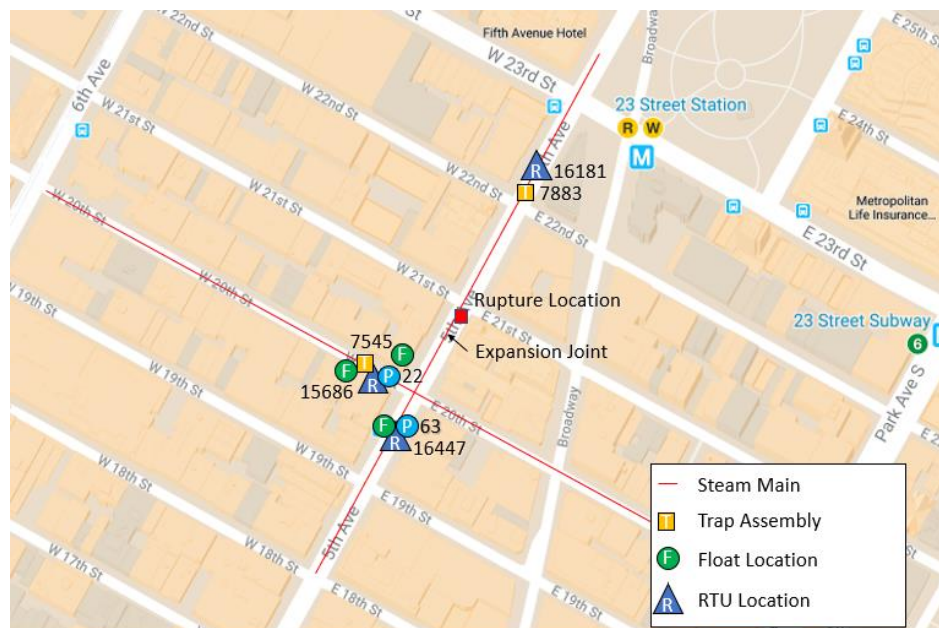
Figure 17 - Map of Equipment Tested from 20th Street and Fifth Avenue

The part of the RMS system in the immediate area of the incident was two RTU boxes (#15686 and #16447) near the intersection of East 20th Street and Fifth Avenue, as shown in Figure 17. Data showed that RTU #15686 had not been transmitting information since before July 5th, 2018.²⁸ Testing on November 1, 2018 confirmed that the RTU was not functioning. RTU #15686 was connected to manhole float #MVMH1006 and pump manhole float #PMH7642. The two floats were not retained by Con Edison, therefore the functionality of the two float devices could not be tested. Even if the floats had been tested and found functional, the information they provide would not have been transmitted to Con Edison since RTU #15686 was not functioning. In addition to the floats, Con Edison had a trap temperature RMS attached to RTU #15686. The trap temperature thermocouple was not tested, as it was connected to a non-reporting RTU.²⁹
