# Steam Distribution Pipeline Corrosion Study

Consolidated Edison Company of New York

**Report No.:** E-AD-SA (LMCK) 10310686, Rev. 0

**Date:** 11/30/2021

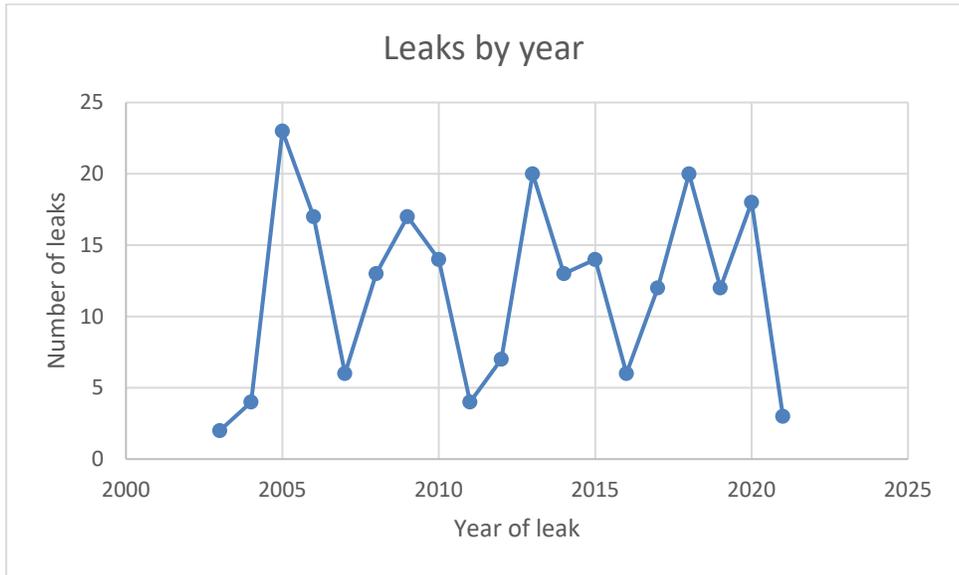
The evidence shows that CECONY's steam distribution pipes are seeing three contributing sources to its overall corrosion threat profile, pH based general corrosion, steam condensate localized aggressive pitting, and flow accelerated corrosion (FAC). Each corrosion mechanism will be outlined and an approach to mitigation will be provided as part of this report. To begin DNV reviewed and summarized the history of internal corrosion related events, Figure 1 shows a summary of 6 o'clock related leaks from 2003 to 2021.

**Figure 1 – Count of leaks at the 6 o'clock location by year since 2003.**

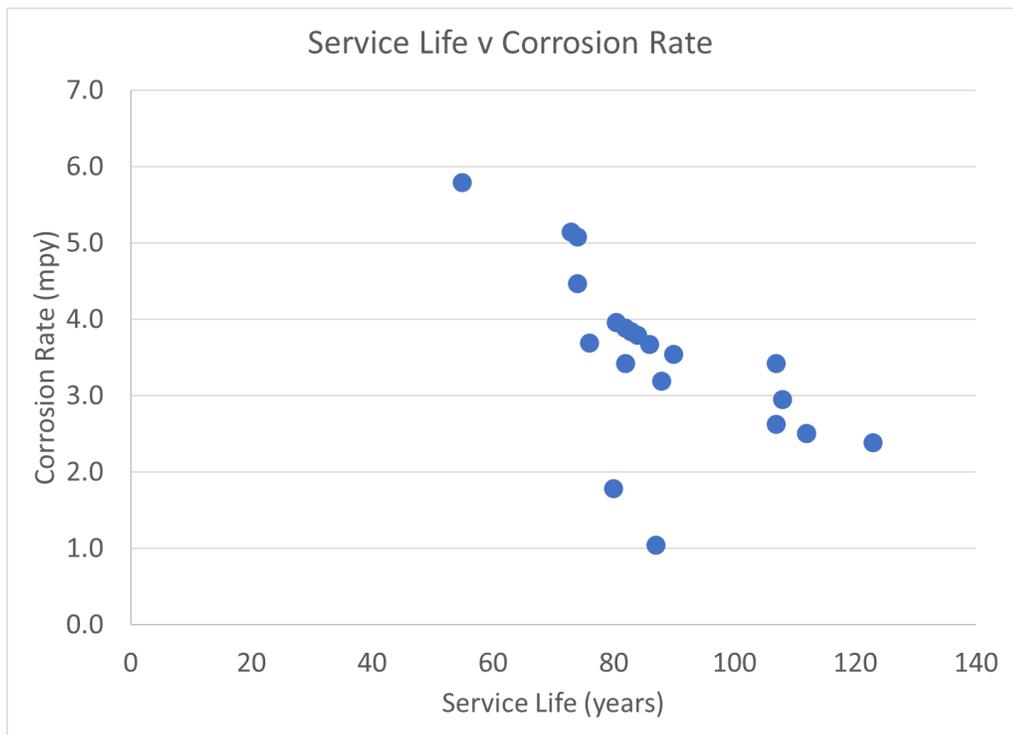
The corrosion failures break down as shown in Figure 2.

**Figure 2 - Corrosion rate vs service life for corrosion related features**

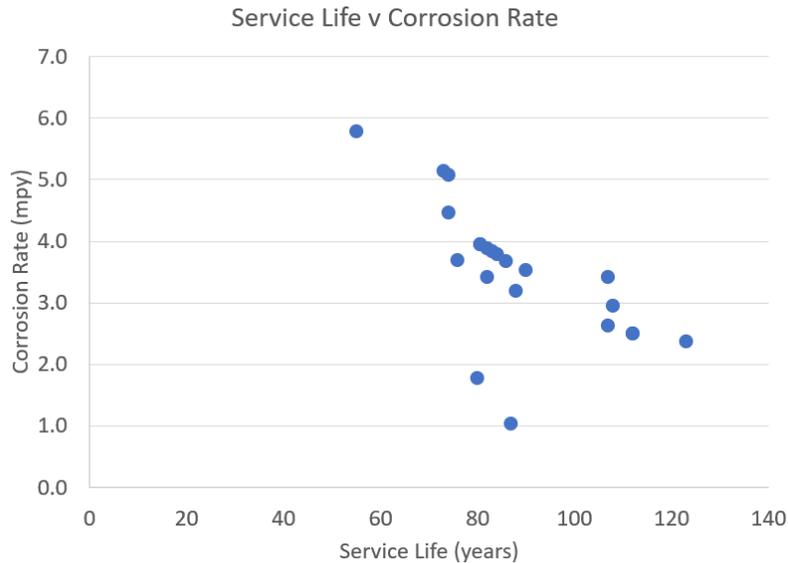
**Figure 10 – Linearized corrosion rate by service life**

The MIT laboratory data tend to overpredict internal corrosion rates evident in CECONY’s piping, which is expected because the laboratory work measured instantaneous corrosion rates on coupons. In the field, a short-term chemistry upset, pooled condensate, and flowing condensate likely act together to create locally high corrosion rates that persist during the upset condition. The corrosion rates likely diminish inside the steam piping once the corrosive condition moves downstream, is corrected by condensate evaporation, and evacuation of the condensate from the piping system. It is clear from the laboratory and field experiences that if an aggressive corrosion mechanism remains relatively stationary on the internal surface of the steam piping, corrosion rates can create the condition for a through wall penetration and loss of steam containment.

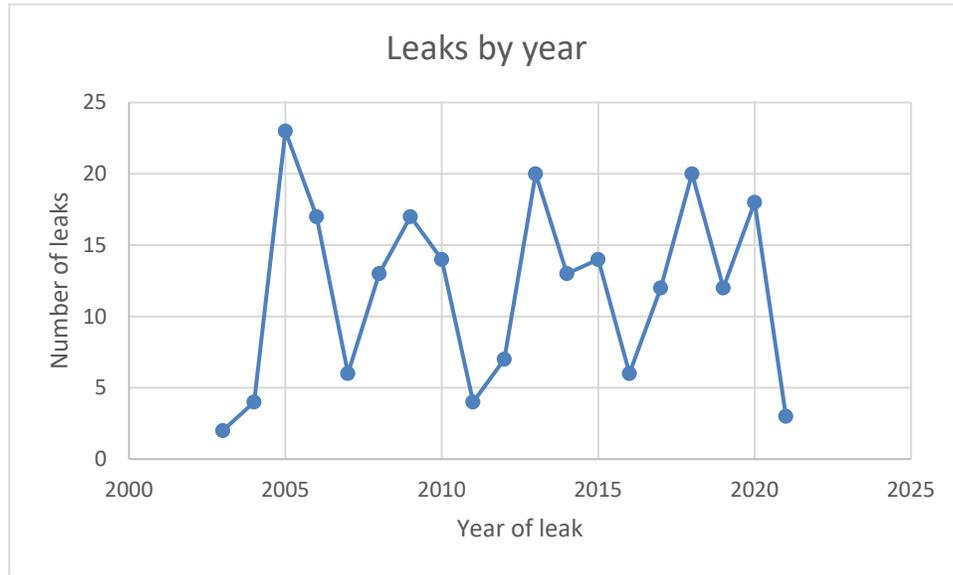
**Figure 11 - Corrosion relate leaks at 6 o'clock position by year**

Six o'clock leaks are areas where steam condensate collected in the bottom of the pipe. This steam condensate would consist of a low pH (between 4.89 and 7.96 based on the information in figures 4 through 6 above). If carbon dioxide or contaminants are present the pH and the overall local corrosion rate would also be impacted negatively. A combination of these conditions would lead to accelerated corrosion at these locations. If pooling of the steam condensate in this location could be avoided, the corrosion failure would not occur.

The surest way to eliminate general corrosion of the distribution piping by the steam condensate is to have no standing steam condensate present in the system.

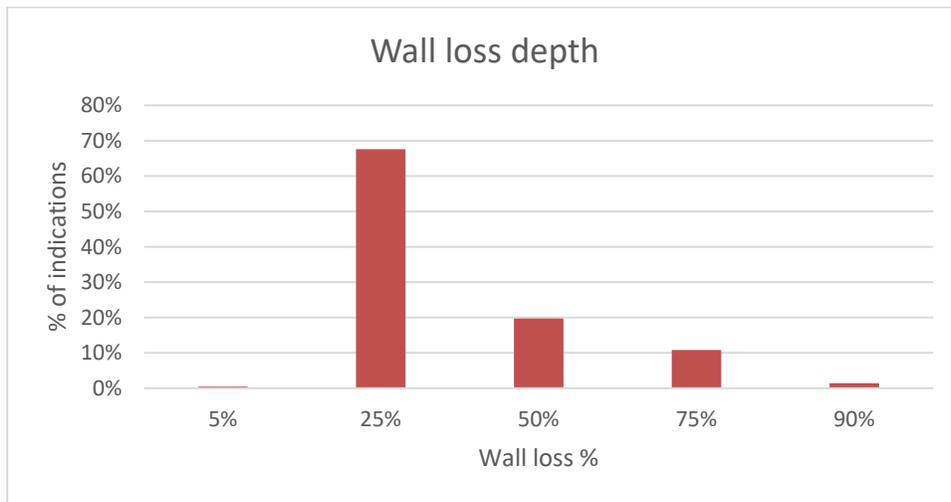
Two thirds of inspected indications were reported as 25% wall loss per Figure 21. Similarly, three quarters of flaws had a length less than 10 inches per Figure 22.

**Figure 21 - Reported wall loss depth for indications**

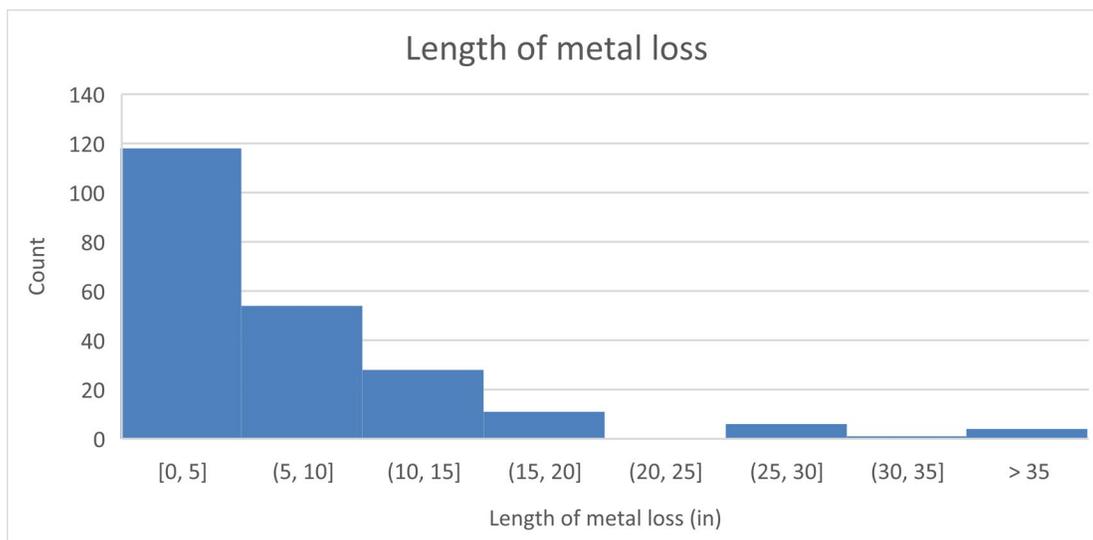
**Figure 22 – Length of reported metal loss features.**

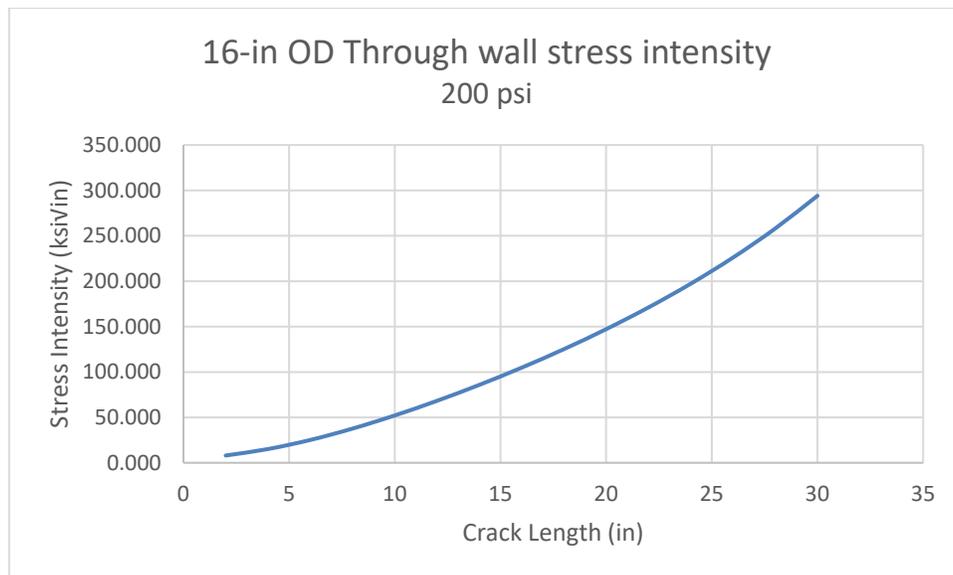
The stress intensity for the 16-inch OD case under 200 psi internal pressure loading for various crack lengths is presented in Figure 23. This stress intensity would be compared to the material's toughness to determine the  $K_I$  in the FAD diagram. The reference stress, which is used to generate the load ratio,  $L^P_R$ , under the same loading scenario is shown in Figure 24.

**Figure 23 – Stress intensity of a through-wall axial crack under 200 psi internal pressure at various crack lengths**

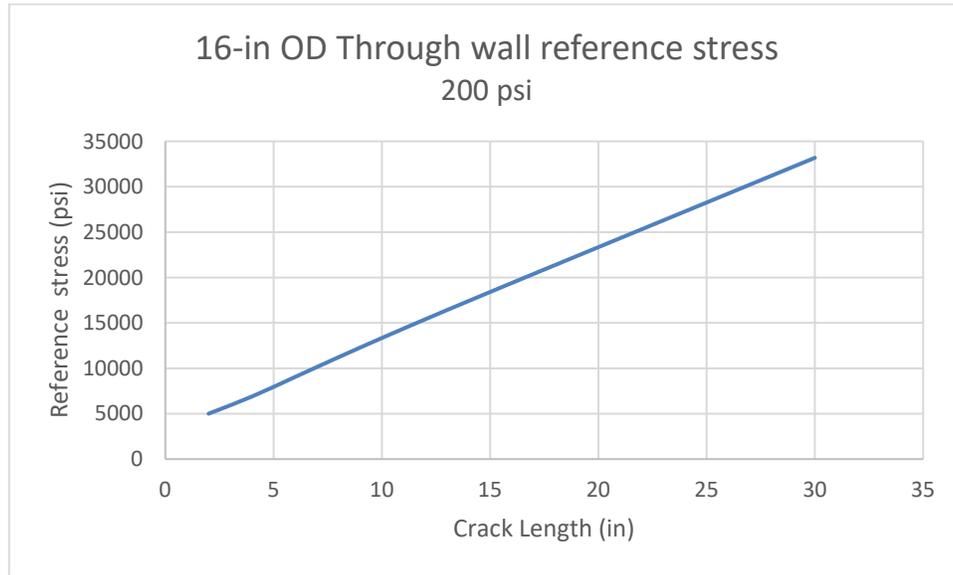
**Figure 24 – Reference stress for a through-wall axial crack under 200 psi internal pressure at various crack lengths**

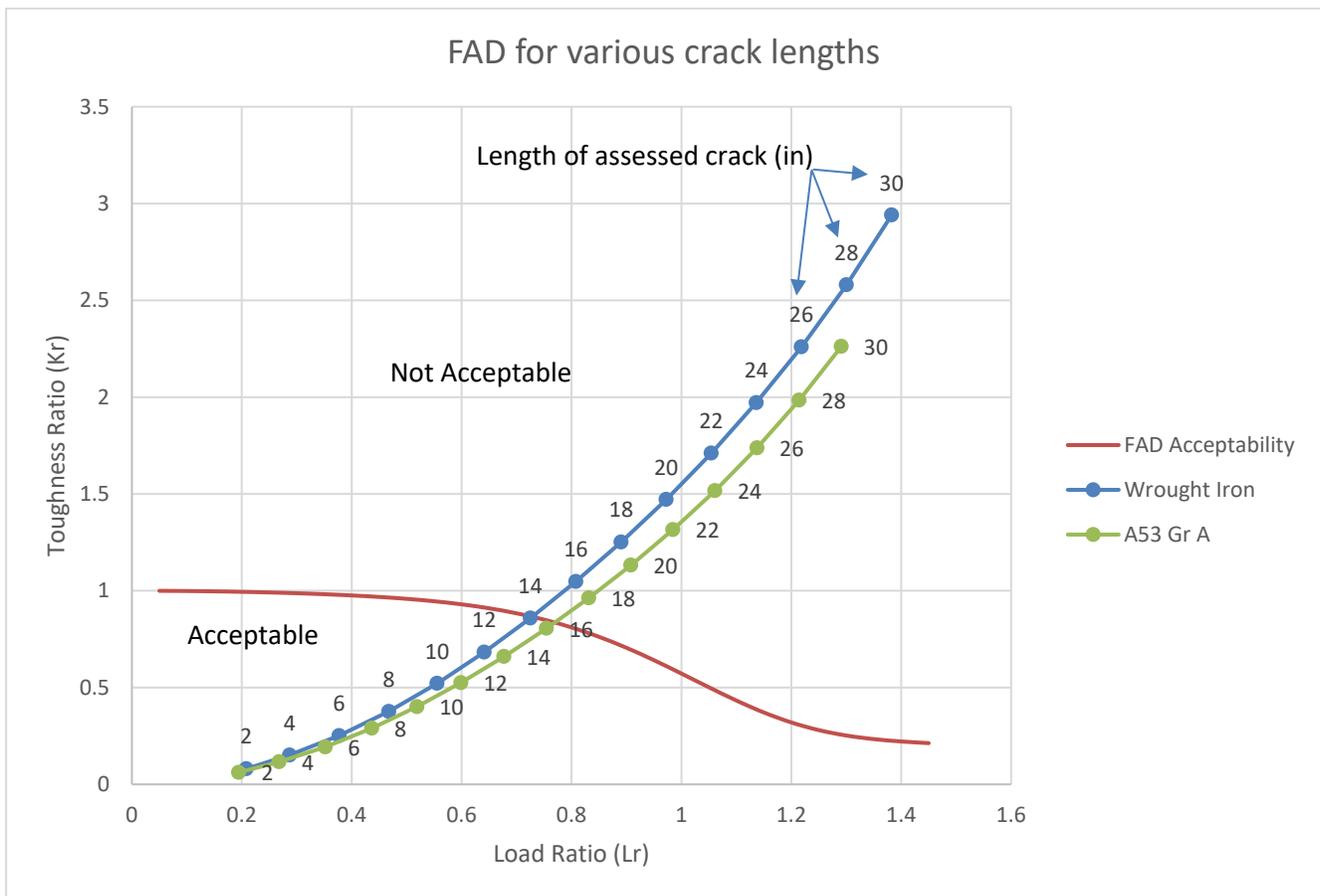
Incorporating this yield and toughness information with the results from section 3.2.3 yields the FAD shown in Figure 25. This figure shows a maximum acceptable crack length for the 16-inch OD wrought iron pipe of 14 inches, and 16 inches for the A52 Grade A pipe.

**Figure 25 – FAD for Wrought Iron and A53 Grade A steel. The region above the red line would be unacceptable, while the region below is acceptable. Lengths of each assessed crack is shown next to each data point. Crack lengths are shown in inches.**

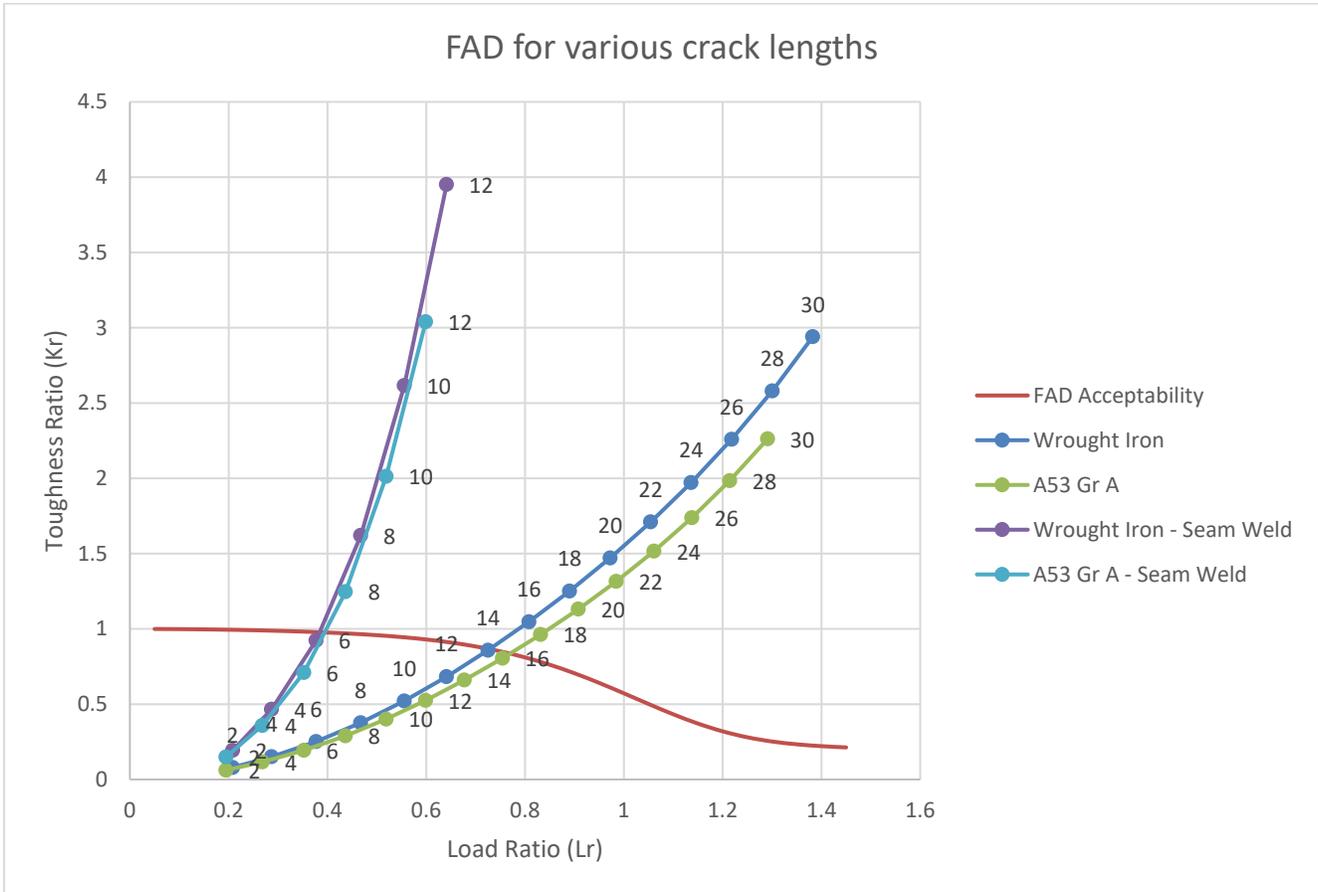
Seam welds introduce additional residual stress on top of the operational stresses the pipe is operating under. These residual stresses serve to increase the stress intensity along the crack tip, therefore reducing the size of a stable flaw. The results displayed above illustrate the stress intensity and reference stress of flaws in the base metal sufficiently far from the seam weld. Because only pipes newer than 2011 are required to be seamless, these residual stresses should be considered in the instance that a region of local metal loss grew through wall along a seam weld. Calculations for residual stresses in the seam weld were taken from API 579 Section 9D.6. The FAD for flaws both with and without the residual stress from the seam weld are displayed in Figure 26.

**Figure 26 – FAD for Wrought Iron and A53 Grade A steel both with and without the residual stress from the seam weld. Cases including the residual stresses from the seam weld are appended with “Seam Weld” in the legend. The region above the red line would be unacceptable, while the region below is acceptable. Lengths of each assessed crack is shown next to each data point. Crack lengths are shown in inches.**

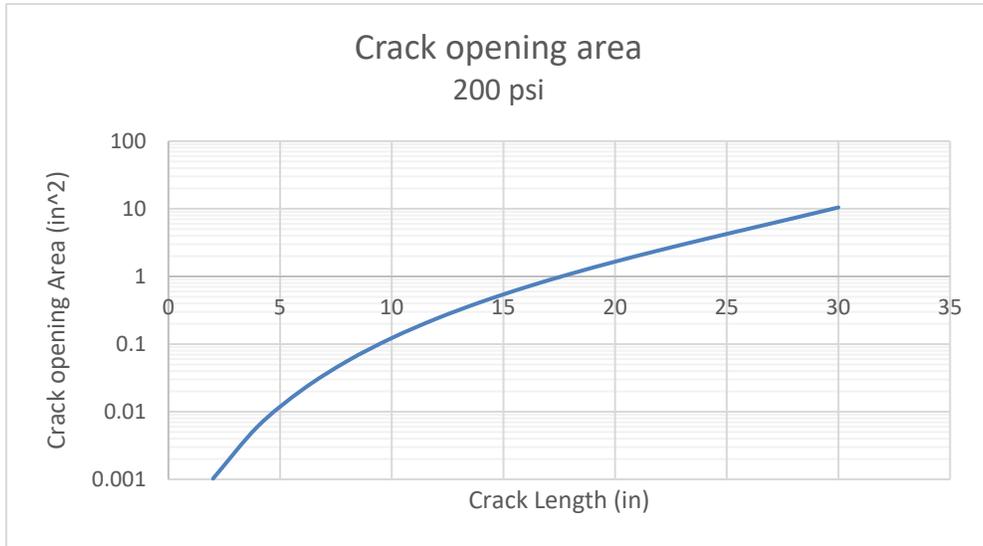
Calculations for the flow rates associated with a given crack area show that for superheated steam at 200 psi and 400°F, a crack length of 14 inches (the maximum acceptable length for wrought iron pipe away from a seam weld), a leak rate of 0.72 lbs/second is predicted. The critical crack length for a flaw in a seam weld in a wrought iron pipe is 6 inches, which has a calculated leak rate of 0.036 lbs/sec.

**Figure 27 – Crack opening area for a through-wall axial crack under 200 psi internal pressure at various crack lengths**

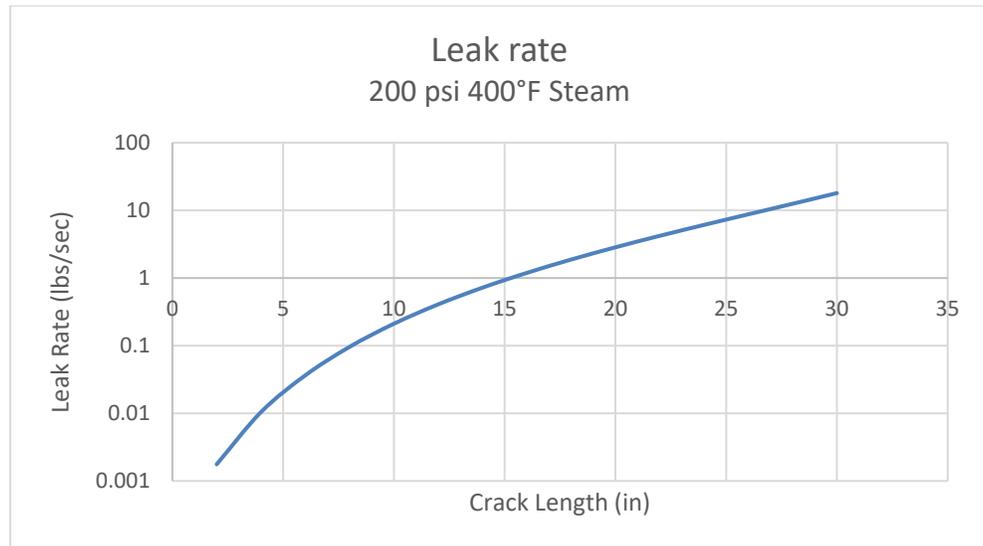
**Figure 28 – Leak rate for through-wall axial crack under 200 psi, 400°F steam at various crack lengths**
