STATE OF NEW YORK  
DEPARTMENT OF PUBLIC SERVICE

Report on  
Steam Pipeline Rupture  
41<sup>st</sup> Street & Lexington Avenue  
Consolidated Edison Company of New York. Inc.  
July 18, 2007  
(CASE 07-S-0984)

Safety Section  
Office of Electric, Gas & Water  
February 2008

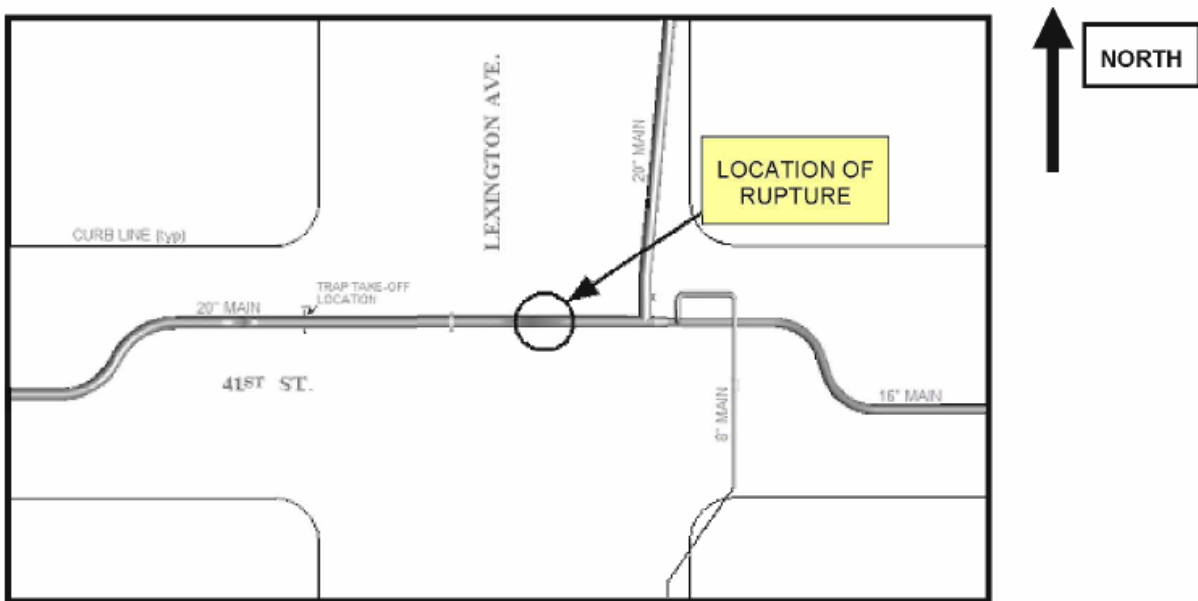
Figure 1 - Plan View of Steam Main Configuration

The steam distribution facilities at the intersection of 41<sup>st</sup> Street and Lexington Avenue, as they existed on July 18, 2007, are shown in Figures 1 and 2. A 20-inch main ran east-west across 41<sup>st</sup> Street, in the northern half of the street. Near the northeast corner of the intersection it connected with another 20-inch main at a T-connection, which then ran north along Lexington Avenue, just west of the eastern curb. Just east of the T-connection, the 20-inch main reduced down to 16 inches. An eight-inch main connected to the top of the 16-inch main east of the reduction in diameter, then turned in a series of bends and followed the sidewalk south along Lexington Avenue to serve two customers.

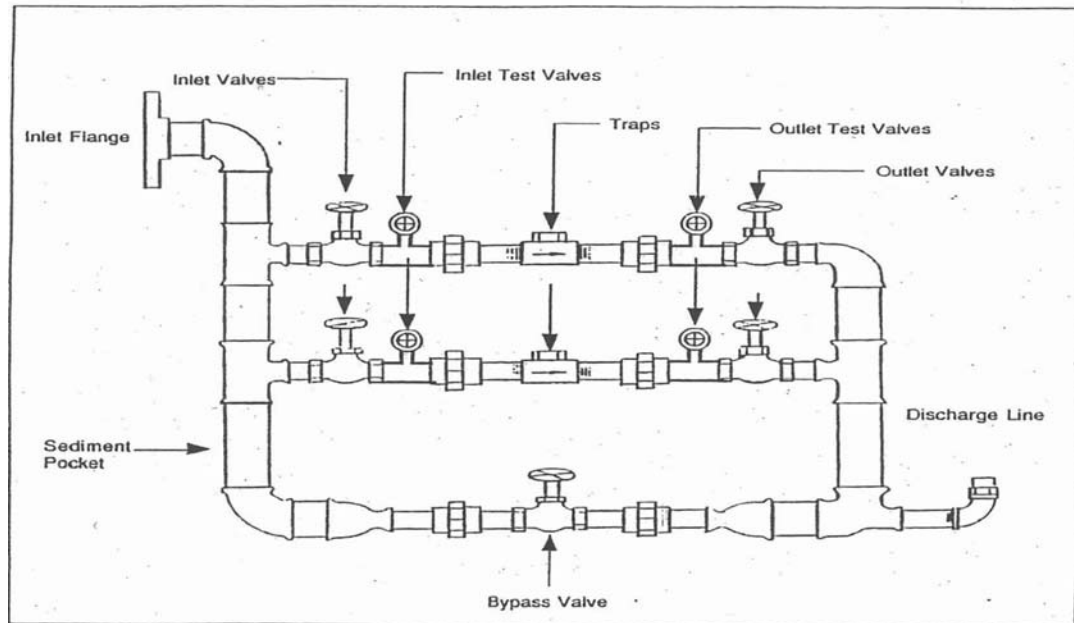
Figure 12 - Diagram of a Trap Assembly

A steam trap assembly was located in a manhole on 41<sup>st</sup> Street just west of Lexington Avenue. The assembly consists of three parallel runs of piping in a manifold. Also located on the front end of the manifold in many cases is a blow down valve, manually used to clear the trap assembly of excessive water and debris during certain operations. The bottom run of piping has a bypass valve for the assembly. On the top and middle run of pipe are two identical steam traps, preceded in-line with isolation valves. The traps are essentially thermodynamic valves, which open when condensate collects to a certain level behind the valve. In typical operations, the traps will pulse open every few minutes. The three pipe runs collect at the end of the manifold and then drain directly into the sewer system (see Figures 12 and 13 below).

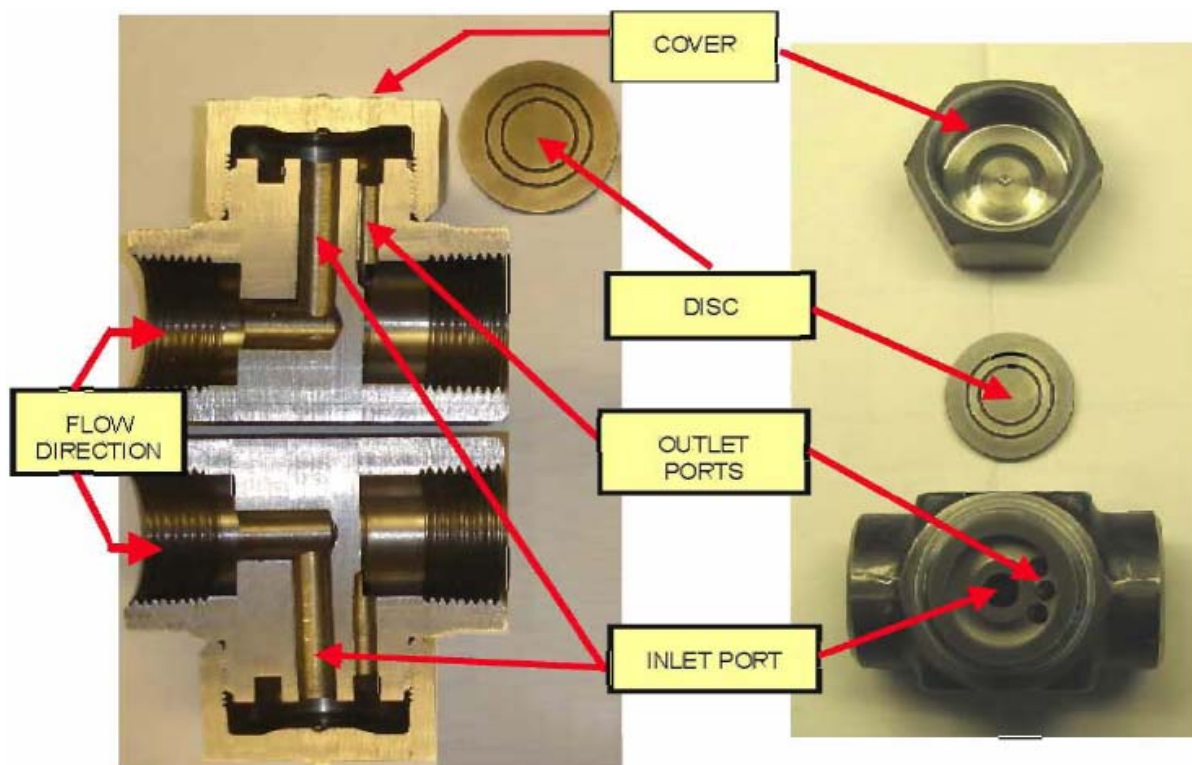
Figure 13 - Steam Trap Cut-Away  
Source: ABS Report 1763931-R-001

ABS analyzed the operating conditions of the steam system on the date of the incident. Its report states that 912 feet of piping drained to the fish-mouth connection mentioned above, where a 2-inch diameter pipe carried condensate to the steam trap assembly. Approximately 47 feet of horizontal piping crossed beneath the intersection at the low elevation (top of pipe at elevation 26.7 feet) – refer to Figure 2). The two steam traps were designed to remove approximately 3,700 pounds of condensate per hour (lbs/hr) combined. Normal condensate generation for the pipe draining to that location was approximately 400 lbs/hr. However, the inlet ports of the traps were clogged with debris.

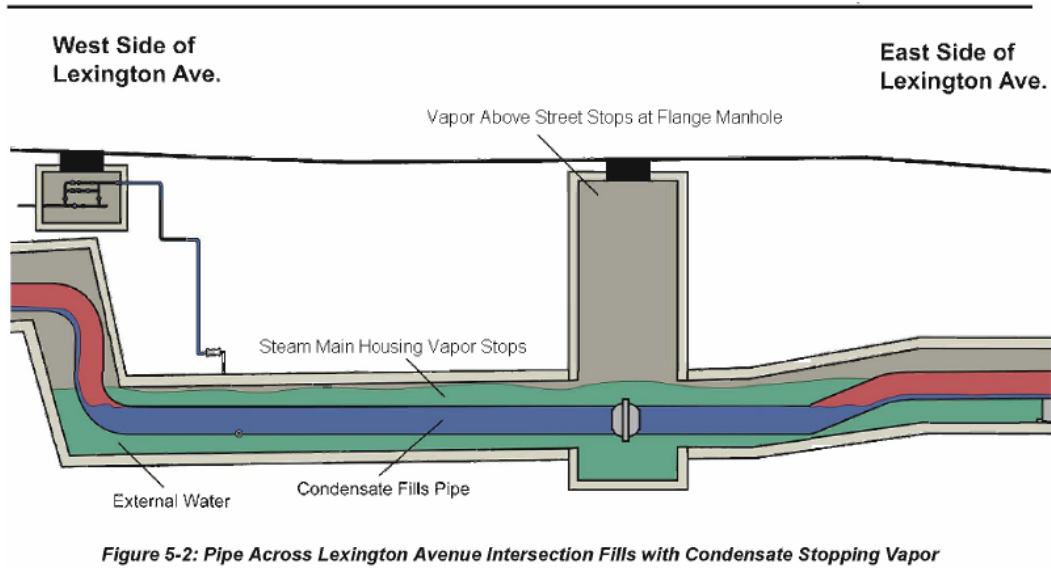
Figure 18 – Pipe Filled with Condensate Stopping Steam Flow

Analysis of the data from pressure sensing telemetry indicates that the pressure differential across the intersection was approximately plus or minus 1 psi from approximately 10:00 AM to 5:30 PM. With the late afternoon operation of valve CV3 described previously, the pressure differential across the intersection rose, with the higher pressure on the west side, allowing steam to come into contact with the condensate, where a steam bubble became entrapped and created the water-hammer phenomenon described earlier (see Figures 18 and 19).

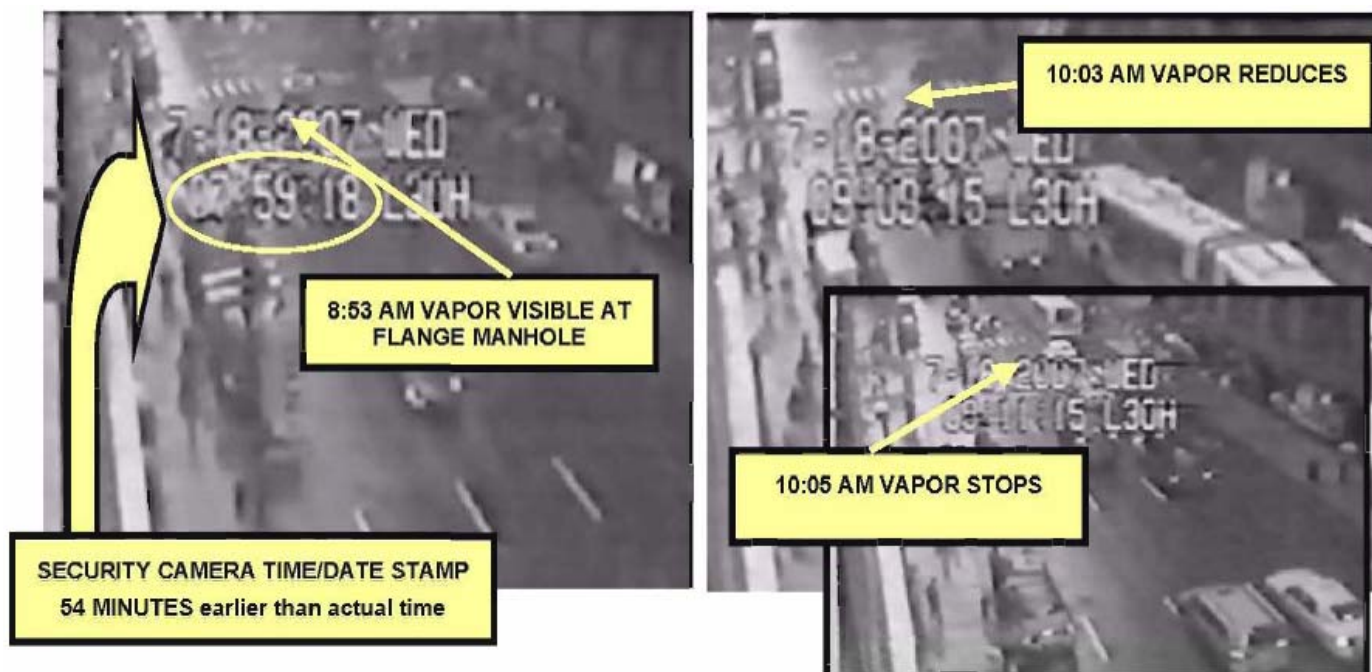
Figure 20 - Start and End of Observable Vapor Condition  
Source: ABS Report 1763931-R-001

An interview of Con Edison management personnel present on the day of the incident, determined that Con Edison initiated a vapor patrol sometime between 8:30 AM and 9:00 AM due to the amount of rainfall predicted, using six experienced people to carry out this task. No vapor condition was observed at 41<sup>st</sup> Street and Lexington Avenue when it was patrolled at approximately 11:30 AM. Subsequent to the incident, Staff suggested that a review of video recorded by a security camera aimed at the intersection from a nearby building be pursued to determine if a vapor condition had existed earlier that morning. The security tapes revealed the existence and then disappearance of a vapor condition at 8:53 AM and 10:05 AM, respectively (see Figure 20 below<sup>17</sup>).
