21029 Agricola Wind- Rapid Ordinary High Water Mark (OHWM) - OHWM Form 1.1	
Project	21029 Agricola Wind Project
ID	378464
Survey Date	08/15/2023
User	Rachel Nazak
General Information	
Project ID #	05-ST003
Site Name	21029 Agricola Wind
Date	08/15/2023
Time	02:38 PM
Location	
Latitude	42.73166717
Longitude	-76.501242
Datum	NAD83/2011
Investigator(s)	JK JP
Step 1: Site overview from remote and online resources	
Check boxes for online resources used to evaluate site	LIDAR, climatic data, geologic maps, land use maps, other, satellite imagery, topographic maps
Other	Natural Resource Mapper
Describe land use and flow conditions from online resources.	Stream occurs between road and agriculture field. Rain within 24 hours prior to survey. This stream partially corresponds with a NYSDEC mapped unprotected stream.
Step 2: Site conditions during field assessment	
Describe Site Condition	Stream is a roadside drainage ditch with steep walls. Vegetation around stream is mowed. Fish observed in pool to north of culvert. Water present in stream channel at time of survey.

Towns of Scipio and Venice, Cayuga County, New York

Wetland and Stream Delineation Report

Agricola Wind Project

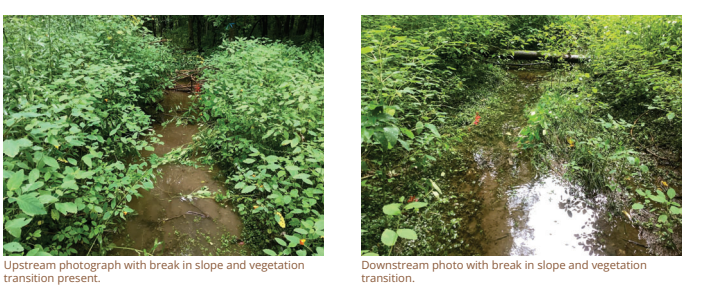
Sediment Indicators	
Soil development	
Changes in character of soil	
Mudcracks	
Changes in particle-sized distribution	
Vegetation Indicators	
Change in vegetation type and/or density	Present
Vegetation Indicator Location	x
Vegetation Change From	vegetation absent
Vegetation Change To	forbs
Vegetation matted down and/or bent:	Present
Matted/Bent Vegetation Indicator Location	x
Exposed roots below intact soil layer:	
Ancillary Indicators	
Wracking/presence of organic litter	
Presence of large wood	
Leaf litter disturbed or washed away	
Water staining	
Weathered clasts or bedrock	
Other observed indicators?	No
Step 4: Additional Information	
Is additional information needed to support this determination?	No
Step 5: Rationale	
Describe rationale for location of OHWM	Break in slope and change in vegetation type and/or density from vegetation absent to forbs were the strongest and most reliable indicators used to define the OHWM. Additionally, vegetation matted down and/or bent occurred intermittently and was used to support the other OHWM indicators where present.

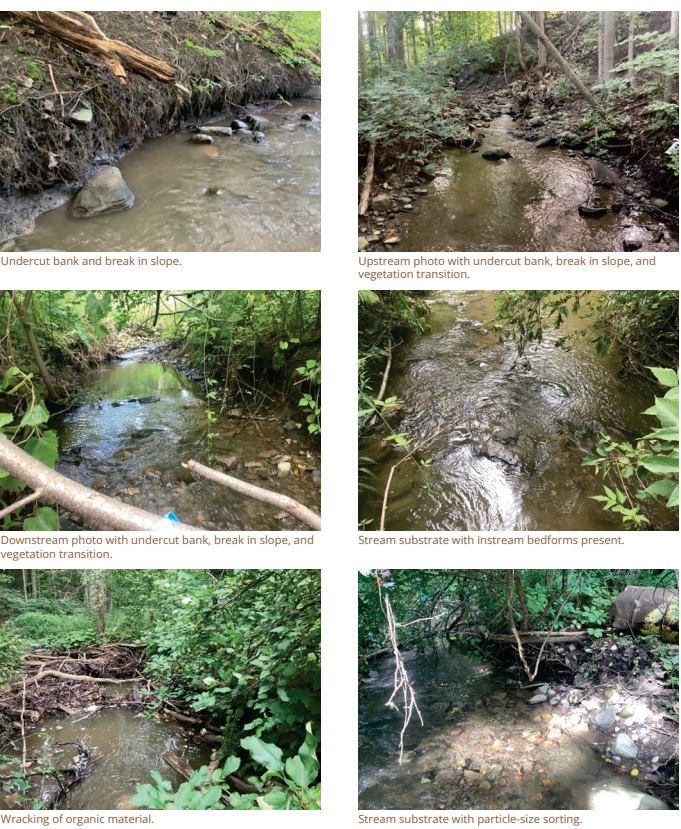
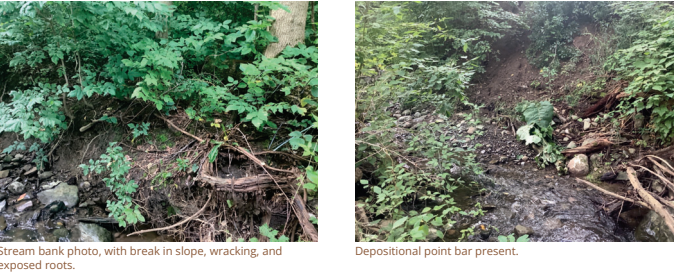
21029 Agricola Wind- Rapid Ordinary High Water Mark (OHWM) - OHWM Form 1.1	
Project	21029 Agricola Wind Project
ID	379645
Survey Date	08/18/2023
User	Rachel Nazak
General Information	
Project ID #	23-ST021
Site Name	21029 Agricola Wind
Date	08/18/2023
Time	10:09 AM
Location	
Latitude	42.725355
Longitude	-76.517294
Investigator(s)	RN JP
Step 1: Site overview from remote and online resources	
Check boxes for online resources used to evaluate site	LIDAR, climatic data, geologic maps, land use maps, other, satellite imagery, topographic maps
Other	Natural Resource Mapper
Describe land use and flow conditions from online resources.	Stream is located at the bottom of a ravine located between agriculture fields. Rain within 48 hours prior to survey.
Step 2: Site conditions during field assessment	
Describe Site Condition	Stream runs through a steep ravine bordered by agriculture fields. Pockets of emergent wetlands occur along stream. Receives water from agriculture tile discharge. Water present in stream channel at time of survey.

Step 3 Indicators	
Geomorphic Indicators	
Break in slope	Present
Break in Slope Indicator Location	x
On the bank	
Undercut Bank	Present
Undercut Bank Indicator Location	x
Valley Bottom	Present
Valley Bottom Indicator Location	a
Other break in slope description	
Shelving	Present
Shelving Indicator Location	a
Shelf at top of bank

Step 5: Rationale	
Describe rationale for location of OHWM	Break in slope, changes in particle-sized distribution from gravel/cobble to silt/loam, and change in vegetation type and/or density from vegetation absent to woody shrubs were the strongest and most reliable indicators used to define the OHWM. Additionally, other indicators were observed intermittently and were used to support the determination of the OHWM when present.
Additional observations or notes
