Re: Case 06-M-1078 – Proceeding on Motion of the Commission to
Audit the Performance of Consolidated Edison Company of
New York, Inc. in Response to Outage Emergencies

Case 06-E-0894
Investigation of Electric Power Outages in Con Edison's Long Island City Network

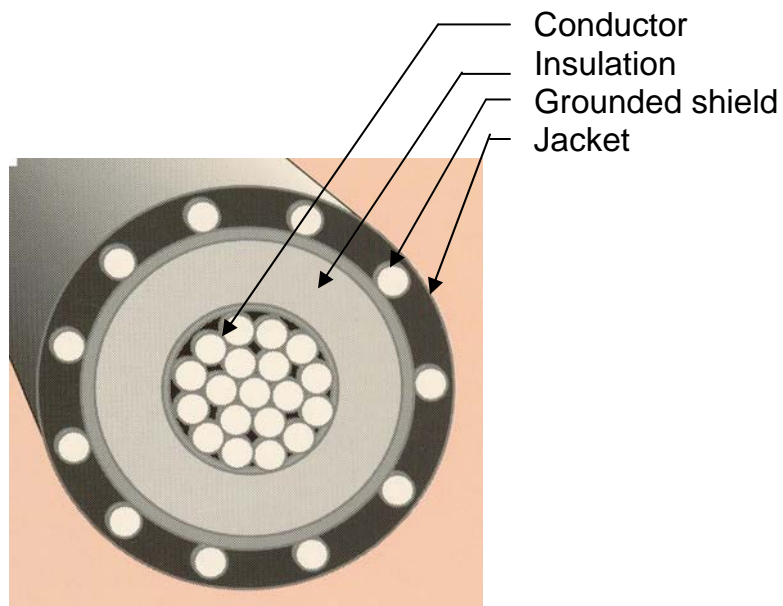
Figure 3.2.1-1 – Primary Cable¹¹

On the Con Edison system, a primary cable is an insulated conductor designed to carry electrical power at voltages above 4,000 volts (4 kV) up to about 33,000 volts. The cable consists of the following components: a metallic conductor or conductors, a layer of insulation such as paper (PILC), cross-linked polyethylene (a plastic material identified as XLPE), or ethylene propylene rubber (EPR), semiconducting layers (consisting of a carbon-black filled polymeric material) between both the conductor and the insulation, and the insulation and the jacket, and a grounded concentric layer of metallic shielding over this insulation; sometimes, an overall non-metallic layer known as a jacket covers the complete construction. A typical primary cable is shown in Figure 3.2.1-1 below.

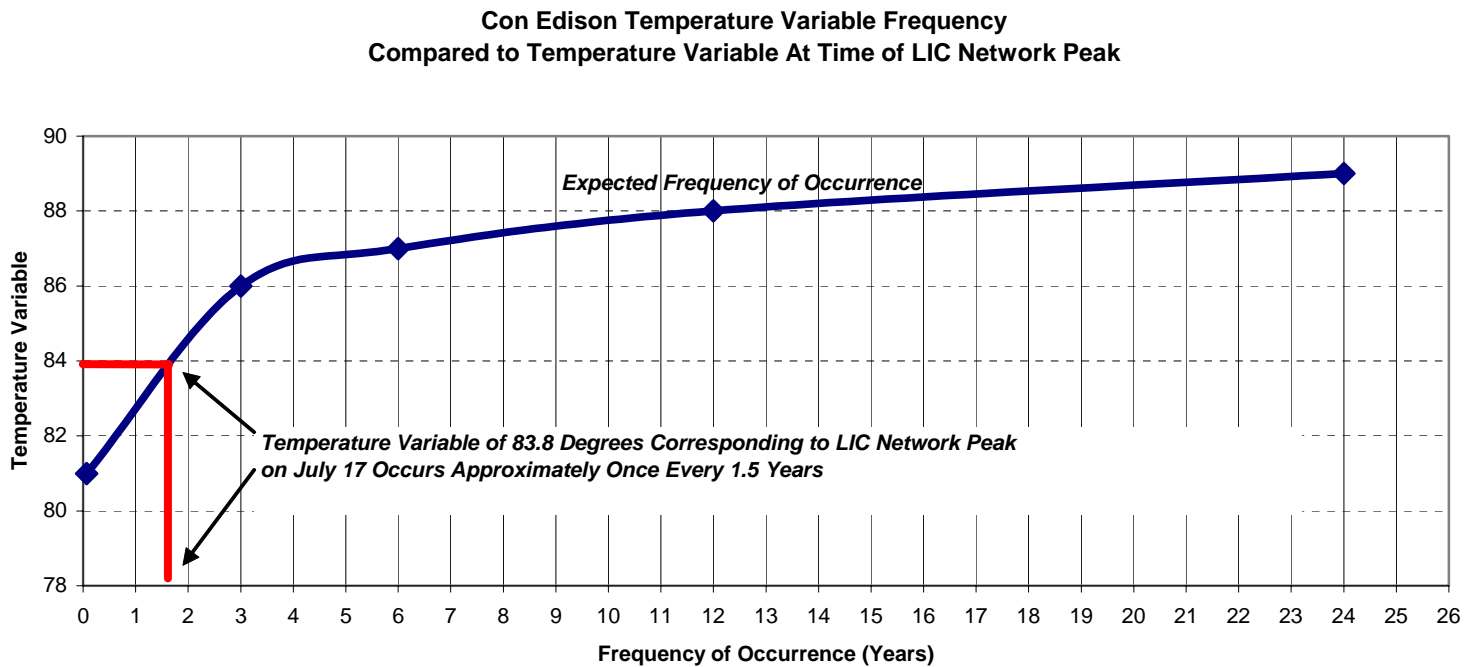
Figure 4.3-2 – Weather Conditions During Long Island City Network Peak Can Be Expected Approximately Once Every 1.5 Years⁵⁹

As a relative comparison, the temperature variable at the time of the Long Island City network event's peak on July 17, 2006 was 83.8 degrees. The system's temperature variable design criterion of 86 degrees was not exceeded at any time during the event. Figure 4.3-2 below illustrates that a temperature variable of 83.8 degrees can be expected to occur approximately once every 1.5 years. From the perspective of this temperature variable, the weather conditions experienced during the Long Island City network event were common.

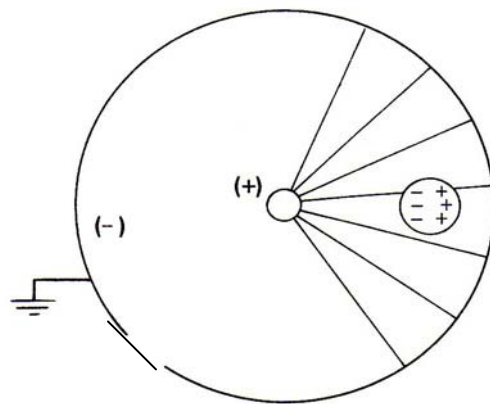
Dielectrophoresis describes the movement of uncharged but polarized particles or molecules (such as moisture) in a divergent electrical field. In the example of an otherwise uniform single conductor electrical cable, the field increases as a particle or molecule gets closer to the conductor. An uncharged particle will be polarized at any given point in time so that it will have a negatively charged dipole with its negative side, for instance, toward the conductor that is positive at that instant. Since the negative side of this dipole exists in a stronger field than the positive side, the particle will be attracted toward the field of greatest field intensity (see Figure 1 below). In an alternating current system, as the conductor becomes negatively charged, the polarization process is reversed. This means that the particle is still attracted toward the conductor with its higher electric field.

The practical effect of dielectrophoresis is that moisture will be drawn to the higher dielectric field region even in an alternating field. This high stress point in a perfect cable is the conductor and if moisture is available on the outside of a cable or joint, it will be drawn toward the conductor. This may present some problems for extruded or solid dielectric cables (XLPE or EPR), but it creates a much more serious problem for paper insulated cables.

The practical aspect of this for stop joints is that moisture can be drawn toward the conductor through paper insulation even though there is a rubber like covering (EPR, silicone, XLPE) over the outside layer. As long as there is a voltage drop across the material, moisture will be drawn toward the paper insulation. A metallic barrier (such as the lead sheath of a PILC cable) solves this problem as long as it remains undamaged. An insulating jacket over the semi-conducting surface is generally used, but must be completely sealed to the jacket or sheath of the cable to prevent this occurrence.

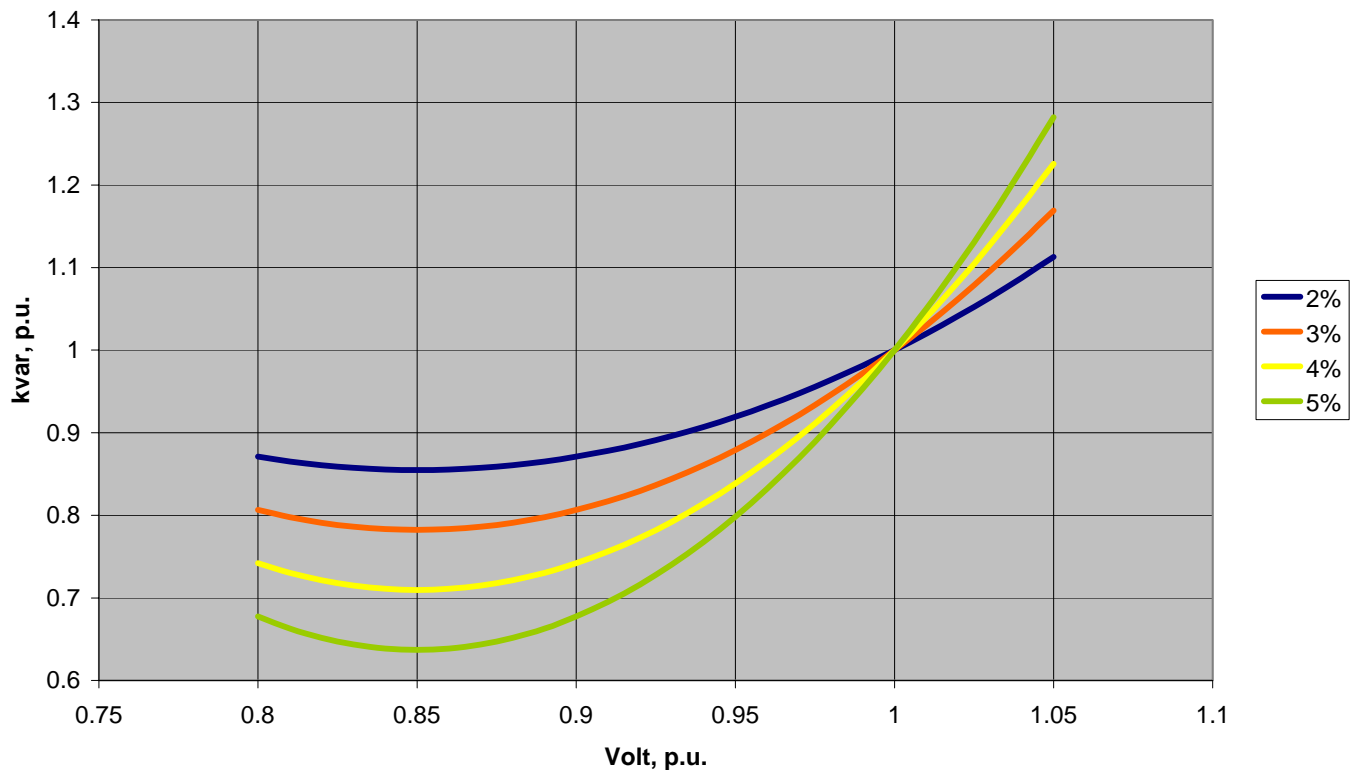
Figure 1 below illustrates several second degree polynomials for dependencies with reactive load to voltage sensitivity in the vicinity of the nominal voltage 2%, 3%, 4%, and 5% in voltage.

Reactive load dependencies on voltage. (Examples of second polynomial curves with different sensitivity factors in the vicinity of the nominal voltage).

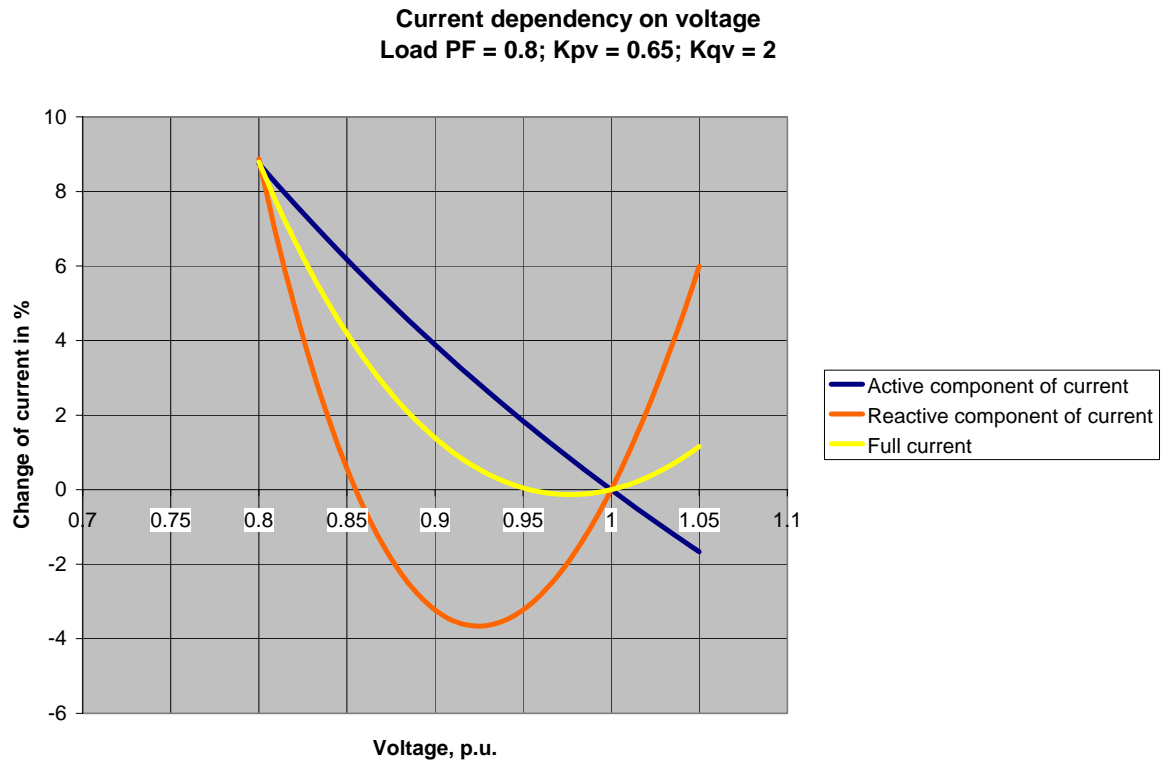
Figure 2

Also seen in Figure 2, when the load power factor is 0.8 and the initial reactive load sensitivity factor is 2, the actual current does not practically change with voltage reduction down to 95% of nominal. After that, the current increases, due to the reduction of the reactive load sensitivity. According to the static reactive load-to voltage sensitivities for air conditioners and refrigerators, they are in the range of 2.3 – 2.5%.

Current dependency on voltage. Apparent current increases when the voltage is below 95% of the nominal voltage and reaches four percent of increase, when the voltage is 0.85 p.u. The real component of the current is increased by 6% at voltage 0.85 p.u., while the reactive component of current returns close to the nominal value. (Kpv is the real load to voltage sensitivity factor, and Kqv is the reactive load to voltage sensitivity factor).

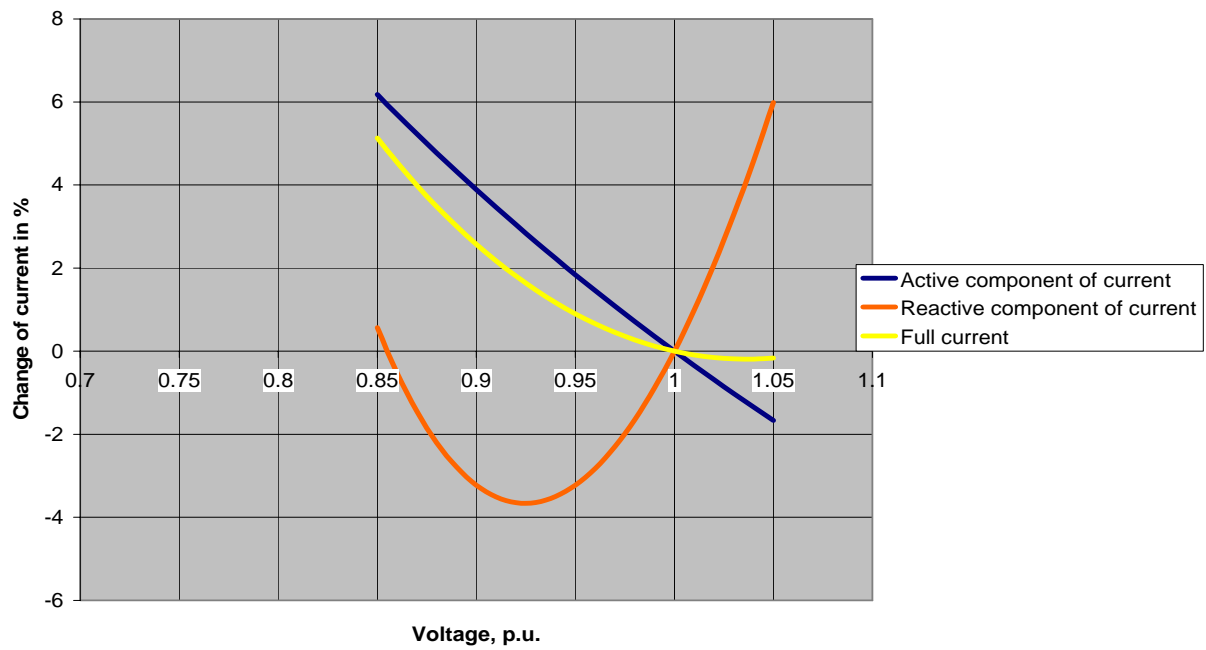
Figure 3

With the same initial sensitivity of the reactive load (2%), but with higher power factors (smaller portion of the reactive component), the apparent (full) current increases with voltage below the nominal (*See*, Figures 3 and 4).

Current dependency on voltage
Load PF = 0.9; Kpv = 0.65; Kqv = 2

Current dependency on voltage. Current increases when the voltage is below the nominal voltage.

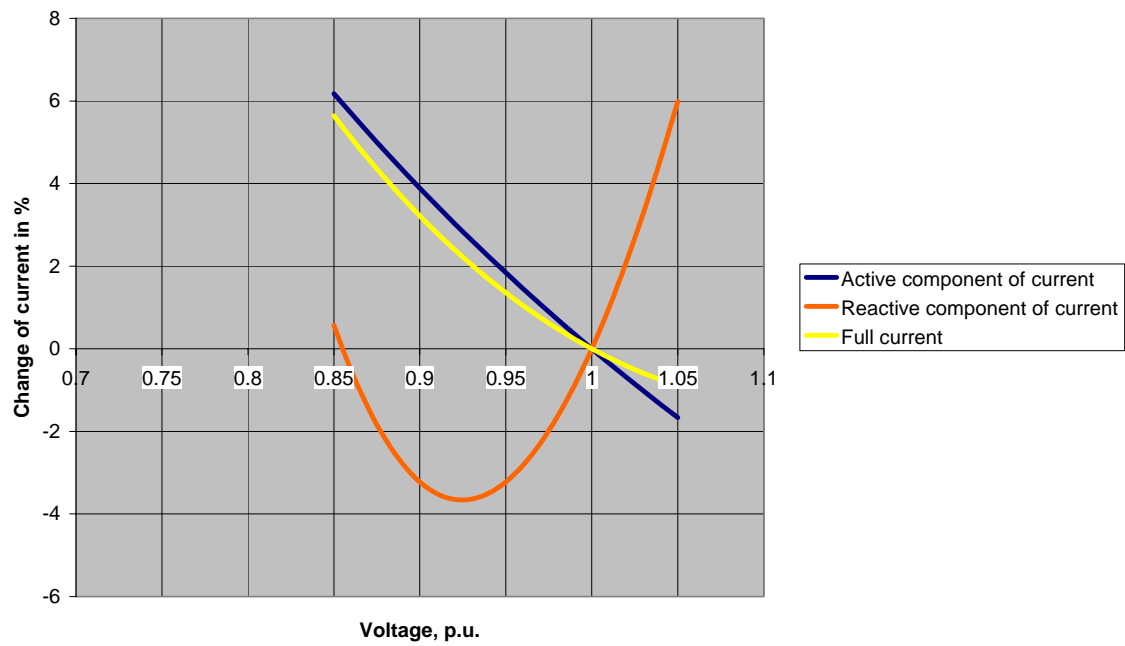
Figure 4

Current dependency on voltage
Load PF = 0.95; Kpv = 0.65; Kqv = 2

Current dependency on voltage. Current increases when the voltage is below the nominal voltage.

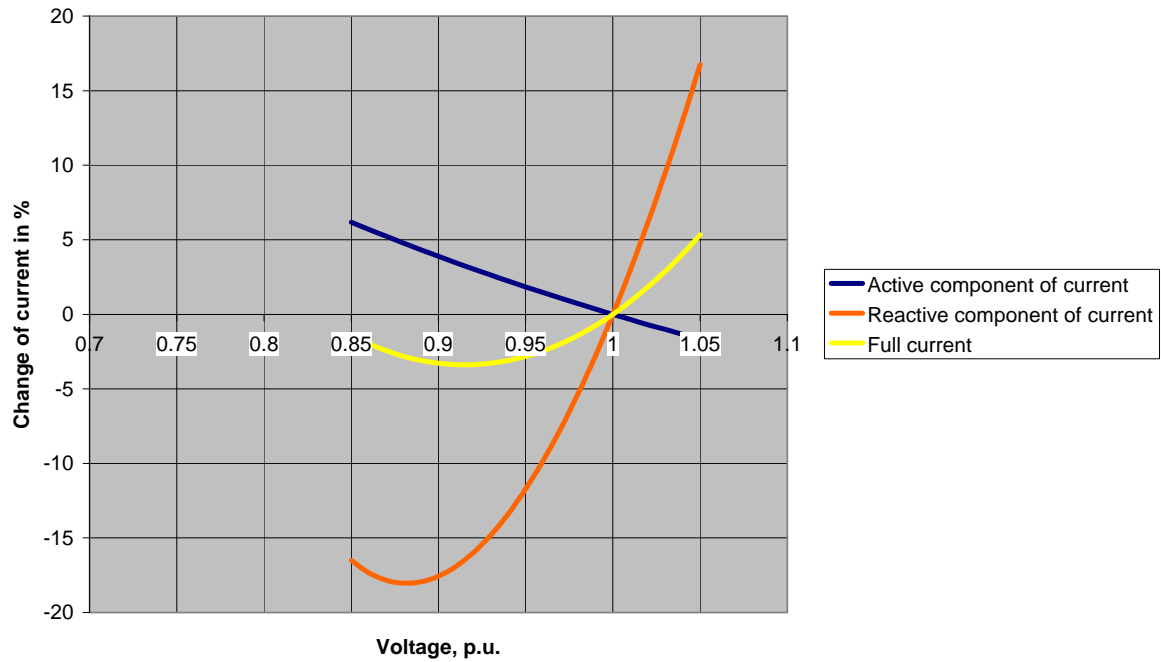
If the sensitivities of the reactive load are higher, then a reduction of the actual load current with voltage reduction is more likely. As seen in Figure 5 below, when the load power factor is 0.8, and the initial reactive load sensitivity is 4%, the actual current is reduced, if the voltage is below nominal. With a power factor of 0.9, the current starts increasing, when the voltage is below 90% of the nominal, and only with a power factor greater than 0.95 does the current increase below the nominal voltage (*See*, Figures 6 and 7). The reactive load to voltage sensitivities in a large network depend on the composition of different loads. Static reactive load to voltage sensitivities for residential load in summer is 2.9%, for commercial load it is 3.5%, and for industrial loads it is 6.0%. A mix of loads, which provides a sensitivity factor about 4%, is very realistic.

Current dependency on voltage
Load PF = 0.80; Kpv = 0.65; Kqv = 4

Current dependency on voltage. Current is reduced when voltage is below the nominal voltage due to low power factor and high reactive load sensitivity to voltage.

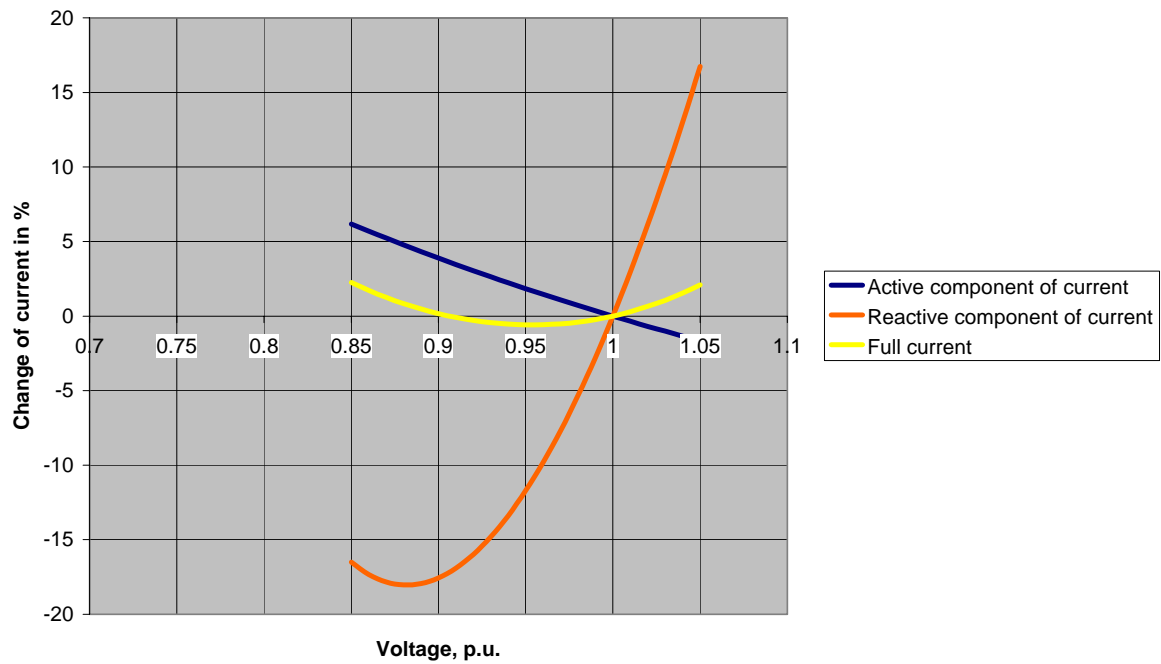
Figure 6

Current dependency on voltage
Load PF = 0.90; Kpv = 0.65; Kqv = 4

Current dependency on voltage. Current is increased when the voltage is below 90% of the nominal.

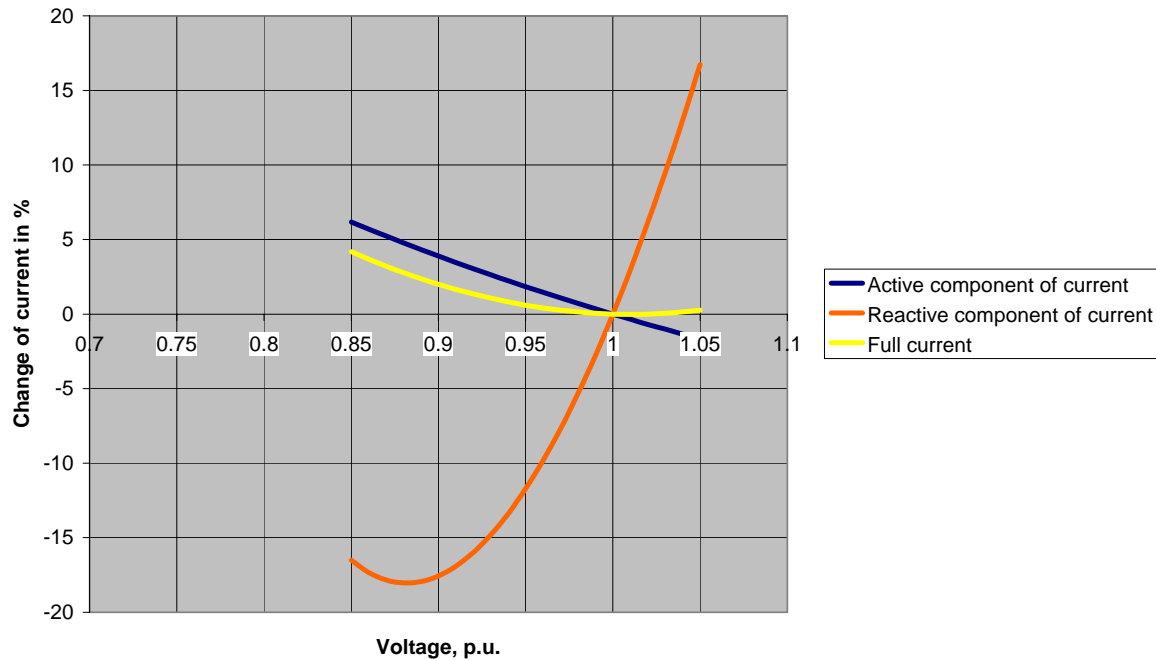
Figure 7

Current dependency on voltage
Load PF = 0.95; Kpv = 0.65; Kqv = 4

Current dependency on voltage. Current is increased when the voltage is below nominal due to high load power factor.
