Re: Case 06-M-0878 – Joint Petition of National Grid PLC and KeySpan Corporation for Approval of Stock Acquisition and Other Regulatory Authorizations – Annual Asset Condition Report Filing by Niagara Mohawk Power Corporation d/b/a National Grid

REPORT ON THE CONDITION OF PHYSICAL ELEMENTS OF TRANSMISSION AND DISTRIBUTION SYSTEMS

CASE 06-M-0878

OCTOBER 1, 2012

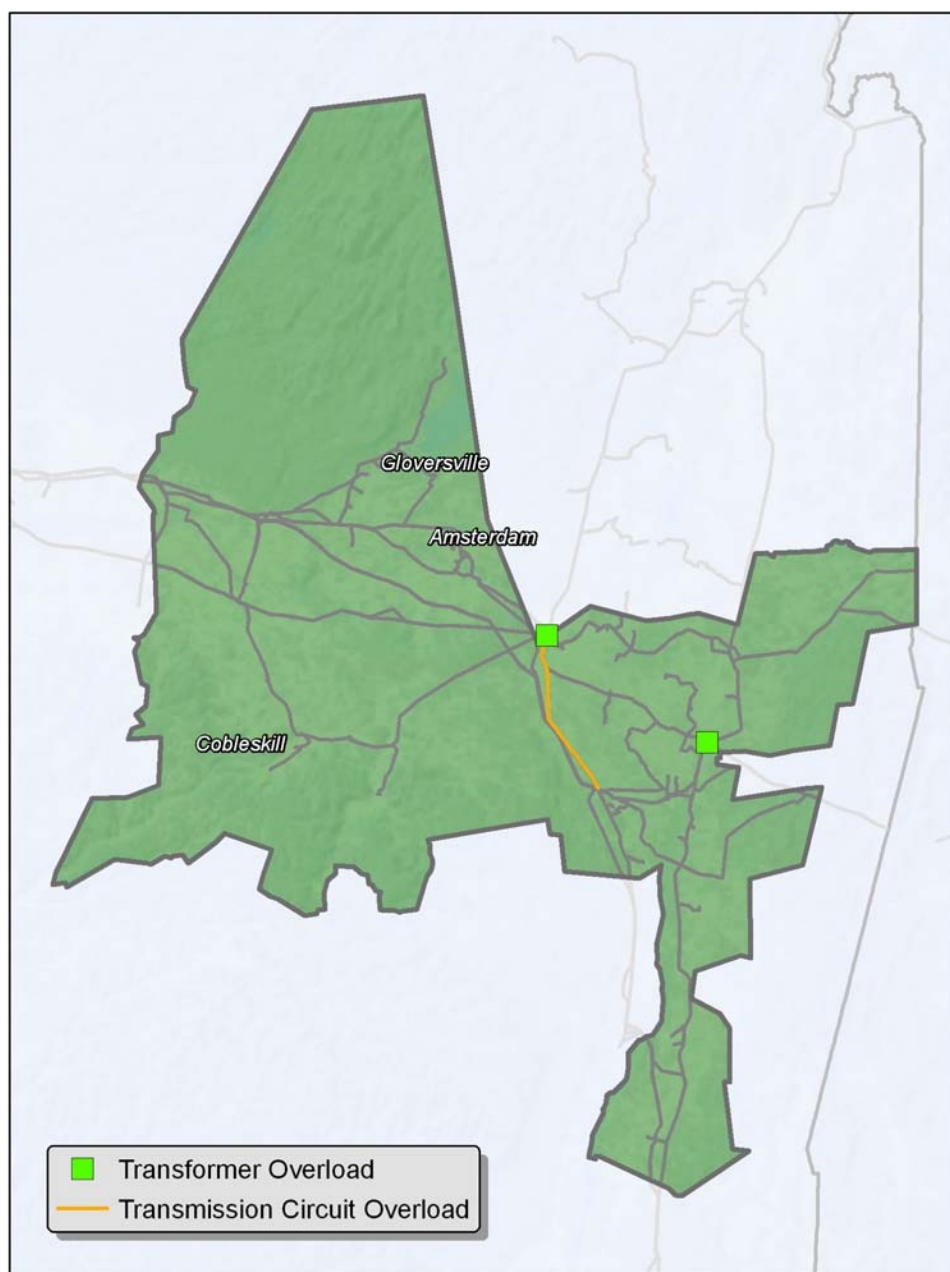
Figure 3-17
Capital and Hudson Valley Area Forecasted Transmission Capacity Constraints Map

Impacted Asset	kV	Contingency	Need Year	Power Flow Case	Driving Issue	Project Number (s)	Comments / Mitigation / Corrective Action
Rotterdam 230-115 kV transformer TB8	230-115	Bus fault at Rotterdam with stuck breaker R82	2012	sum12_90_10_NRRP_Final_x_x	118% LTE 104% STE	C34523	The recommended solution is the new 230-115 kV Eastover substation in the Northeast Region.
Altamont-New Scotland #20	115	Rotterdam-Jordan #31	2026	Sum26_90_10_NRRP_final_x_x	117% LTE		The preferred alternative is to install a reactor in the #20 line. Since this problem is beyond the mid term planning horizon, load developments in the area will be monitored in the interim.
Reynolds Rd 345-115 kV transformer	345-115	bus section 99 at Albany	2026	Sum26_90_10_NRRP_final_x_x	112% LTE		The preferred alternative is to install the second 230-115 kV transformer at Eastover Rd. Because this problem is beyond the mid term planning horizon, load developments in the area will be monitored in the interim.

Rotterdam-New Scotland #19	115	Rotterdam-Jordan #31	2026	Sum26_90_10_NRRP_final_x_x	116% LTE		The preferred alternative is to install a reactor in the #19 line. Because this problem is beyond the mid term planning horizon, load developments in the area will be monitored in the interim.

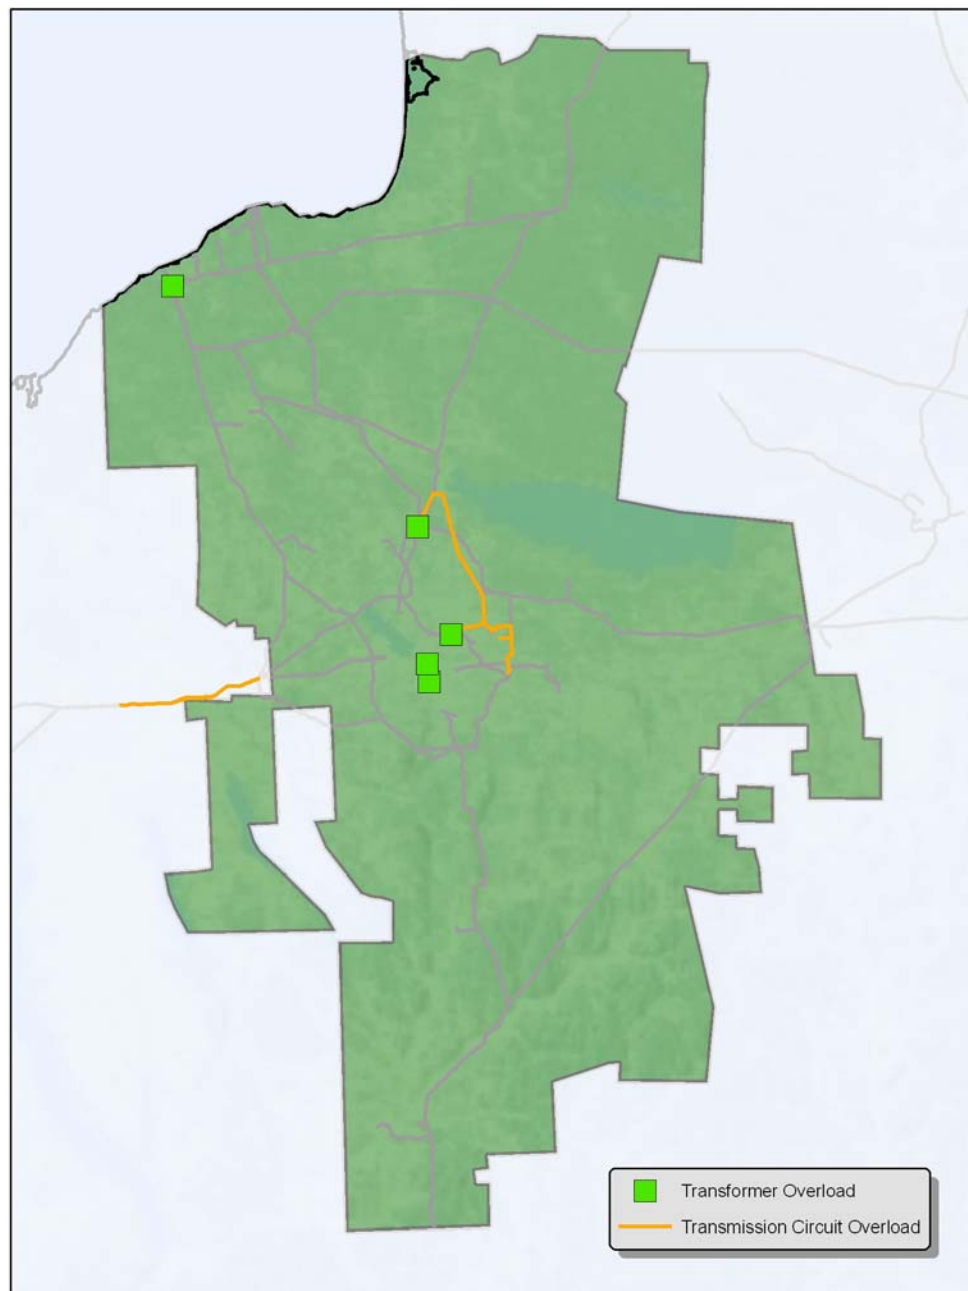
Figure 3-35
Syracuse Oswego Cortland Study Area Forecasted Transmission Capacity Constraints Map

Impacted Asset	kV	Contingency	Need Year	Power Flow Case	Driving Issue	Project Number (s)	Comments / Mitigation / Corrective Action
Clay Transformer Bank	345		2012	2016 FERC base case			A spare transformer will be put into service. See Note 1
Clay – Teall line	115		2012	2016 FERC base case		CNYPL28	This line will be reconducted (12.83 miles). See Note 2
Clay – Dewitt line	115		2012	2016 FERC base case		CNYPL28	This line will be reconducted (10.24 miles). See Note 3
Ash Street substation	115	3 Phase fault	2012	NYISO 2012	Over Duty (112%)	CNYPL26	Affected breakers will be replaced with higher rated units.
Oswego substation	115	3 Phase fault	2012	NYISO 2012	Over Duty (130%)	CNYPL26	Affected breakers will be replaced with higher rated units.
Teall substation	115	3 Phase fault	2012	NYISO 2012	Over Duty (125%)	CNYPL26	Affected breakers will be replaced with higher rated units.
Temple substation	115	3 Phase fault	2012	NYISO 2012	Over Duty (111%)	CNYPL26	Affected breakers will be replaced with higher rated units.

Presently, there is a spare transformer located at that station, which was intended to be put into service in place of the smaller TB. This bank is a part of Transmission Asset Strategy's Transformer Replacement Project, which will replace this bank with the existing spare and install a new spare. As this solution will take up to 12 weeks, it will need to be done during light load conditions.

The recommended solution is to reconductor 12.83 miles of this line. Because this issue involves contingencies that produce overloads above STE, interim measures must be taken. It is

The recommended solution is to reconductor 10.24 miles of this line. Interim operating measures such as load switching, generation redispatch, or load shedding may be necessary.

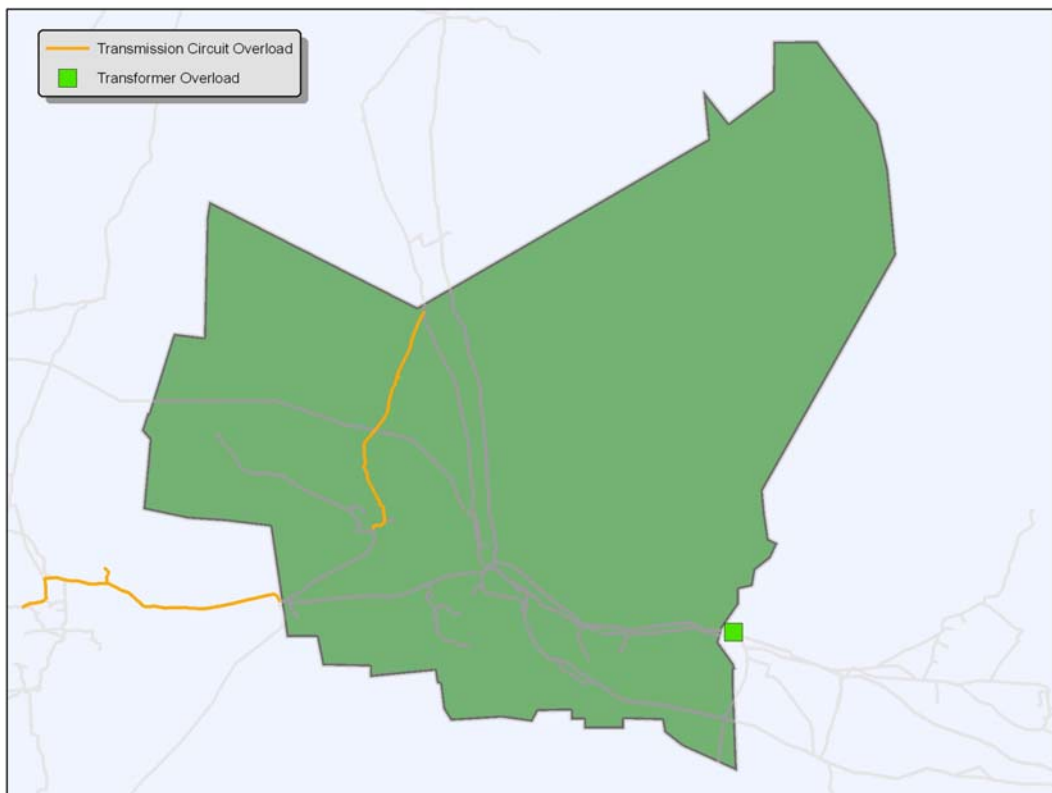
Figure 3-45
Utica Rome Study Area Forecasted Transmission Capacity Constraints Map

Impacted Asset	kV	Contingency	Need Year	Power Flow Case	Driving Issue	Project Number (s)	Comments / Mitigation / Corrective Action
3 (Boonville-Rome)	115	Rome south bus fault	2012	Summer 2012	101.9% of LTE	C03778	Rome Rebuild project will put line #3 and #4 on the same bus, which will eliminate the contingency of losing #1 and #4 together for a fault on the south bus.
8 (Rome – Camden wire)	115	Fault at Oneida on LN8 (Oneida-Ferner) with R80 breaker failure	2012	Summer 2012	Area Voltages at .83 pu		The recommended solution is to add a 25 MVar capacitor bank at Rome.
5 (Teall – Oneida)	115	N-1-1: Edic 345/115 kV TB3 followed by 14 (Edic-New Scotland)	2016	Summer 2016	130% of LTE, 108% of STE		An operational solution exists. However, it is also recommended that the Edic 345/115 kV TB3 transformer be moved to a spare position with breaker R160 and R110. See Note 1.
14 (Boonville-Griffiss)	115	N-1-1: 1 (Rome-Oneida) followed by opening of breaker 30 at Boonville	2016	Summer 2016	119% of LTE, 104% of STE		A permanent solution must be determined by further study. See Note 2.

While it is recommended for many contingencies that the phase shifter angle be increased to its maximum value, this action is often not sufficient to completely eliminate the problem and a reduction of Central-East transfer must also be made. Therefore, another option being considered is to replace the phase shifting transformer with one having a larger range.

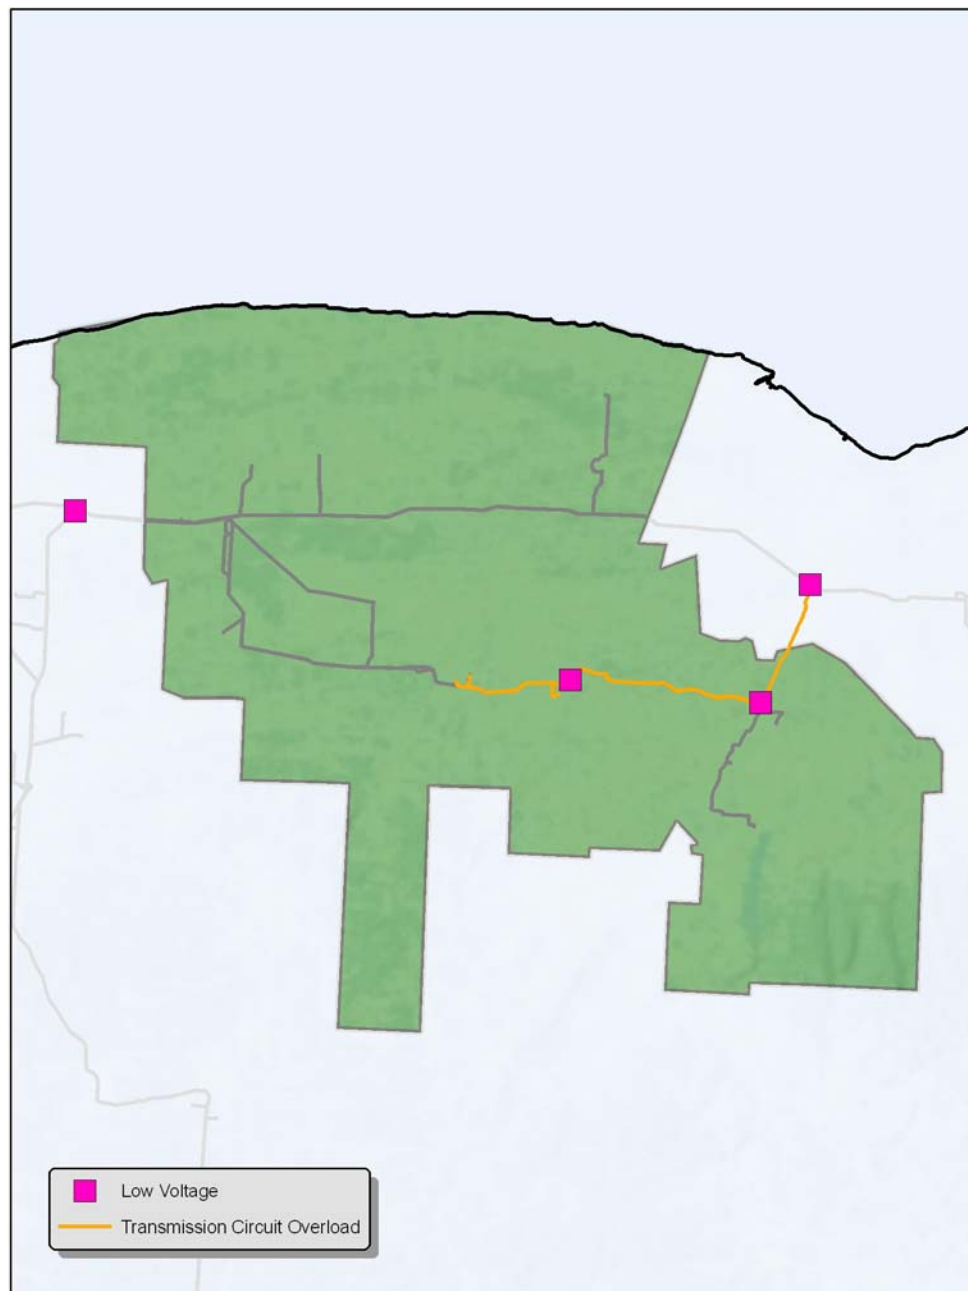
Figure 3-55
Genesee Study Area Forecasted Transmission Capacity Constraints Map

Impacted Asset	kV	Contingency	Need Year	Power Flow Case	Driving Issue	Project Number (s)	Comments / Mitigation / Corrective Action
Golah and Brockport Area Voltages	115	Lockport Stuck Bus Tie Breaker	2012	Summer 2016	Voltages below 0.60 pu	C31482	The recommended solution is to add a second bus tie breaker at Lockport. See Note 1.
110 (Mortimer-Golah)	115	Lockport Stuck Bus Tie Breaker	2012	Summer 2016	232% LTE, 199% STE	C31482	The recommended solution is to add a second bus tie breaker at Lockport. See Note 1.
Mortimer bus tie breaker	115	Lockport Stuck Bus Tie Breaker	2012	Summer 2016	157% LTE, 137% STE	C31482	The recommended solution is to add a second bus tie breaker at Lockport. See Note 1.
119 (SE Batavia-Golah)	115	Lockport Stuck Bus Tie Breaker	2012	Summer 2016	142% LTE, 132% STE	C31482	The recommended solution is to add a second bus tie breaker at Lockport. See Note 1.
Golah Voltages	115	Mortimer Stuck Bus Tie Breaker	2012	Summer 2016	Voltages below 0.50 pu	C24629, C24631, C24631	The recommended solution is to add a second bus tie breaker at Mortimer. See Note 2
