STATE OF NEW YORK DEPARTMENT OF PUBLIC SERVICE

Re: Case 08-V-0835 – In the Matter of Verizon New York Inc.’s Network Review Plan.

Volt-Ohm Resistance Test Method to verify ONT Ground Path Continuity

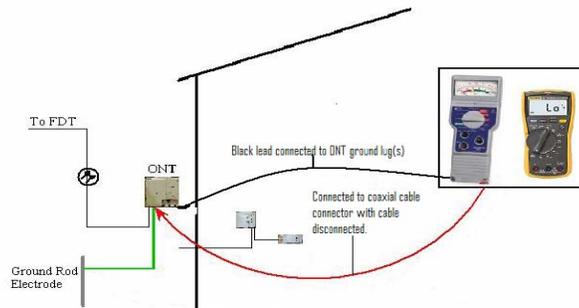
This is the method for verifying ground path continuity ONTs and must be used in every case where the technician has immediate access to the ONT. This test may be preformed with either a Sidekick or Volt-Ohm meter.

1. With the ONT Technician door open, connect the Red Lead to one of the ONT coaxial connector with the coaxial cable disconnected.
2. Connect the Black Lead to the ONT ground lug(s)
3. Turn the resistance test function
 - Sidekick Meter: Turn the dial to the “R x 1” position
 - Volt-Ohm Meter: Turn the dial to the Ohm (Ω) position
4. Check the Resistance (Ω) reading
 - $\leq 0.5\Omega$ verifies the continuity of the ground path through the ONT
 - $>0.5\Omega$ indicates a problem with the ground path within the ONT

³ See the enclosure for the "ONT Ground Continuity Testing Protocol" recommended. If the company wishes to propose a different test, it should discuss it directly with Joseph Baniak of my staff, and if he is in agreement with the proposal, it may be substituted for the test proposed here.
