# **NEW YORK STATE ELECTRIC & GAS CORPORATION**

**2018 Annual Reliability Report**

**March 31, 2019**

Submitted in compliance with:  
Case 02-E-1240 – Standards on Reliability of Electric Service – Annual Report  
As Amended in Electric Service Standards Annual Reliability Report Guidelines – 12/19/2008

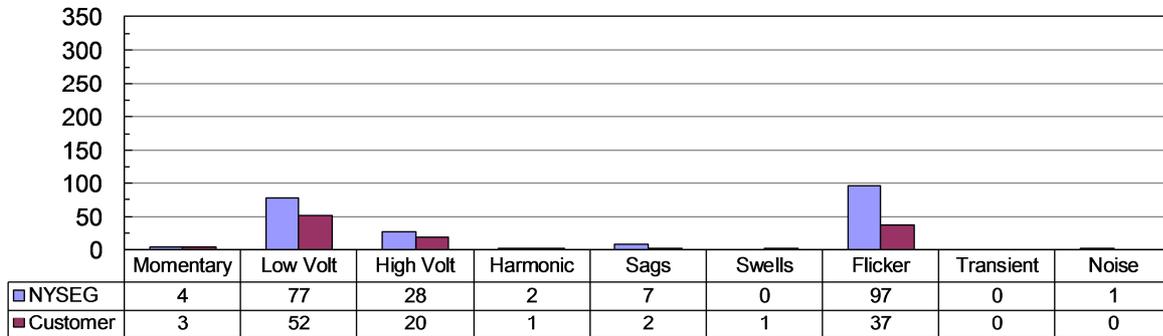
### 2018 Reported Power Quality Incidents by Problem Type and Party

The following pages contain the data that was collected throughout 2018 regarding the PQ calls NYSEG received and the resulting investigations that were conducted.

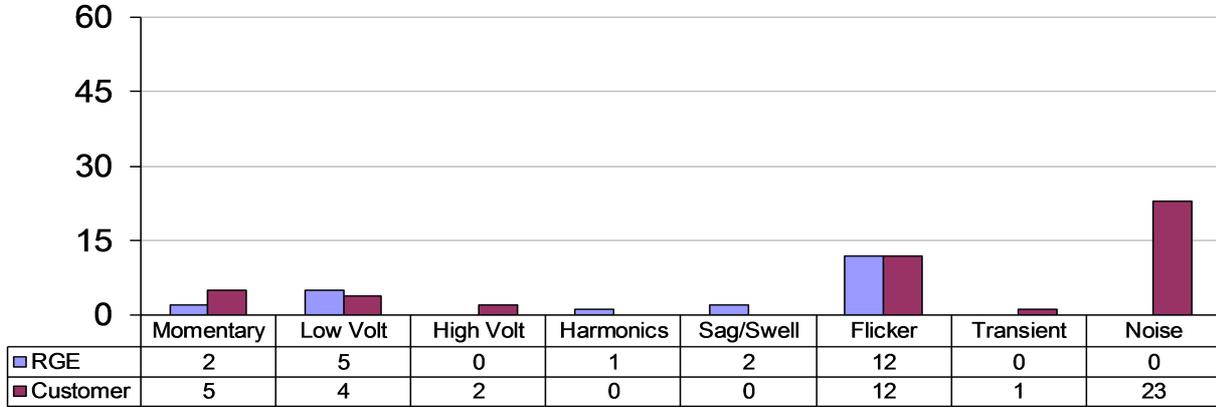
### 2018 Reported Power Quality Incidents by Problem Type and Party

The following pages contain the data that was collected throughout 2018 regarding the PQ calls RG&E received and the resulting investigations that were conducted.
