Re: Case 04-M-0159, Proceeding on the Motion of the Commission to Examine
the Safety of Electric Transmission and Distribution Systems
Consolidated Edison Company of New York, Inc.'s *Report on the Results of
Stray Voltage Tests and Facility Inspections for the Period beginning
January 1, 2009 and Ending on December 31, 2009*

STRAY VOLTAGE TEST and FACILITY INSPECTION

February 15, 2010

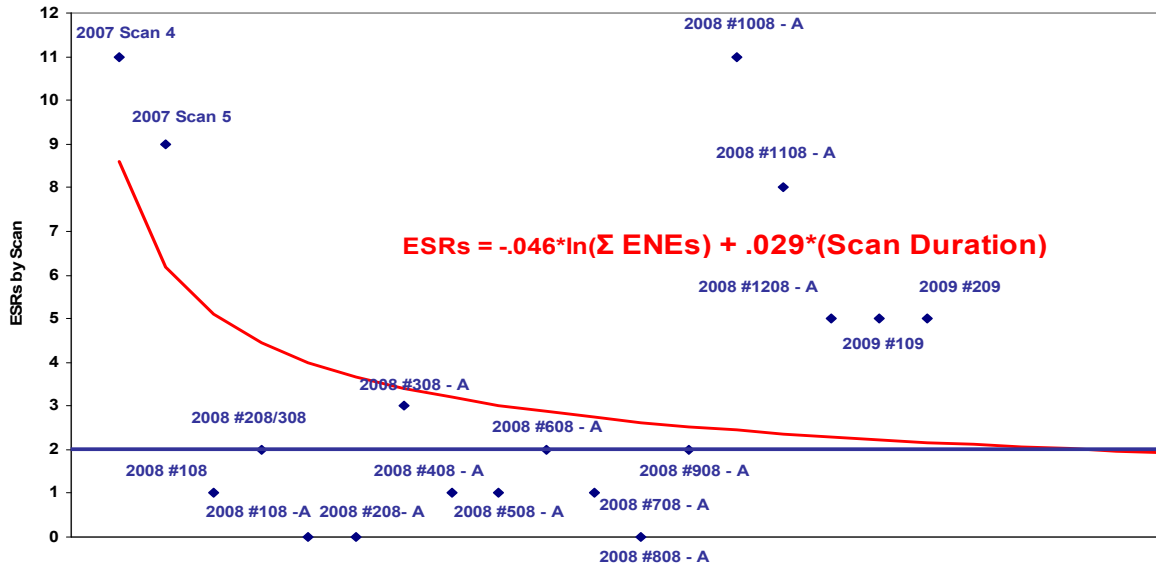
Chart 1
Con Edison
ESRs by Scan
vs. Cumulative ENEs and Scan Duration

The reduction of ESRs associated with Con Edison appears on Chart 1. The duration of scans from the (2008) scan duration level were reduced to 35 days each after scan #708-A. The expected ESRs at this scan duration level should fall to approximately 2 per month early in 2009. This prediction is consistent with the 2009 actual results of 24 shocks due to Con Edison responsibility. Based on this prediction we expect a similar result in 2010.

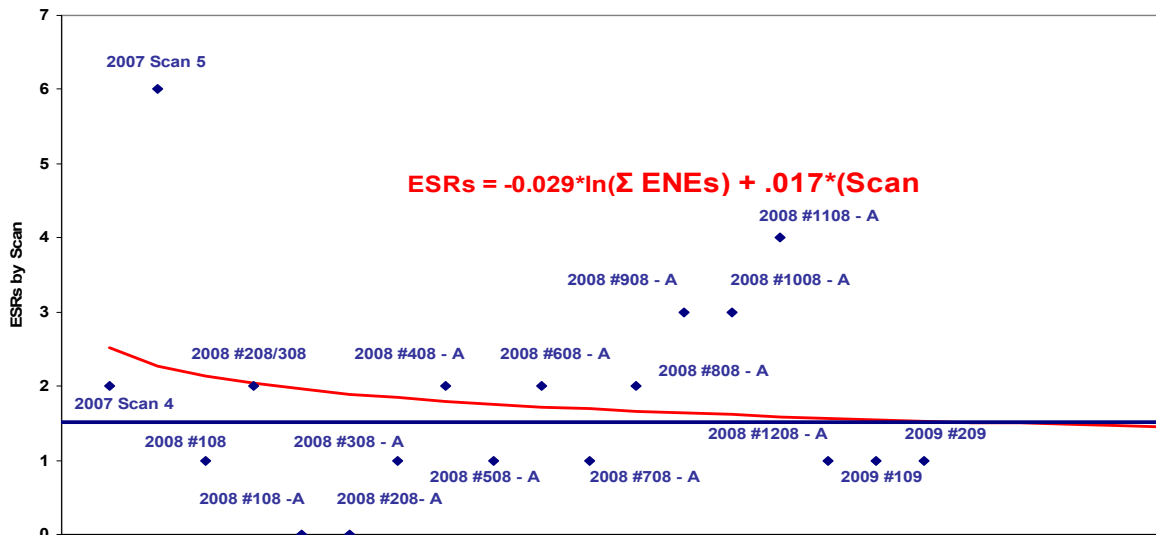
Chart 2
DOT
ESRs by Scan
vs. Cumulative ENEs and Scan Duration

The reduction of ESRs associated with the DOT appears on Chart 2. The duration of scans from the (2008) scan duration level were reduced to 35 days each after scan #708-A. At 35 days per scan through the end of 2009 expected ESRs should fall between 1 to 2 per month. This demonstrates marginal improvement over current scan durations. In 2009 there were 6 shocks associated with DOT equipment failures. This result is better than predicted, and is likely the result of various programs implemented by both DOT and Con Edison to mitigate shocks.

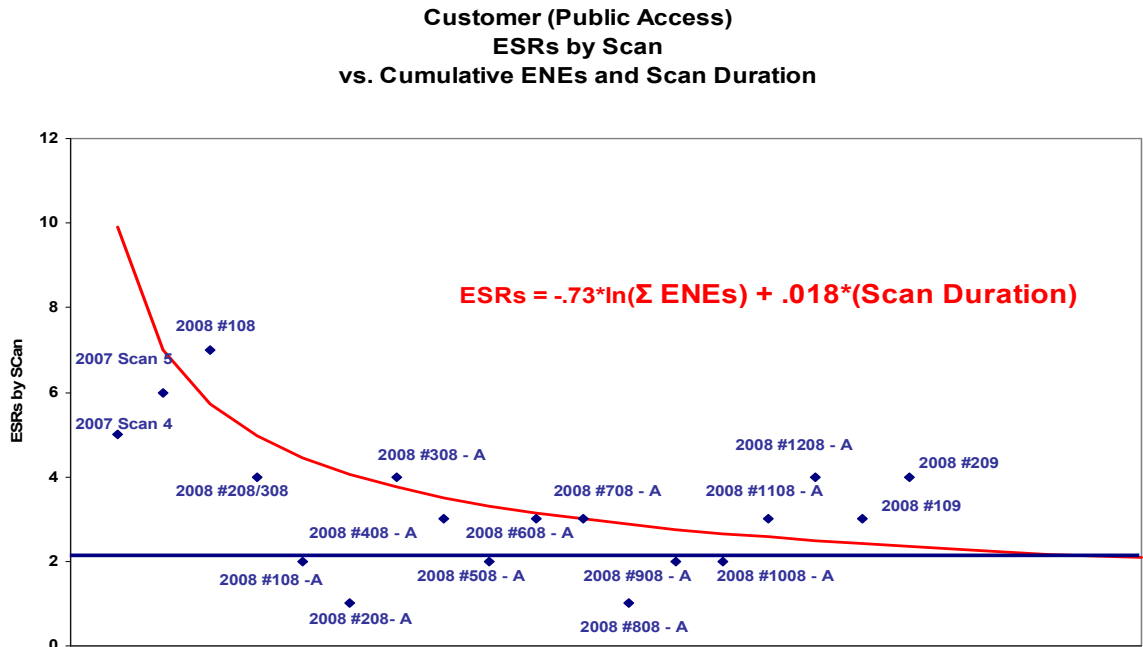
Chart 3

The reduction of ESRs associated with Customer Equipment (Public Access) appears on Chart 3. The duration of scans from the (2008) scan duration level were reduced to 35 days each after scan #708-A. At 35 days per scan through the end of 2009 expected ESRs should fall to approximately 2 per month with no significant reduction anticipated below that level in the near future. These ESRs appear essentially insensitive to changes in scan duration at this point in time. The actual performance indicates that these shock events are less sensitive to our mitigation efforts than we initially projected. In 2009 we responded to 33 validated shock reports on publicly accessible customer equipment, this is 38% higher than predicted by the model.
