**CENTRAL HUDSON GAS & ELECTRIC
CORPORATION**

STRAY VOLTAGE TESTING

FACILITY INSPECTIONS

2013 Stray Voltage Testing and Facility Inspections

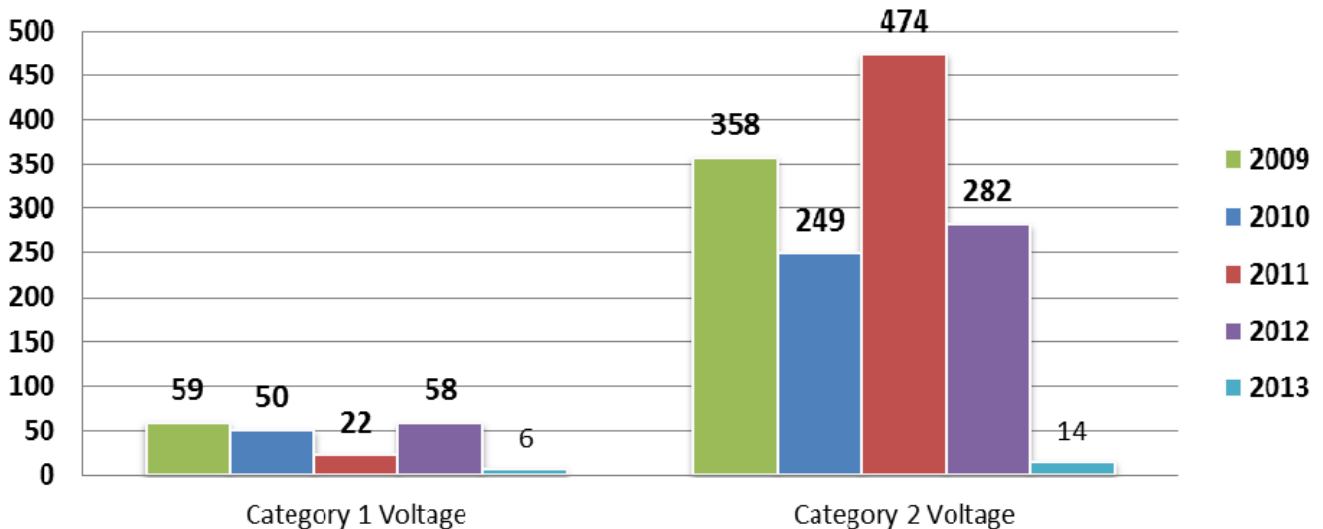
Summary of Harmonics Analysis 2009 - 2013

Asset Class	Total Findings (2009 - 2013)		
	Cat. 1	Cat. 2	Cat. 3
Overhead Distribution	170	1331	2
Underground (Non-URD)	0	0	0
URD (Pads)	1	21	0
Street and Traffic Lights	24	3	0
Transmission Overhead	0	22	0
Substation Fences	0	0	0
Total	195	1377	2
