NYSEG

2022 Annual Reliability Report

Case 23-E-0119 – Standards on Reliability of Electric Service – Annual Report
As Amended in Electric Service Standards Annual Reliability Report Guidelines – 12/19/2008

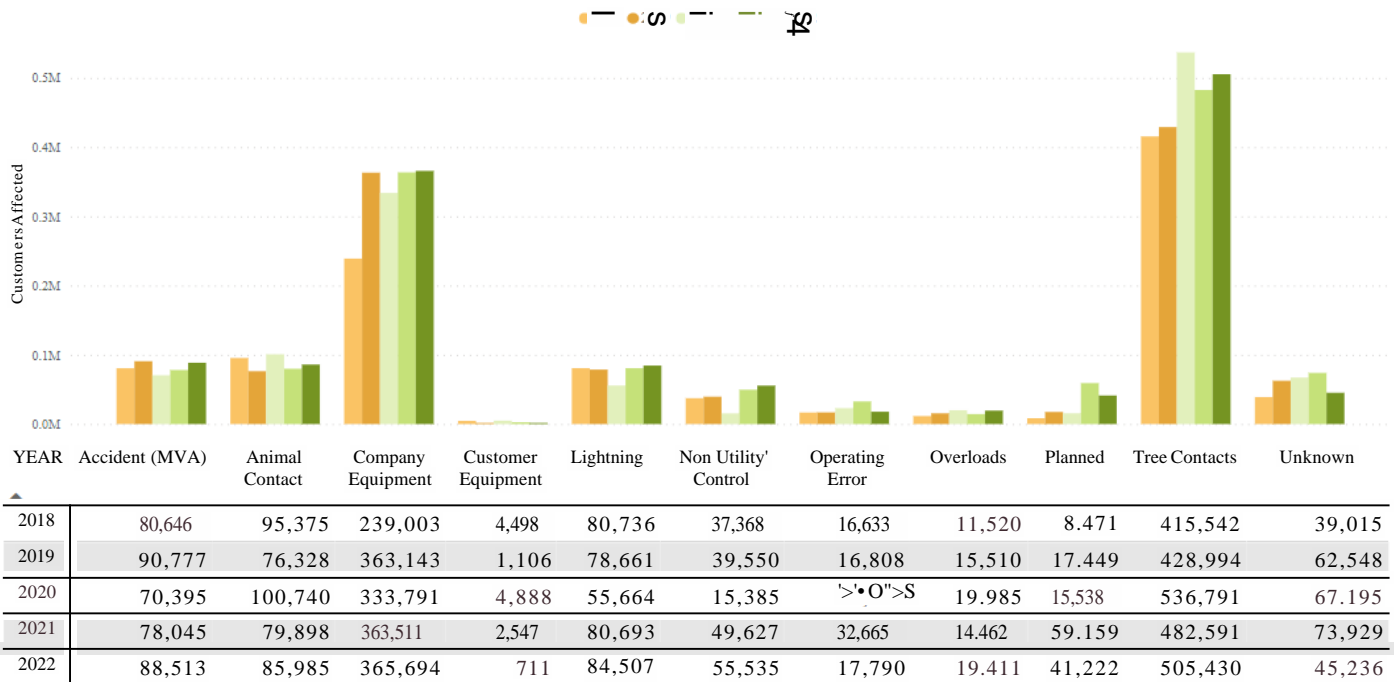
The following graph provides a five-year history of the customers affected by the PSC cause groups:

The graph of customers interrupted by cause demonstrates the high impact to SAIFI from tree related outages and its role as the leading factor in NYSEG failing to meet its SAIFI performance measure.

NYSEG will continue to aggressively execute the vegetation reclamation program to prioritize reliability benefits. In addition, we are evaluating the scope of the vegetation management program, replacing aged and deteriorated equipment, and improving current reliability focused programs while developing new programs designed to improve system reliability.
