Consolidated Edison Company of New York, Inc.'s *2019 Contact Voltage
Test and Facility Inspection Annual Report*

**CONTACT VOLTAGE TEST &
FACILITY INSPECTION
ANNUAL REPORT**

CONSOLIDATED EDISON COMPANY OF NEW YORK, INC.

Report on the results of contact voltage tests & facility inspections for the period beginning

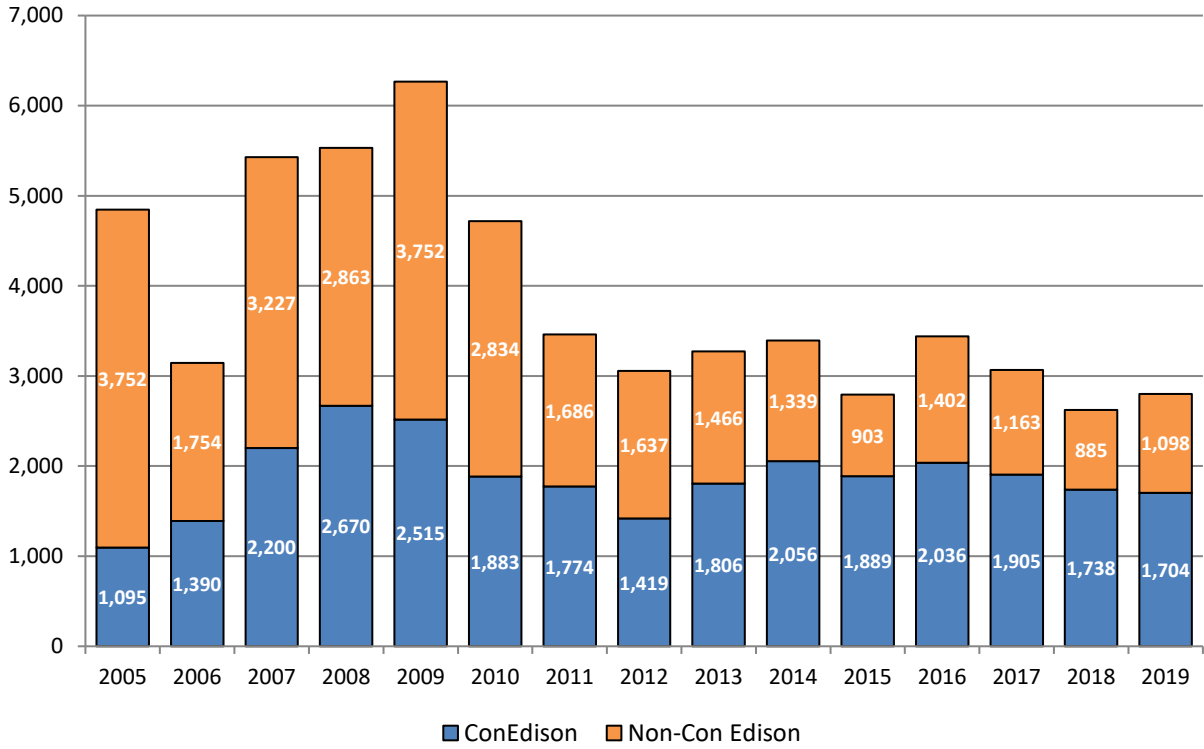
Chart 1
ENE Sources

Since the likelihood of an ESR will increase or decrease in proportion to the total number of energized structures, the detection and repair of identified sources of contact voltage is the principal mitigation effort for reducing ESRs. Each completed repair effectively represents a mitigation of possible ESRs and over time, the potential ESRs decrease accordingly. As can be observed in Chart 1, the sources of ENEs have been decreasing since the inception of the program. Similarly, the Con Edison responsibility ESRs (Chart 2) and Non-Utility responsibility ESRs (Chart 3) show a similar trend.

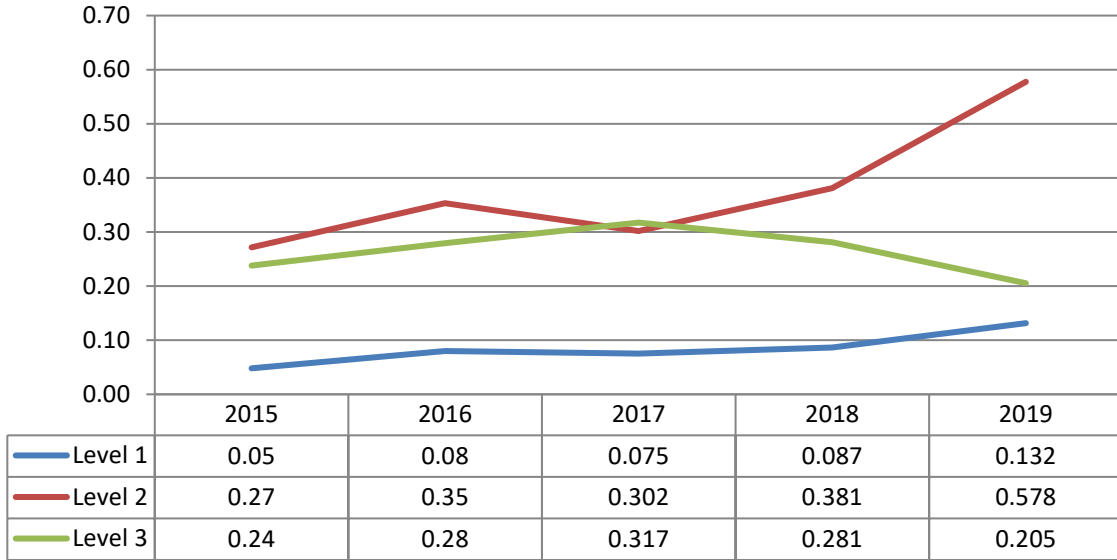
**Chart 5
Defect Rate by Level**

Chart 5 shows the number of defects found per inspection by classification level. The generation rate of L1 and L2 defects found this year are slightly above the five-year average. The rate is mainly driven by the underground program that had the most inspections completed in 2019. Level III continues on a downward trend.

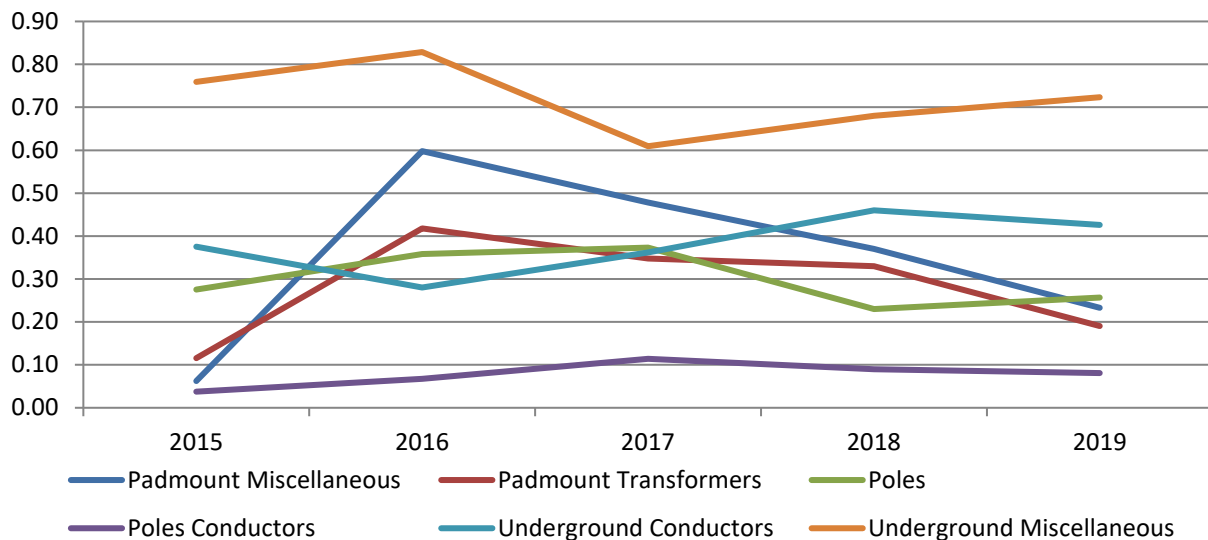
**Chart 6
Defect Rate by Category**

Chart 6 shows the 2019 Defect Rate by Category. The Defect Rate shows a downward trend for four of the six major categories listed. Underground Miscellaneous shows a slight increase and Poles remained on par with 2018.
