**CONTACT VOLTAGE TEST &
FACILITY INSPECTION
ANNUAL REPORT**

CONSOLIDATED EDISON COMPANY OF NEW YORK, INC.

Report on the results of contact voltage tests & facility inspections for the period
beginning January 1, 2013 and ending on December 31, 2013.

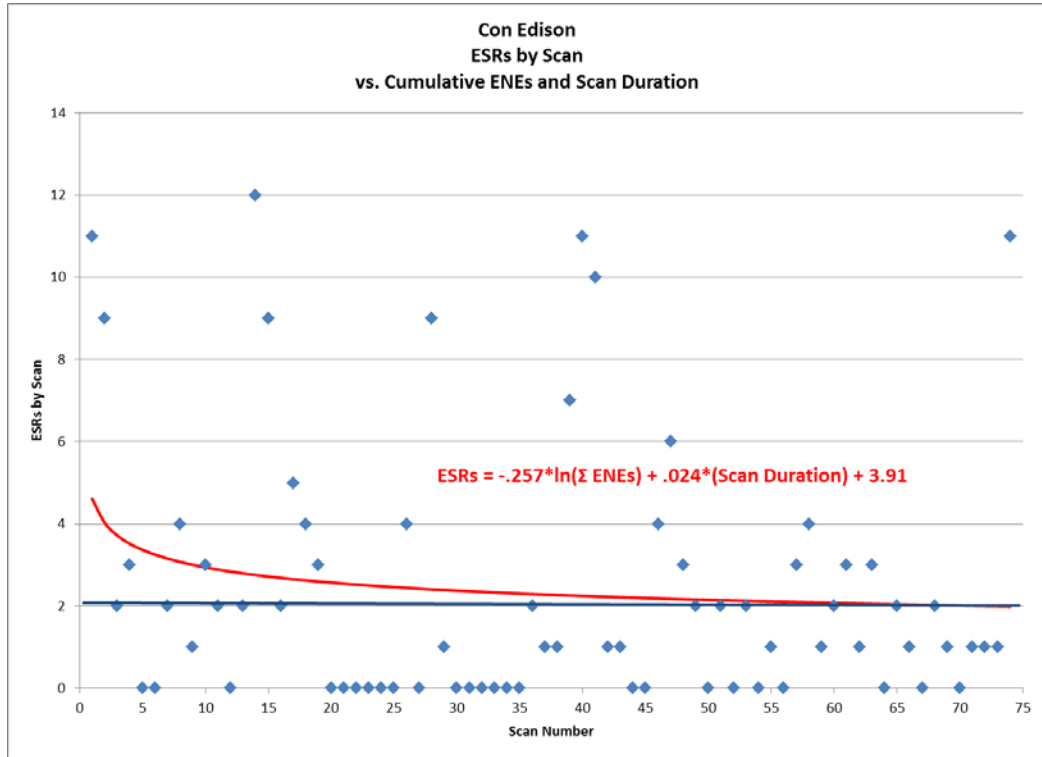
Chart 1

The ESRs associated with Con Edison’s equipment appear on Chart 1. As mentioned above, weather also plays a role in ESR generation. The higher precipitation in 2013 increased the generation rate of Con Edison responsible ESRs. This weather variable is accounted for in the underlying models and in both the 2013 and long term predictions. The duration between scans ranges from approximately 30 to 35 days per scan. If we continue with a comparable ENE

repair rate and scan interval in 2014, as well as experience similar weather patterns, we can expect ESRs to be approximately 2 per scan. This prediction is consistent with the 2013 actual results of 23 shocks due to Con Edison responsibility.

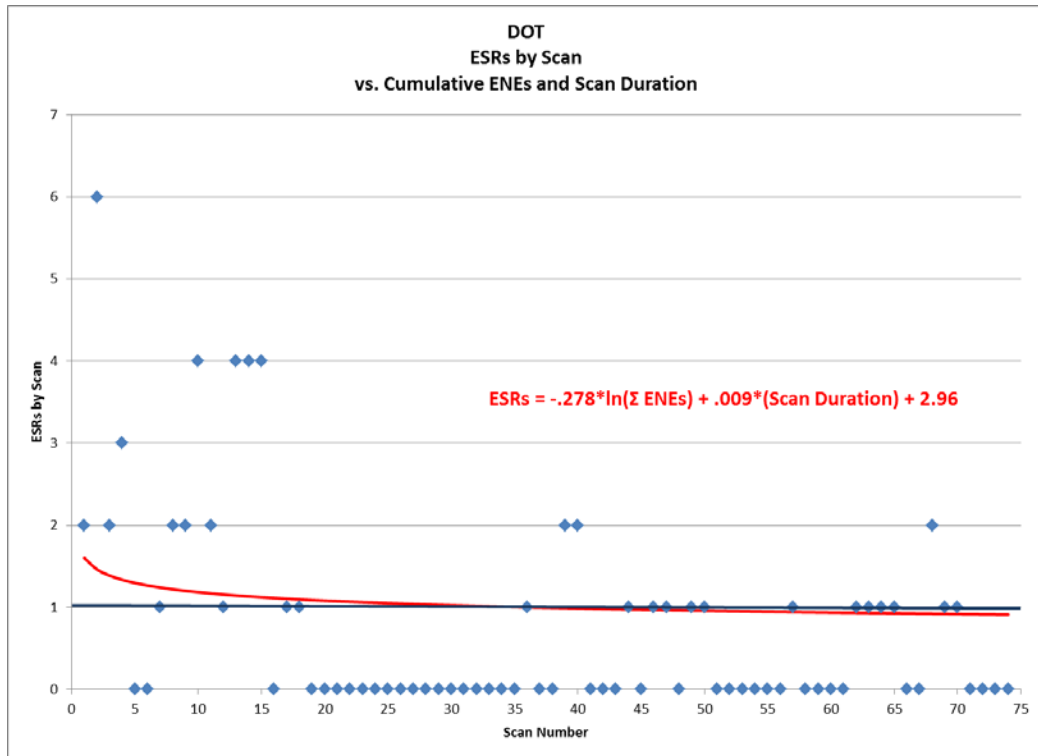
Chart 2

The increase of ESRs associated with the DOT appears on Chart 2. The duration of scans is 30 to 35 days per scan. If we continue a comparable ENE repair rate and scan duration in 2014, we can expect ESRs at this scan duration level to be approximately 1 per scan. The expected ESR per scan rate has decreased from 2 ESR every 1 scan to 1 ESR per scan. In 2013 there were 8 shocks associated with DOT equipment failures. This result is in-line with what was predicted, and is likely the result of various programs implemented by both DOT and Con Edison to mitigate shocks.

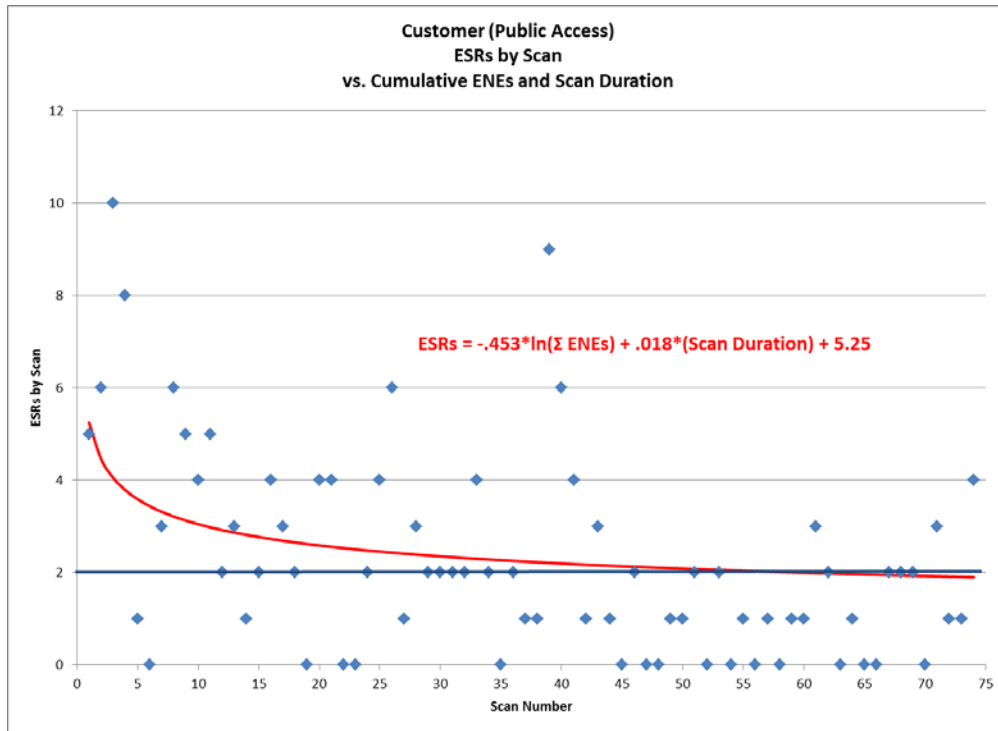
Chart 3

The increase of ESRs associated with Customer Equipment (Public Access) appears on Chart 3. The duration of scans is 30 to 35 days per scan. If we continue a comparable ENE repair rate and scan duration in 2014, we can expect ESRs to remain at 2 per scan, with no significant reduction anticipated below that level in the near future. The actual performance indicates that these shock events are less sensitive to our mitigation efforts than we initially projected. In 2013, we responded to 34 validated shock reports on publicly accessible customer equipment.

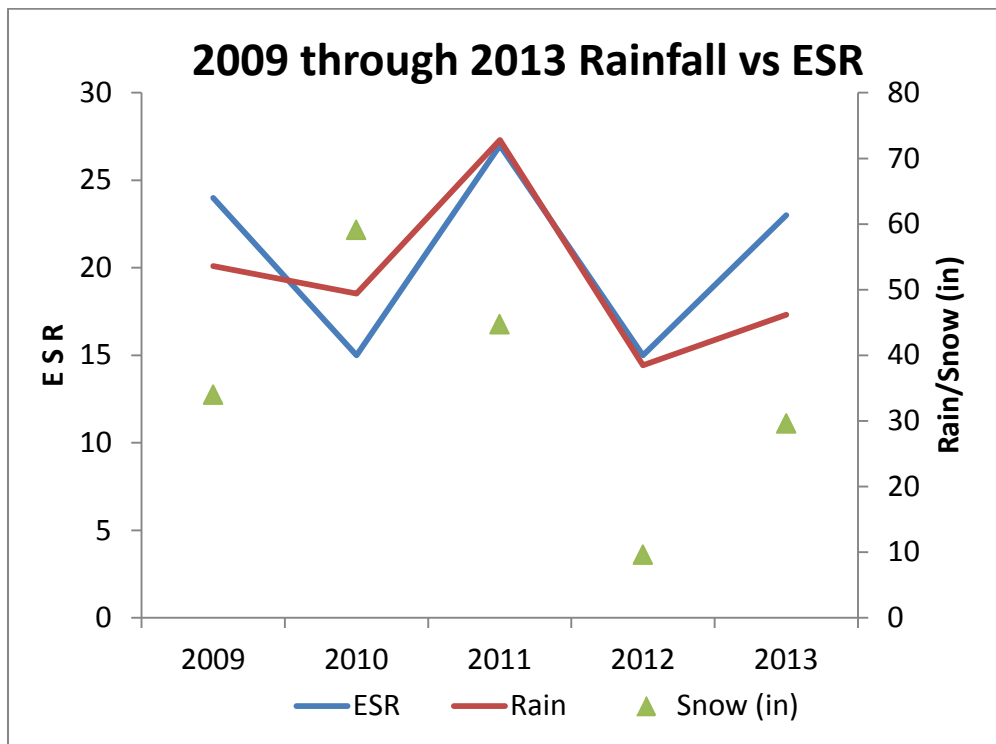
Chart 4

When we look at snow and rainfall year over year (chart 4), we see the system response to ground conditions, as level of precipitation change from 2009 to 2013. As snowfall and rainfall increase from 2009 to 2013, ESRs also increase and as snow and rainfall increased there is an increase in number of ENE/ESR in 2013. We will continue to monitor this correlation in 2014.

Compared to 2012, 2013 was a more severe year in terms of weather with 20 more inches of snow and 173,000 tons more of salt. Despite more severe weather, overall performance year over year remains flat. Overall, ESR emergence rate per scan seems to be at steady state.

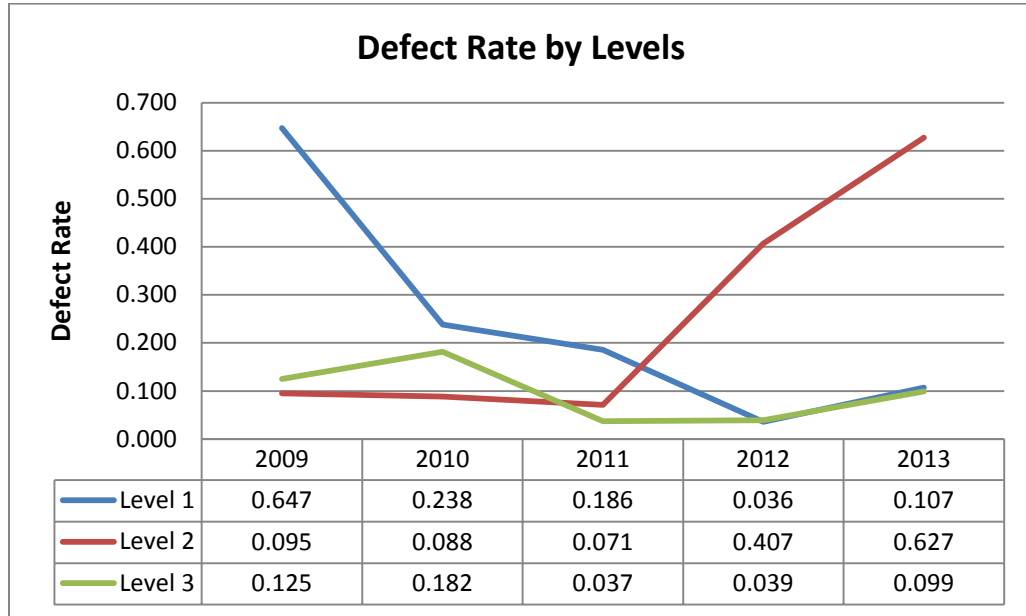
The chart below shows the number of defects found per inspection:

Starting in 2012, the company reclassified Unsealed Ducts and Improperly Sealed Ends from Level I to Level II defects. This was done to account for defects generated by a change in specification and not a true defect condition. Repairs will continue to follow level 1 criteria. This reclassification has led to an overall increase in Level II defects found in 2012 and 2013.

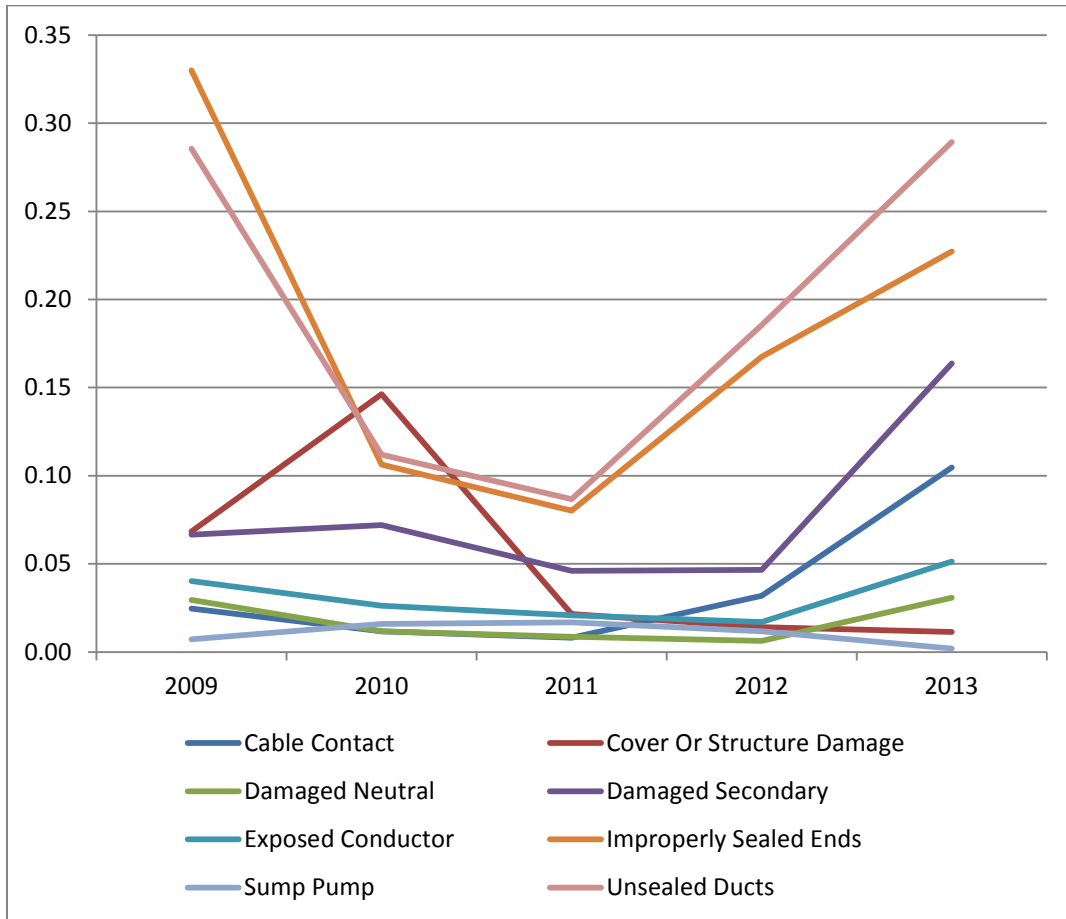
The defect found ratio can be broken down further, by type of repair:

In most categories, we see increases in defect rate from 2012 to 2013. As mentioned earlier, 2013 was a challenging year in terms of weather with 20 more inches of snow and 173k tons more of salt spread when compared to 2012. This weather contributed to a more than doubling of manhole events from the prior year. These manhole events represent stresses to the system and associated components that we may now see revealed through the increasing inspection program defect rates.

The weather directly contributed to the increase in damaged secondary, exposed conductor and damaged neutrals. We also saw an increase in reported cable contact by our contractors due to a misinterpretation of the required cable clearance, which has been addressed through training. We are currently investigating increases in unsealed ducts and improperly sealed ends, but we believe there may be multiple factors involved including: 1) The Company has increased the number of vented covers on the system, which could lead to an increase in the number of structures requiring a flush. This could, in turn, cause
