**CENTRAL HUDSON GAS & ELECTRIC
CORPORATION**

CONTACT (STRAY) VOLTAGE TESTING

FACILITY INSPECTIONS

2020 Contact (Stray) Voltage Testing and Facility Inspections

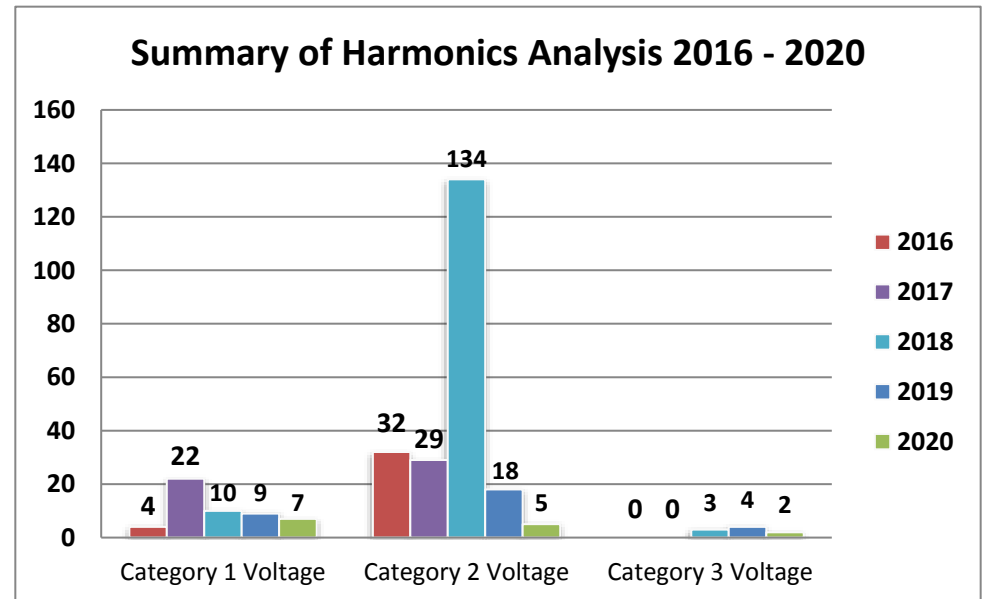
Chart 1 - Summary of Harmonic Analysis

Asset Class	Total Findings (2016 - 2020)		
	Cat. 1	Cat. 2	Cat. 3
Overhead Distribution	21	108	8
Underground (Non-URD)	0	0	0
URD (Pads)	0	6	0
Street and Traffic Lights	31	1	0
Transmission Overhead	0	103	1
Substation Fences	0	0	0
Total	52	218	9
