# CENTRAL HUDSON GAS & ELECTRIC CORPORATION

## **CONTACT (STRAY) VOLTAGE TESTING**

## **FACILITY INSPECTIONS**

2022 Contact (Stray) Voltage Testing and Facility Inspections

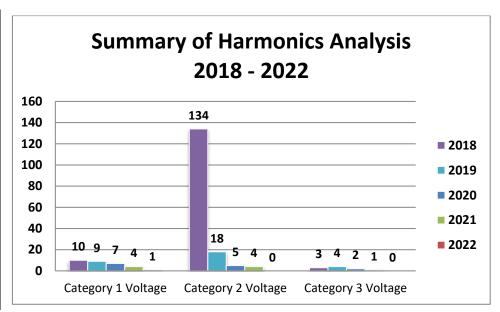
Chart 1 - Summary of Harmonic Analysis

Total Findings (2018 - 2022)					
Asset Class	Cat. 1	Cat. 2	Cat. 3			
Overhead Distribution	7	79	8			
Underground (Non-URD)	0	0	0			
URD (Pads)	0	4	0			
Street and Traffic Lights	24	0	0			
Transmission Overhead	0	78	2			
Substation Fences	0	0	0			
Total	31	161	10

Although there are fluctuations in the total number of category two voltage conditions, these naturally occurring conditions have accounted for 79.70% of the voltage findings from 2018-2022. Category two voltages fluctuate due to weather and load conditions. These voltages can be considered part of a properly functioning multi-grounded wye electric system and pose no threat to the public. There have been no findings of naturally occurring voltage in the Underground (Non-URD), Street and Traffic Light, and Substation Fence groups (see Tables 2 & 3).
