## Rochester Gas and Electric Corporation

# STRAY VOLTAGE TEST AND FACILITY INSPECTION PROGRAM

Report on the results of Stray Voltage Tests and  
Facility Inspections for the 12-month period ending  
on December 31, 2015

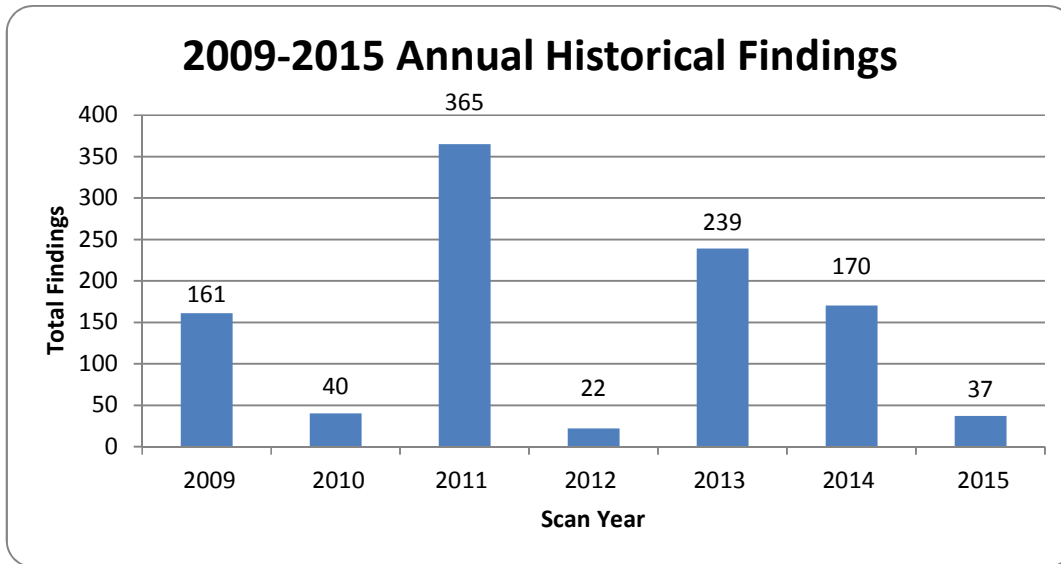
Historical detections of the Mobile Testing program from inception to current year are displayed below.

Results from this year's mobile scan show the majority of energized objects found (33) were on streetlights and traffic signal equipment owned by other Municipalities including the City of Rochester and Monroe County. Final results depict a significant reduction in findings from previous years. This reduction can be attributed to the effort RG&E has made working more closely with the City of Rochester over the last year to assist and encourage proper investigation and remediation work be completed on a timely basis. A detailed summary of energized objects found during the 2015 mobile testing effort and status of repairs can be viewed in the Appendix of this report.
