**CONTACT VOLTAGE TEST &  
FACILITY INSPECTION  
ANNUAL REPORT**

**CONSOLIDATED EDISON COMPANY OF NEW YORK, INC.**

Report on the results of contact voltage tests & facility inspections for the period beginning

January 1, 2022, and ending on December 31, 2022.

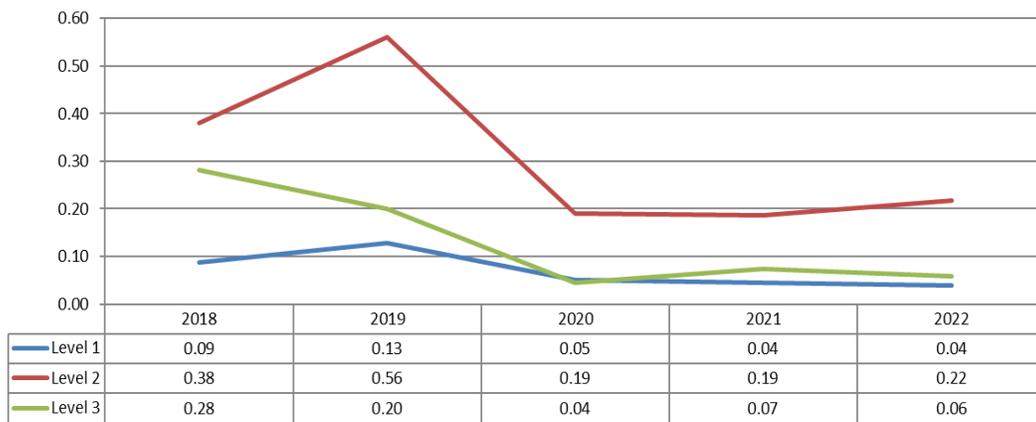
**Chart 5  
Defect Rate by Level**

Chart 5 shows the number of defects found per inspection by classification level. In 2022, the Company experienced a generation rate of L1 defects that was same as that of 2021, while L2 defects experienced 3% increase, and L3 defects experienced a slight decrease.

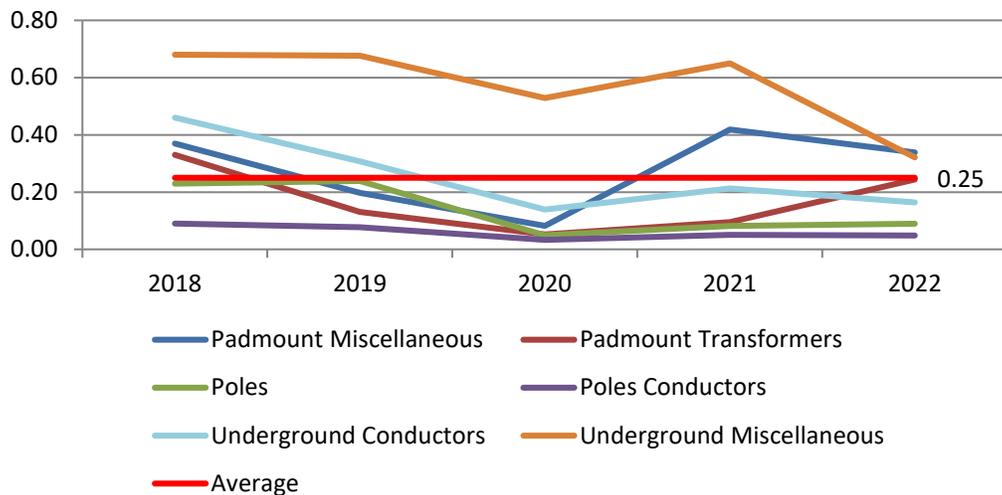
**Chart 6  
Defect Rate by Category**

Chart 6 shows the 2022 Defect Rate by Category. The largest defect increase is in the category of Padmount Transformers specifically due to the hazard warning label missing and defective locks. while Underground Miscellaneous experienced significant decrease lead by a reduction in unsealed ducts and secondary end caps.
