**Hoffman Falls Wind Project**Towns of Eaton, Fenner, Nelson, and Smithfield, Madison County, New York

Visual Impact Assessment Addendum Appendix 8-A

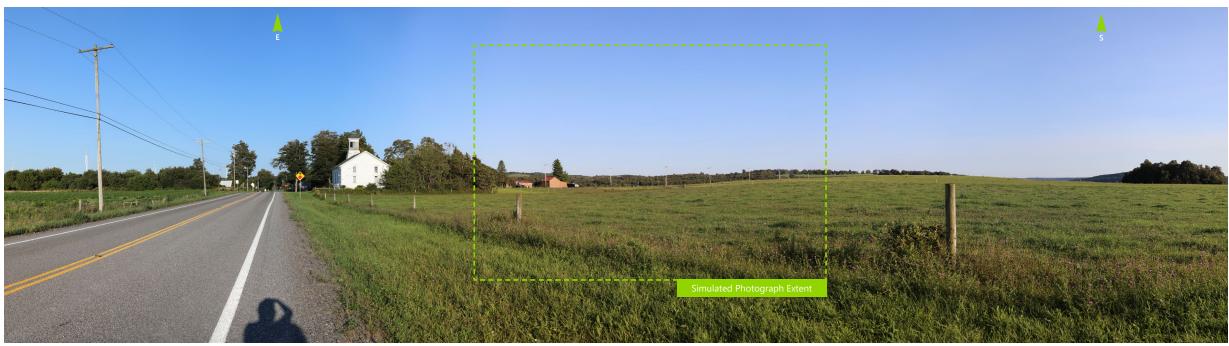
Note: The image above is a panorama photograph taken from Bingley Road in the Town of Fenner panning clockwise from northeast (left) to south (right). The green rectangle represents the extent of the simulated photograph.

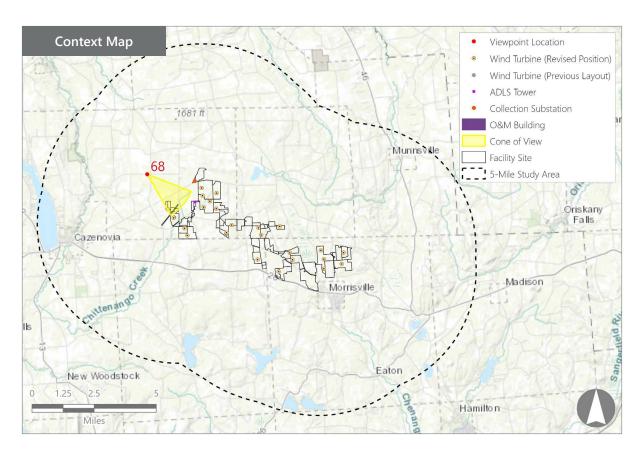
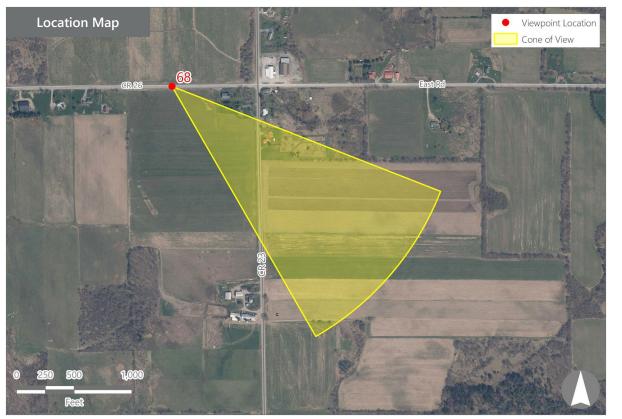
## **VIEWPOINT 68**

#### **Existing View**

### **Proposed View (Post Installation)**

### **Existing View**

Viewpoint 68 is located on Bingley Road just west of its intersection with County Route 23 in the Town of Fenner. This viewpoint is located in the Agricultural/Rural residential LSZ, approximately 1.6 miles from the nearest proposed turbine that would be visible in the selected photograph's field of view. Views from this location are typical of those available to local residents, recreational users of the Heaven and Hell Bike Trail, and visitors/members of the S/NRHP-listed Fenner Baptist Church. Views in this general area include the church and a cluster of buildings and trees bordering County Route 23, surrounded by large open fields and scattered small woodlots. In the selected photo, the existing view to the southeast includes a roadside wire fence in the immediate foreground backed by a pasture that extends from the foreground to a woodlot and hedgerow on the opposite side of County Route 23(which is out of view) in the middle ground. Additional lines of fence posts and a roadside utility line cross the field parallel to Route 23, adding vertical features to the view while also reinforcing the horizontal line of the field edge. On the left side of the view, two buildings with red roofs and lightcolored siding are flanked by large evergreens and draw viewer attention. The horizon is defined by gently rolling wooded hills, except for open fields on the periphery of the selected view. While the utility line presents a horizontal feature that extends across the center of the view, the lightly colored utility poles are man-made vertical elements that rise above the horizon line into a blue sky. The rating panel indicated that the existing view has moderate scenic quality.

#### **Proposed View**

With the proposed Facility in place, a cluster of wind turbines are a prominent new addition above the horizon on the right side of the view. More spread out and distant turbines have also been added to the center and left portions of the view. The line, color, and perceived scale of the more distant turbines are consistent with the existing utility poles, and due to their greater distance from the viewer and minimal color contrast with the sky, they are barely noticeable at first glance. To the right of the view the group of closer turbines are more tightly grouped, noticeably taller, and present greater color contrast with the blue sky. These turbines are the tallest features in the landscape, create additional visual clutter on the horizon, and add movement that will attract viewer attention. Despite the introduction of large new vertical features on the right of the view, the sky remains expansive, and the turbines are consistent with other vertical man-made features in the landscape. Although the turbines' line and form contrast with the horizontal lines and rounded forms of the existing landscape, they do not significantly detract from the scenic quality of the foreground features in the view.

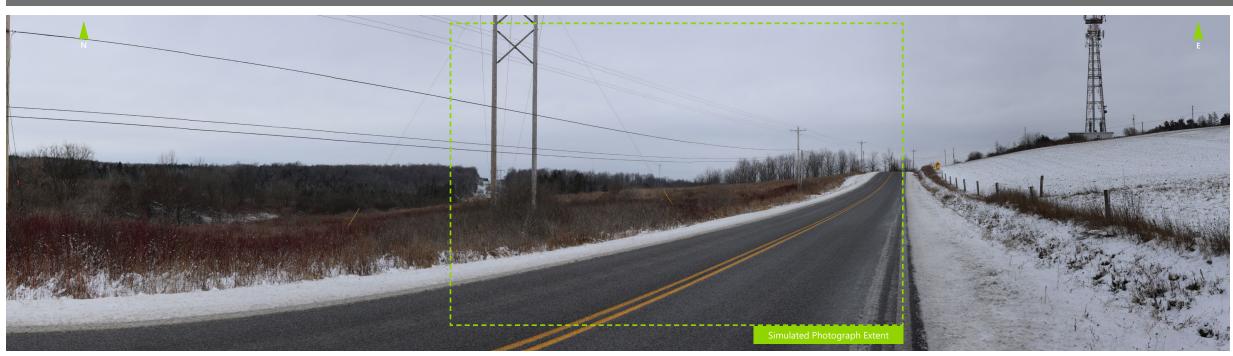
Note: The image above is a panorama photograph taken from Cody Road in the Town of Fenner panning clockwise from north (left) to east (right). The green rectangle represents the extent of the simulated photograph.

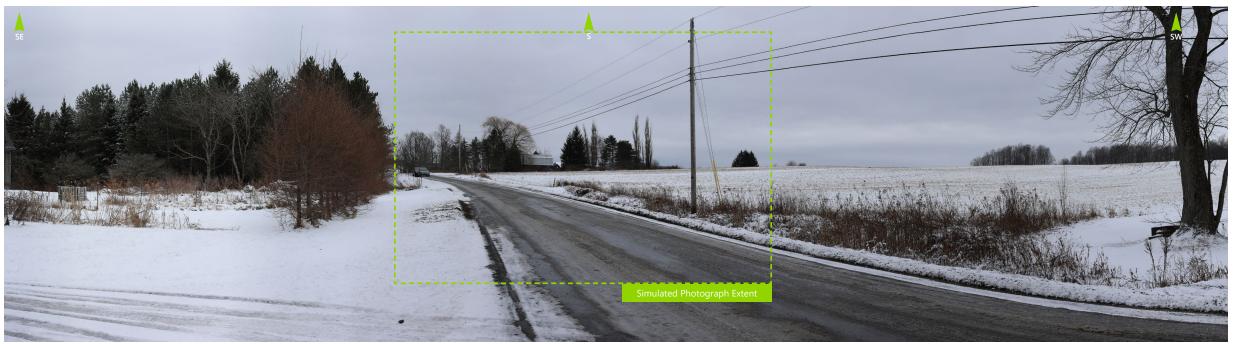
Note: The image above is a panorama photograph taken from South Road in the Town of Fenner panning clockwise from southeast (left) to southwest (right). The green rectangle represents the extent of the simulated photograph.
