Niagara Mohawk Power Corporation

REPORT ON THE CONDITION OF PHYSICAL ELEMENTS OF TRANSMISSION AND DISTRIBUTION SYSTEMS

CASE 06-M-0878

OCTOBER 1, 2009

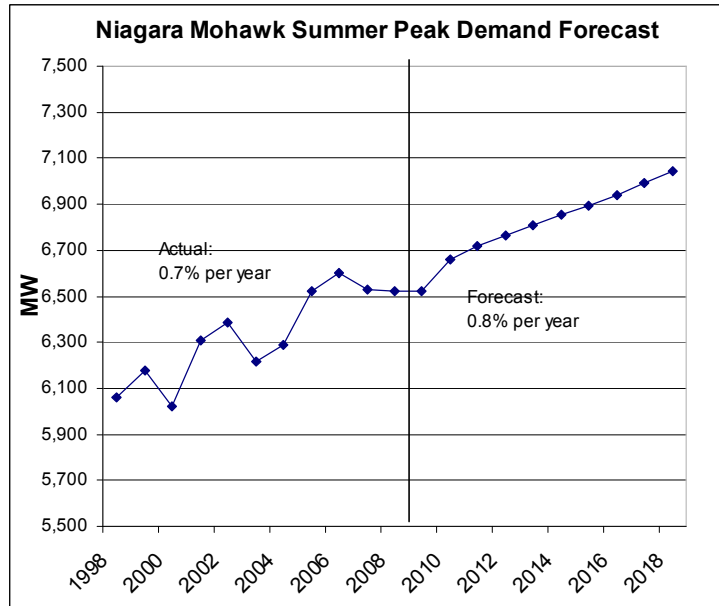
Figure II-2
Niagara Mohawk Summer Peak Demand Forecast

Preliminary results indicate that the summer 2009 peak was 6,154 MW on August 17. This summer's weather was cooler than average contributing to the decline from the 2008 summer peak demand and the historic peak which occurred in 2006.

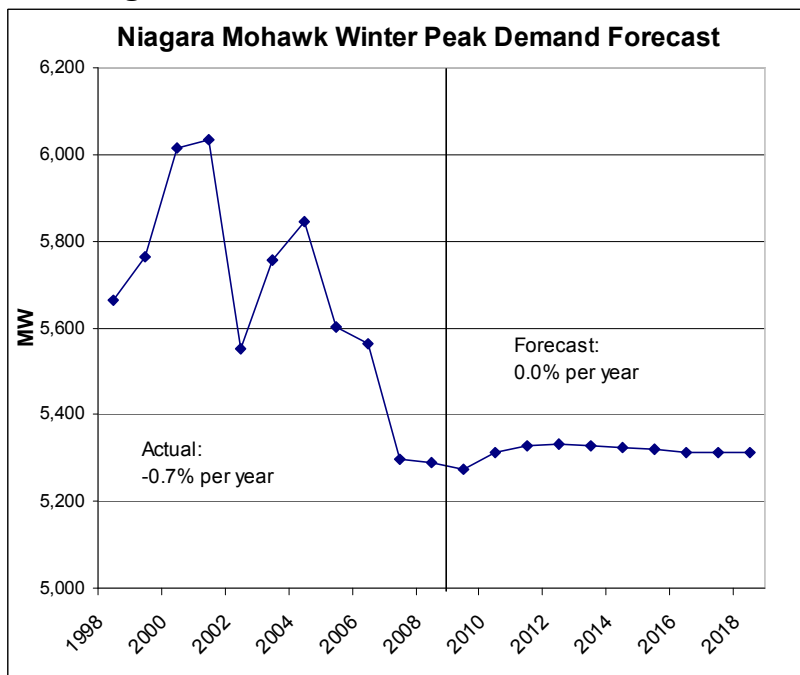
Figure II-3
Niagara Mohawk Winter Peak Demand Forecast

National Grid forecasts Niagara Mohawk’s summer and winter peak MW demands using an econometric model that relates monthly peaks to upstate New York employment, households, peak day weather conditions and peak day indicator variables. For the forecast period, two weather scenarios are assumed, normal and extreme. The normal weather scenario assumes peak day temperatures equal to the most recent 30 year average. The extreme weather scenario assumes extreme peak day temperatures that occur only 5 percent

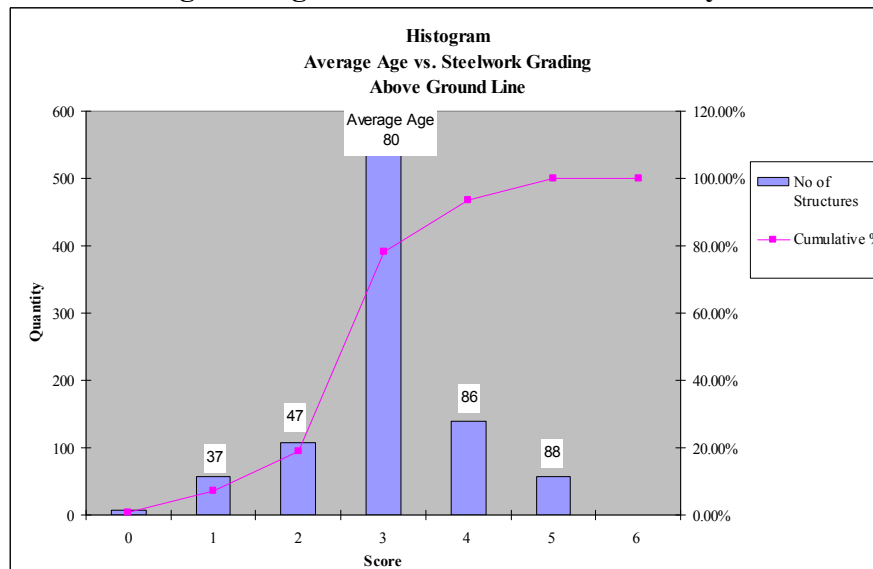
**Figure III-3.
 Engineering Field Walk-Down Data Analysis**

After the follow-up aerial study by Mott MacDonald, the Company conducted field walk-downs on a number of transmission lines. Looking at the analyses in Figure III-3, once a structure reaches Visual Category 4—structural deterioration occurs rapidly (regardless of past painting or maintenance). With limited data, it appears the total time to go from Visual 4 to 6 may be on the order of 10 years. Over the long term, further information will need to be statistically analyzed in order to generate a more accurate degradation model.

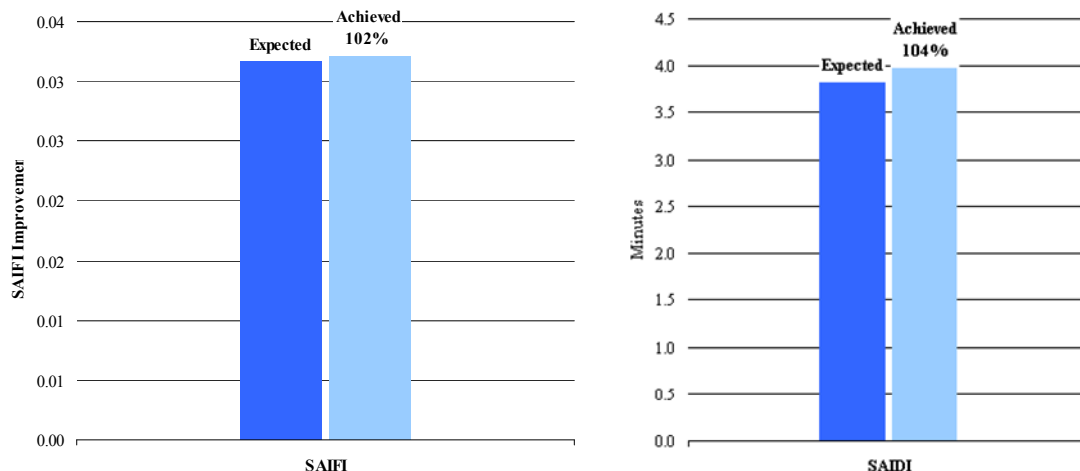
Figure III-25 Feeder Hardening

FY06 - FY08 Feeder Hardening SAIFI and SAIDI Performance
 Reliability Indices of 102 feeders

Based upon analysis of the feeders that were hardened, their performance has improved consistent with the expectations set by the program.
