TRANSMISSION AND DISTRIBUTION CAPITAL INVESTMENT PLAN

CASE 06-M-0878

THE STATE OF NEW YORK PUBLIC SERVICE COMMISSION

JANUARY 29, 2010

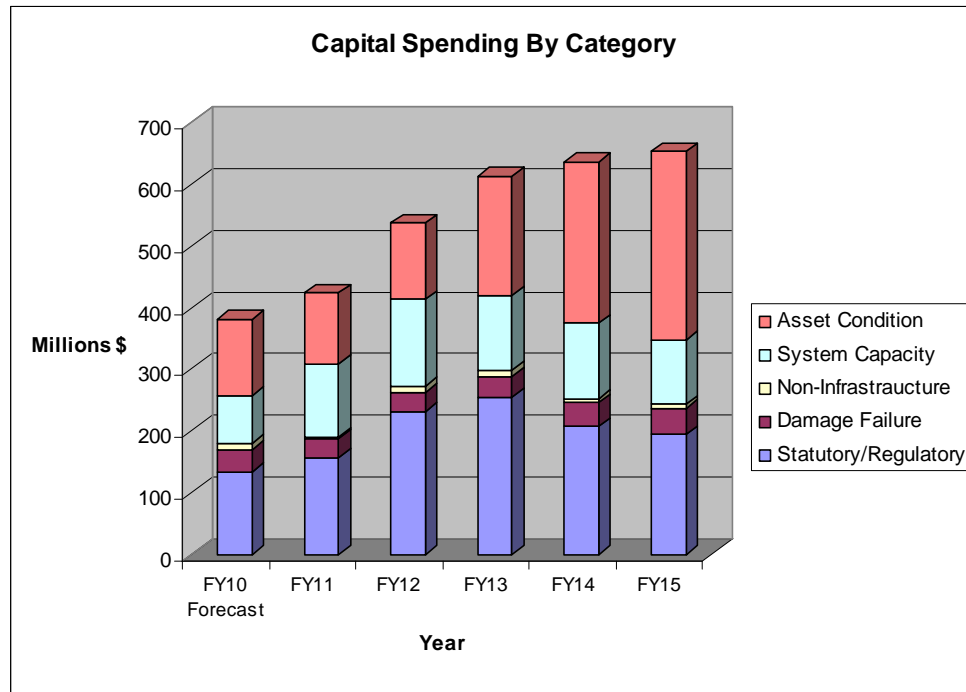
**Figure I-1
Spending by Category**

Figure I-1 and Table I-3 show a breakdown of the FY10-FY15 spending by category. As shown in Figure I-1, almost 43 percent of the planned infrastructure spending over the next five years will be required to address items that are mandatory and non-discretionary in terms of timing. This includes the repair of failed/damaged equipment to restore service to customers and spending to meet the Company’s regulatory/statutory requirements.

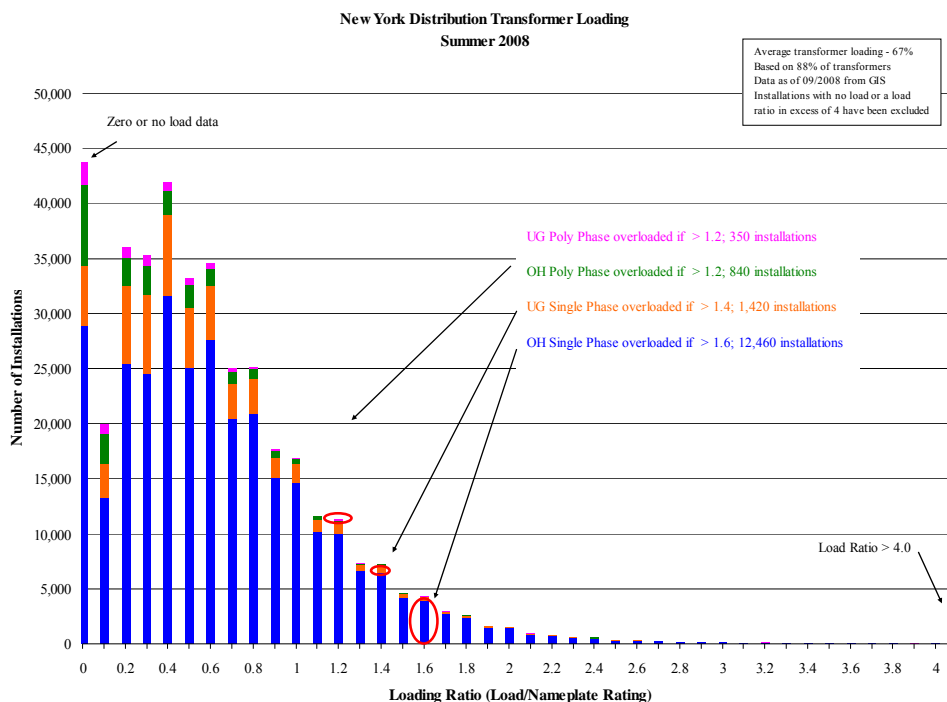
**Figure IV-1
Distribution Line Transformer Loading**

There are approximately 250 transformer failures per year due to overloading, which affects approximately 3,700 customers annually. Further information for this program is provided in Exhibit 39.

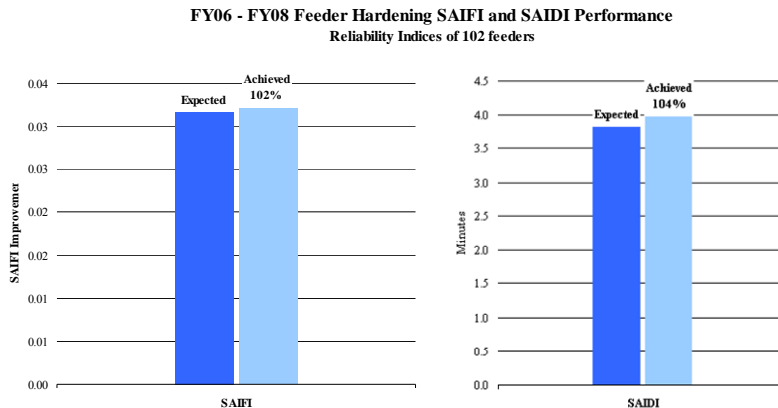
Figure IV-2 Feeder Hardening Reliability Performance

Further information for this program is provided in Exhibit 40.

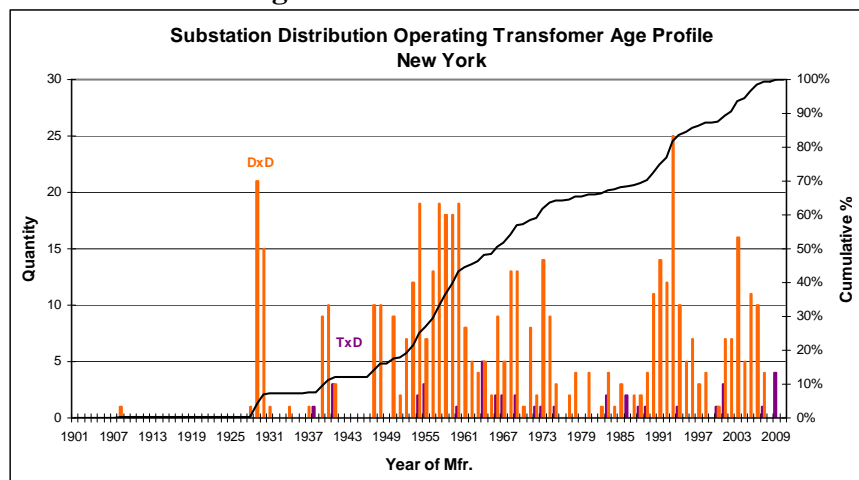
**Figure IV-3.
Age Profile of Transformers**

As noted in the 2009 Asset Condition Report, there are approximately 800 power transformers (69kV and below) with an average age of 34 years (Figure IV-3).⁷²

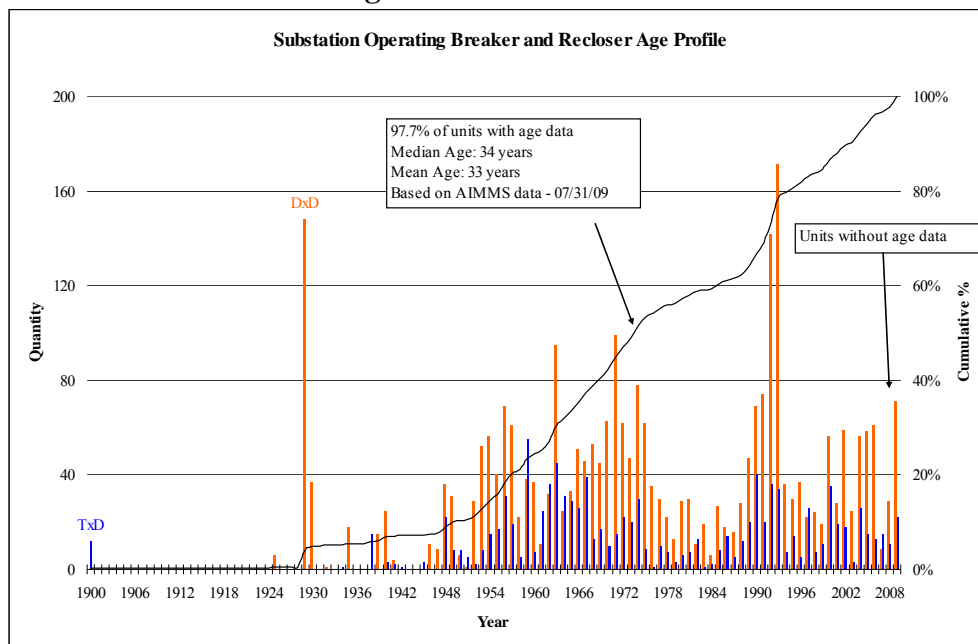
Figure IV-4
Age Profile of Circuit Breakers

The Company has 4,106 circuit breakers (4,053 operating and 53 spares) on the distribution system, with an average age of 33 years (Figure IV-4).⁷⁶ Aged units have been specifically identified for replacement because they are difficult to repair due to the lack of available spare parts. Likewise, unreliable units have been identified for replacement because their replacement would reduce the number of customer interruptions.

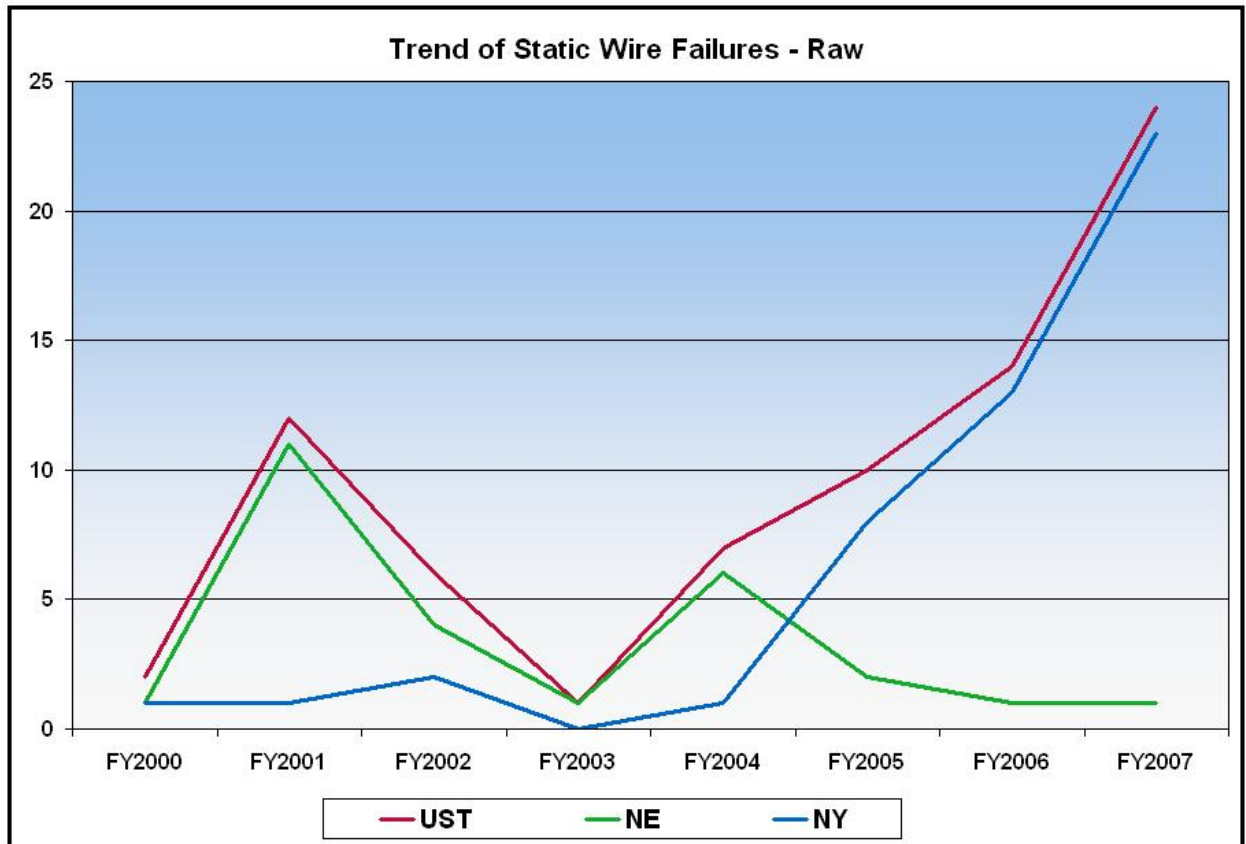
As part of The Company's asset management program, reliability is monitored regularly. In recent years, there has been a spike in shield wire related outages, with most of them occurring in the 115 kV transmission "class" (*see figure below*). Approximately 40% of the shield wire in this class is over 70 years old, which is above the expected asset life of 50 years (as determined by the CIGRE working group 37-27¹²²).

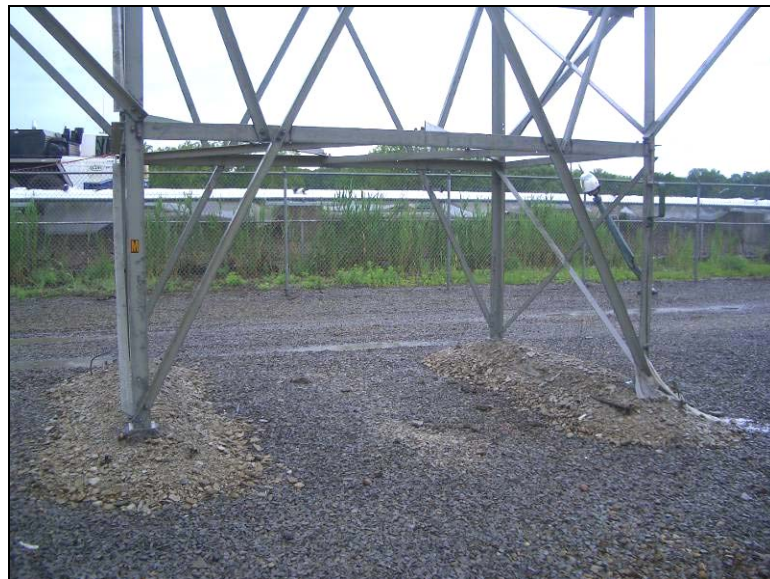
Figure I - 230kV Structure Foundation at Dunkirk

There are many asset condition issues at the Dunkirk substation. The foundations are in poor condition in the 230kV yard, including many structure foundations, affecting the integrity of the structure itself. See Figure I below.

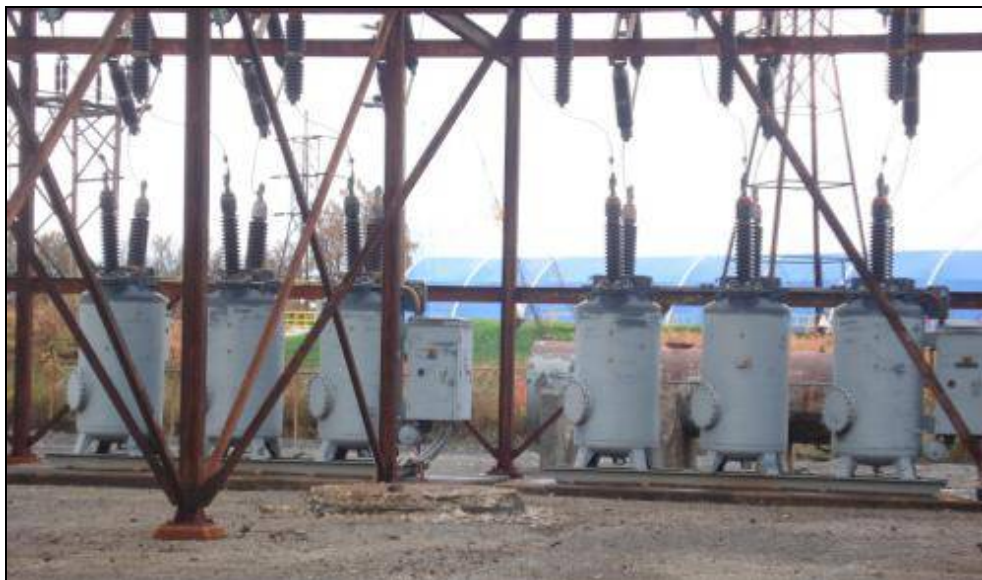
Figure II - Rome Station Structures and Foundations are Severely Deteriorated

The 115kV system at the Rome Station experiences periods of low voltage, particularly if the tie-breaker is opened. The latest station condition assessment performed 10/16/2008 revealed significant asset health concerns including: the 115kV disconnects being degraded and often breaking upon operation, 115kV instrument transformers built in the 1930s that have heavily weakened foundations, failing batteries and chargers during bus outages, the control house has asbestos and deteriorated windows and doors and the steel structure on the North bus is heavily corroded with degraded footers illustrated in Figure II below.

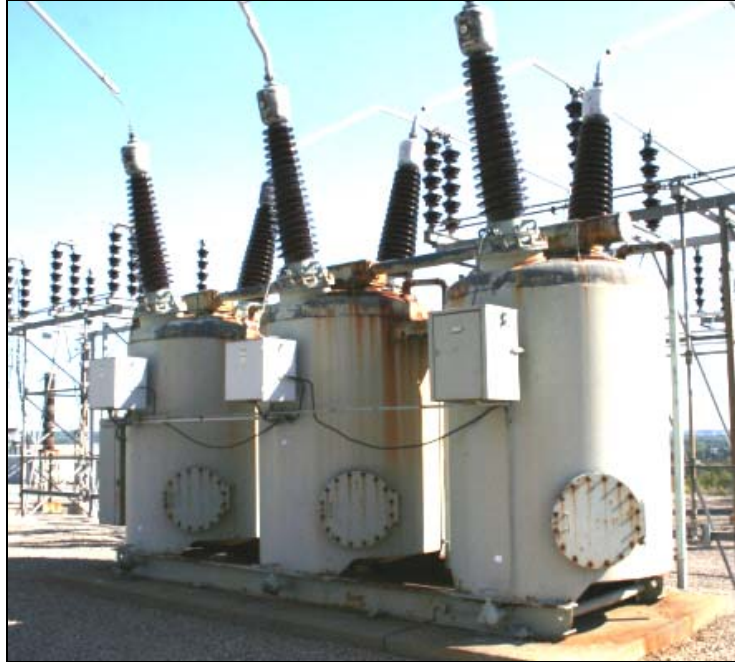
Figure I

Federal Pacific Breakers at Rotterdam are the only ones left on the System

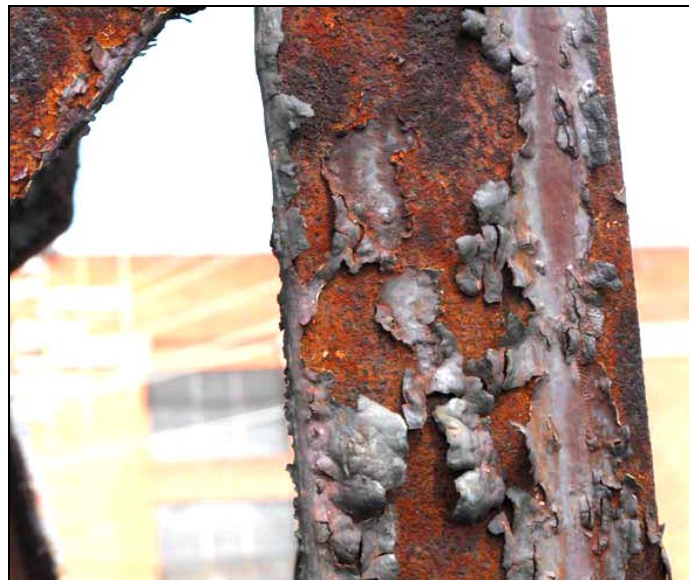
The structures are severely rusted and in need of painting before the steel is compromised. Figure II illustrates the typical steel condition at the station. Column and breaker foundations are also in deteriorated condition and need to be repaired with several potentially needing full replacements.

Steel Structures at Lockport are Deteriorated

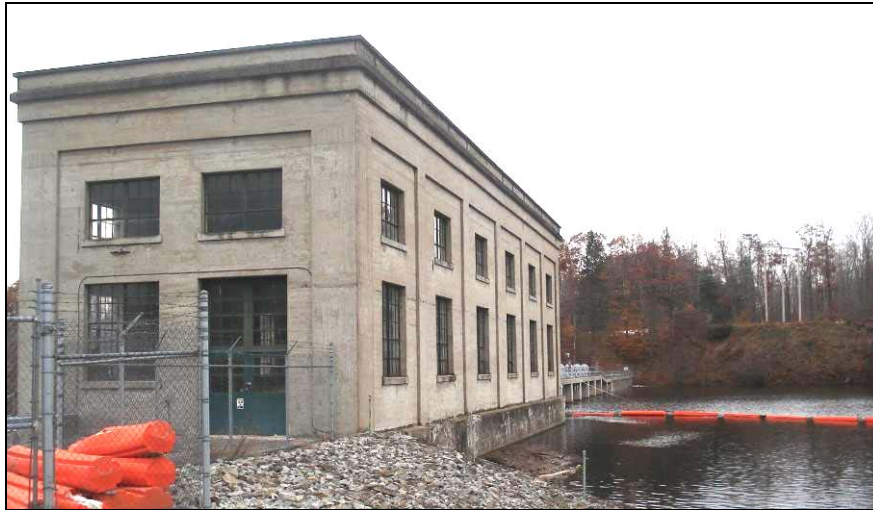
Figure III

Brookfield's Control House at the Lighthouse Hill Site

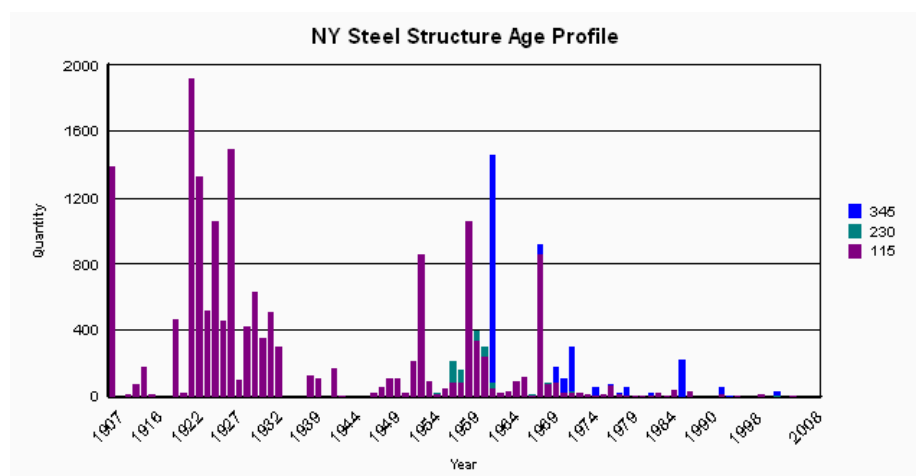
Secondly, the age distribution figures for overhead line assets show an aging population of transmission assets in Upstate New York. A significant portion of the steel structure assets are within the anticipated replacement timeframe of 70 – 110 years (i.e. installed between 1899 and 1939). See the addendum on Asset Modeling at the end of this justification document. The 115 kV population of steel structures is older than the 230 kV and 345 kV one.

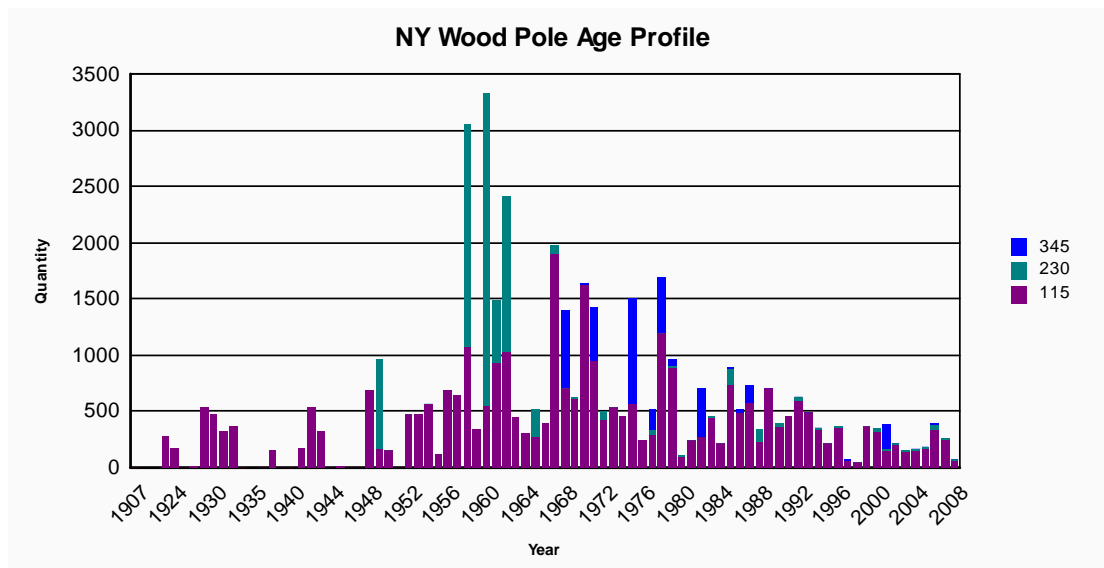
For wood poles, a large portion of the assets are also within the anticipated replacement timeframe of 24 to 100 years (installed between 1909 and 1985). In this case, the 115 kV and 230 kV wood pole populations are older than 345 kV wood poles.

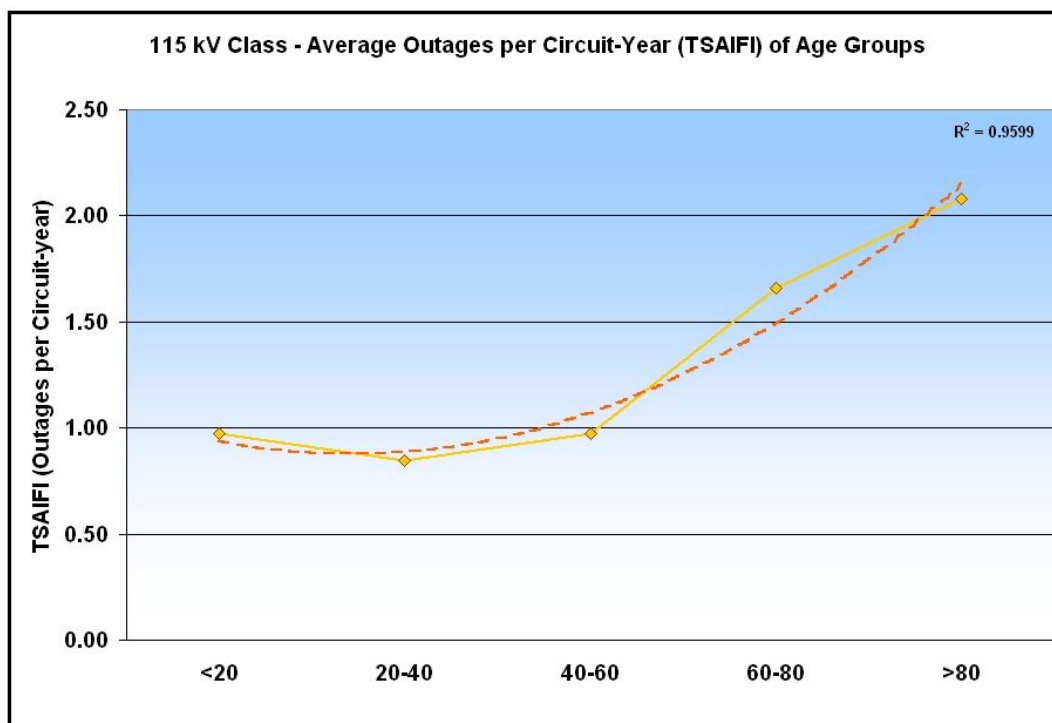
A recent evaluation of the 115 kV transmission assets demonstrated a strong correlation between age and decreasing reliability. The following chart clearly shows that as 115kV overhead lines age, the number of outages increases. It is also important to note that even relatively new circuits will still experience outages.

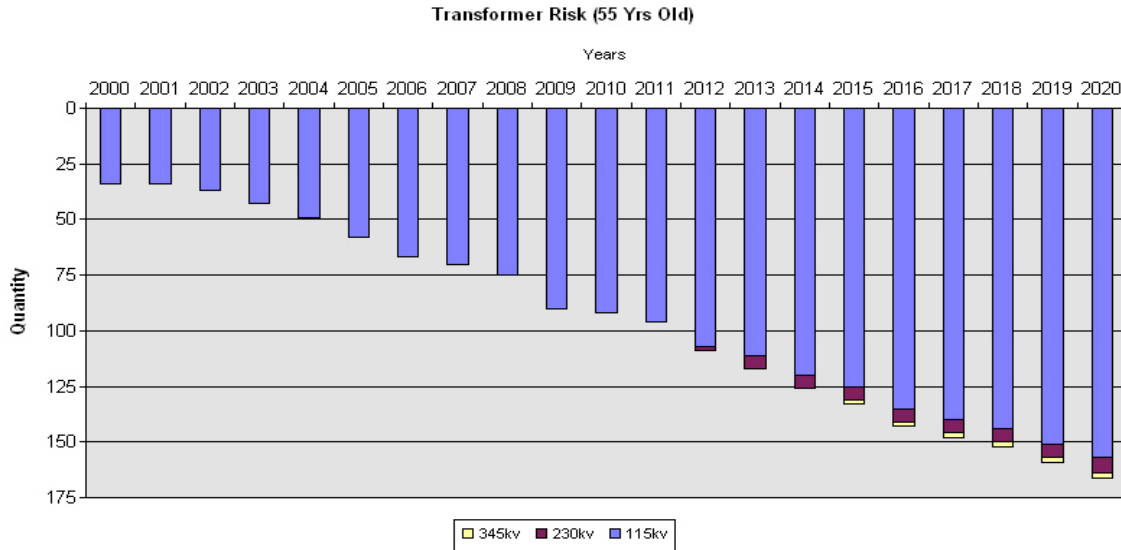
Figure 1 - Transformers in NY over 55 years old

Sustainability – If the replacement rate of the past 10 years is perpetuated, by 2020, there will be more than 150 transformers over the age of 55 (anticipated asset life) including 57 transformers over the age of 80.

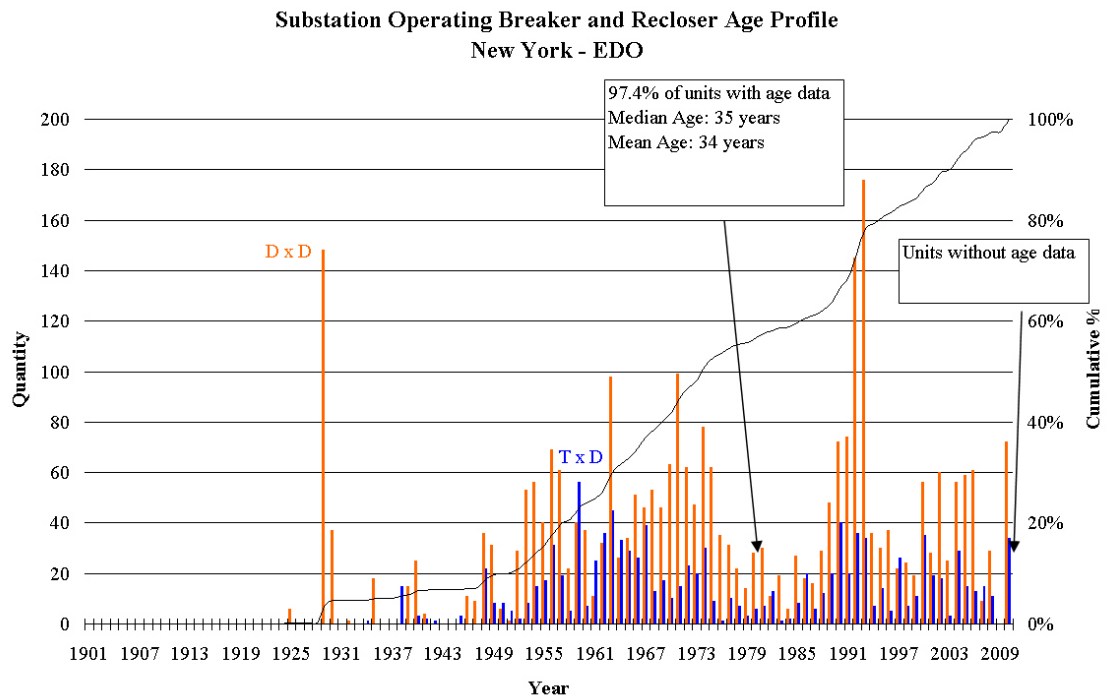
Figure 1 - Substation Breaker Age Profile

- Equipment Condition (See Figure 1) - The current approach to breaker condition coding was developed based on engineering judgment and experience and was supported by discussion with local field staff. These condition codes were reviewed and updated in June of 2009.

- Replace all breakers within the defined time-frame based on the condition codes
- Replace approximately 70 breakers per year to maintain a 60-year life expectancy target for this asset class due to the expected unavailability of spare parts and technological obsolescence.

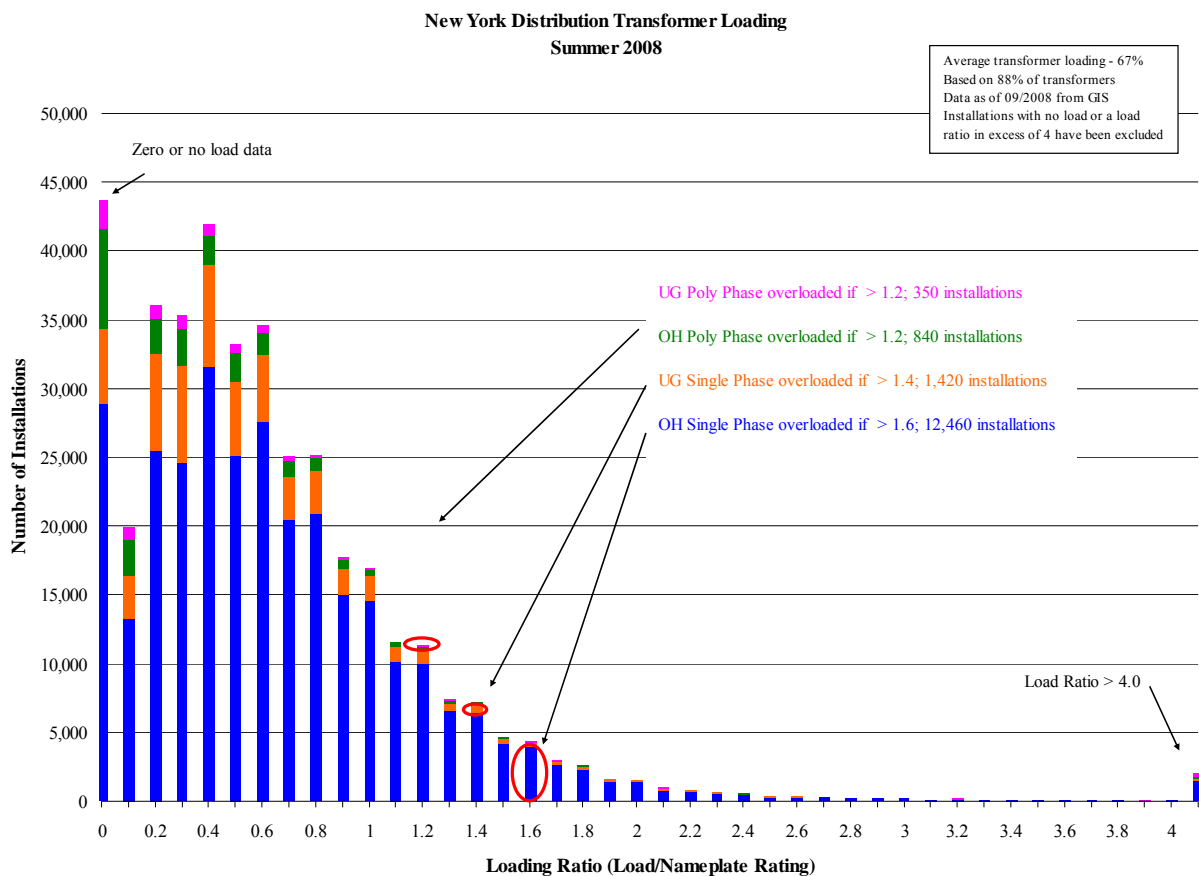
Figure 1 - Distribution Line Transformer Loading

The total population of distribution transformers in New York consists of approximately 442,100 units in 392,000 installations.

- Equipment Loading (See **Figure 1**) - Heavily-loaded transformers are not currently an increasing problem. However, it is important to manage equipment loading with proactive process based on annual reviews in order to maintain this situation.
- Asset Condition - Any condition-based replacements will be managed through the Inspection and Maintenance Program. Condition-based replacements represent much less than one percent of the inspected units.
- Customer Level Reliability - Load and condition-based transformer interruptions do not significantly impact overall system reliability but are significant at the customer level.

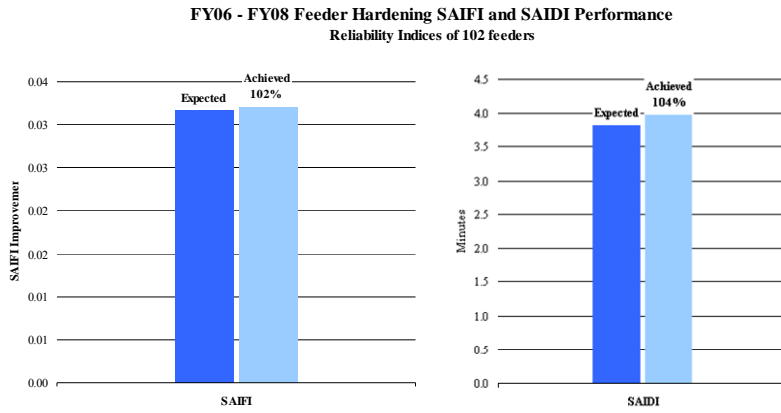
Figure 2 - Feeder Hardening Reliability Perform

FY11 is the last year of the five-year program. Actual improvements on the feeders completed through FY2008 are shown below:

Through October of 2009, approximately 200 feeders have been hardened representing more than 6,000 circuit miles of feeder hardening. The actual performance improvement on the 102 feeders previously completed through the end of FY2008 is shown in Figure 2 at the end of the report.
