**Brief Summary of info below:** Vista Contractors Corp., was digging a trench for a garage foundation without an 811 ticket. While digging with a backhoe (although he claims shovels were used), he struck and damaged the unmarked ½” HDPE gas service line.

**Incident:** Vista Contractors Corp. was digging for a foundation for a new garage at 68 Meadow CT, Wading River. While digging without an 811 ticket the contractor struck and damaged a ½” HDPE gas service to the residence.

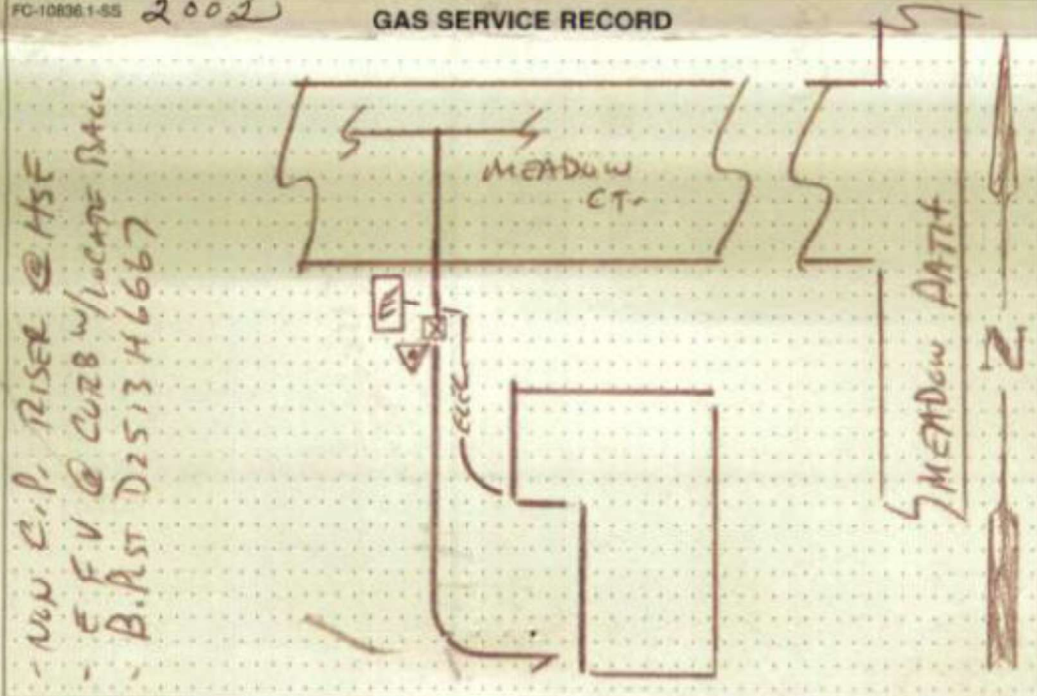
GAS SERVICE RECORD

CUSTOMER ADDRESS  
TOWN WADING RIVER HSE. NO. 7 STREET MEADOW CT. C.P.R. NO. 515835

GAS SERVICE LOCATION  
STREET S MEADOW CT QUAD 075568191

CROSS STREET 138' w/o MEADOW PATH PREMISES USED AS RES

PRESSURE: PRESSURE TEST: AIR @ 200 PS CURB COCK INSTALLED: ☐ YES ☒ NO  
☐ Low (5" W.C.)  
☒ High 124 TIME: Hr. Min 20 CURB COCK LOCATION (IF NONE, PROPERTY LINE) COMMON TRENCH  
139L 110R 25M ☒ YES ☐ NO

PIPE FOOTAGE SIZE MATERIAL DEPTH OF MAIN NA inches  
Main to PL 25 1/2" B.P.S.T  
PL to Meter 240' 1/2" B.P.S.T  
W.O. NO.  
BUSINESS DISTRICT ☐ YES ☐ NO TAX DIST.

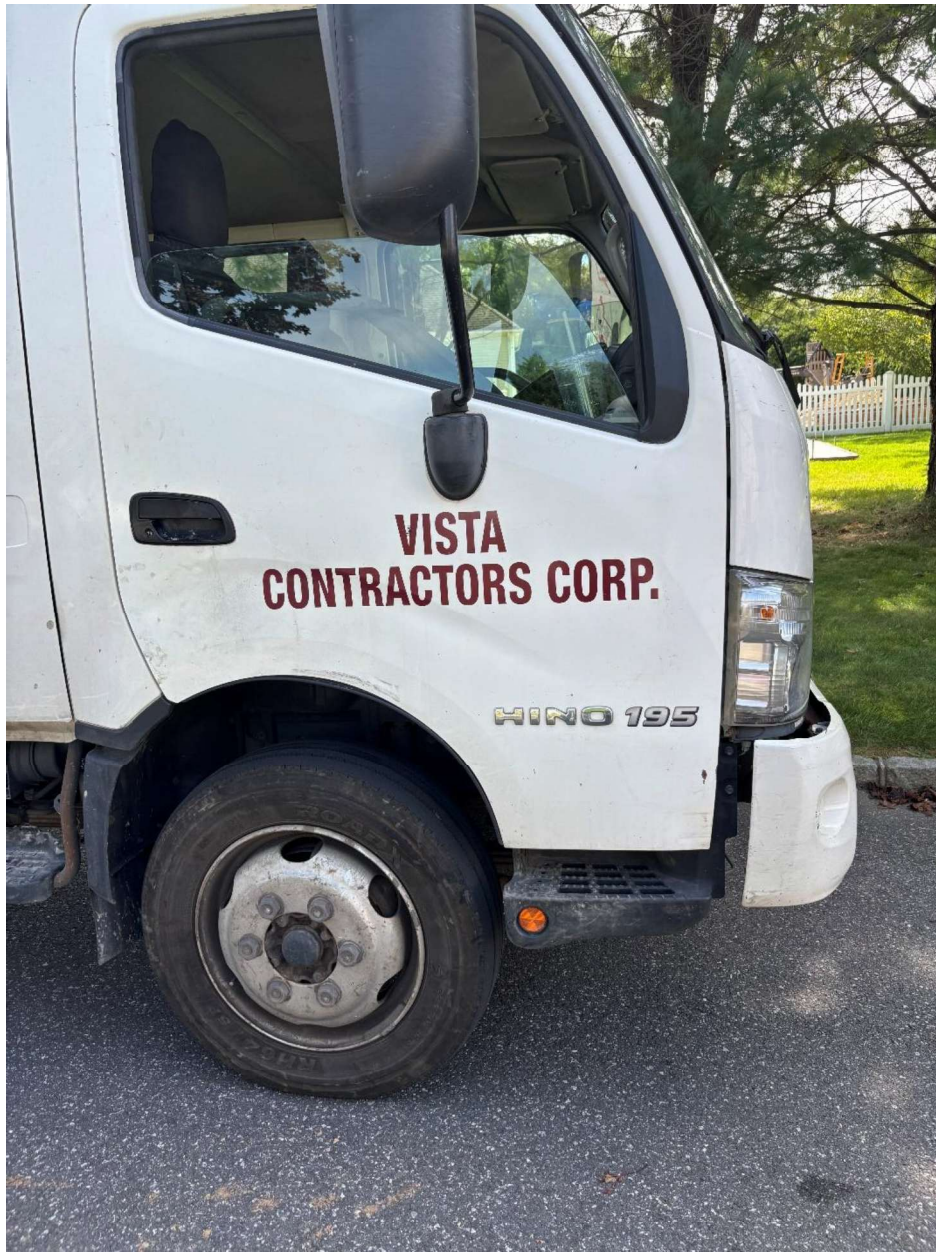
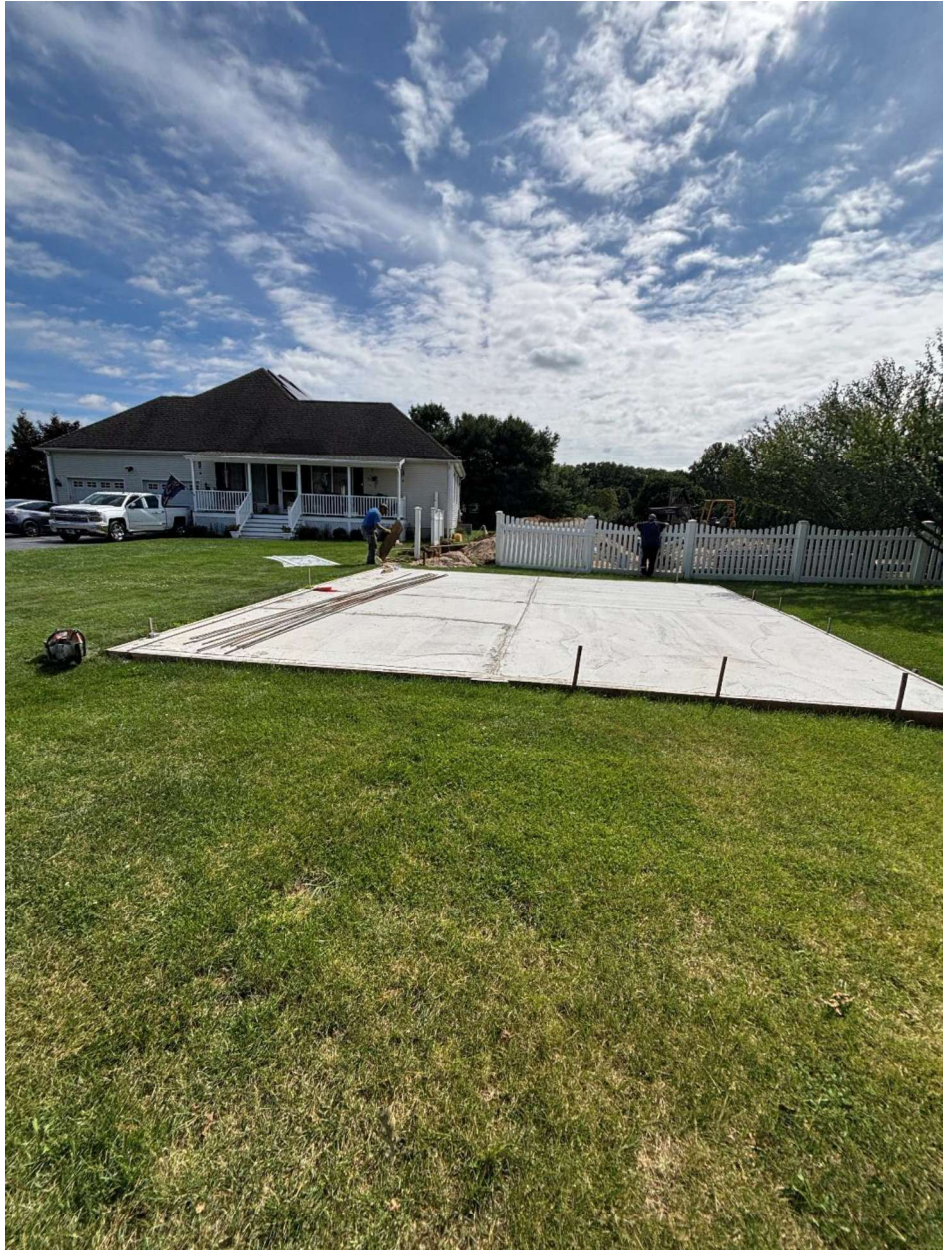
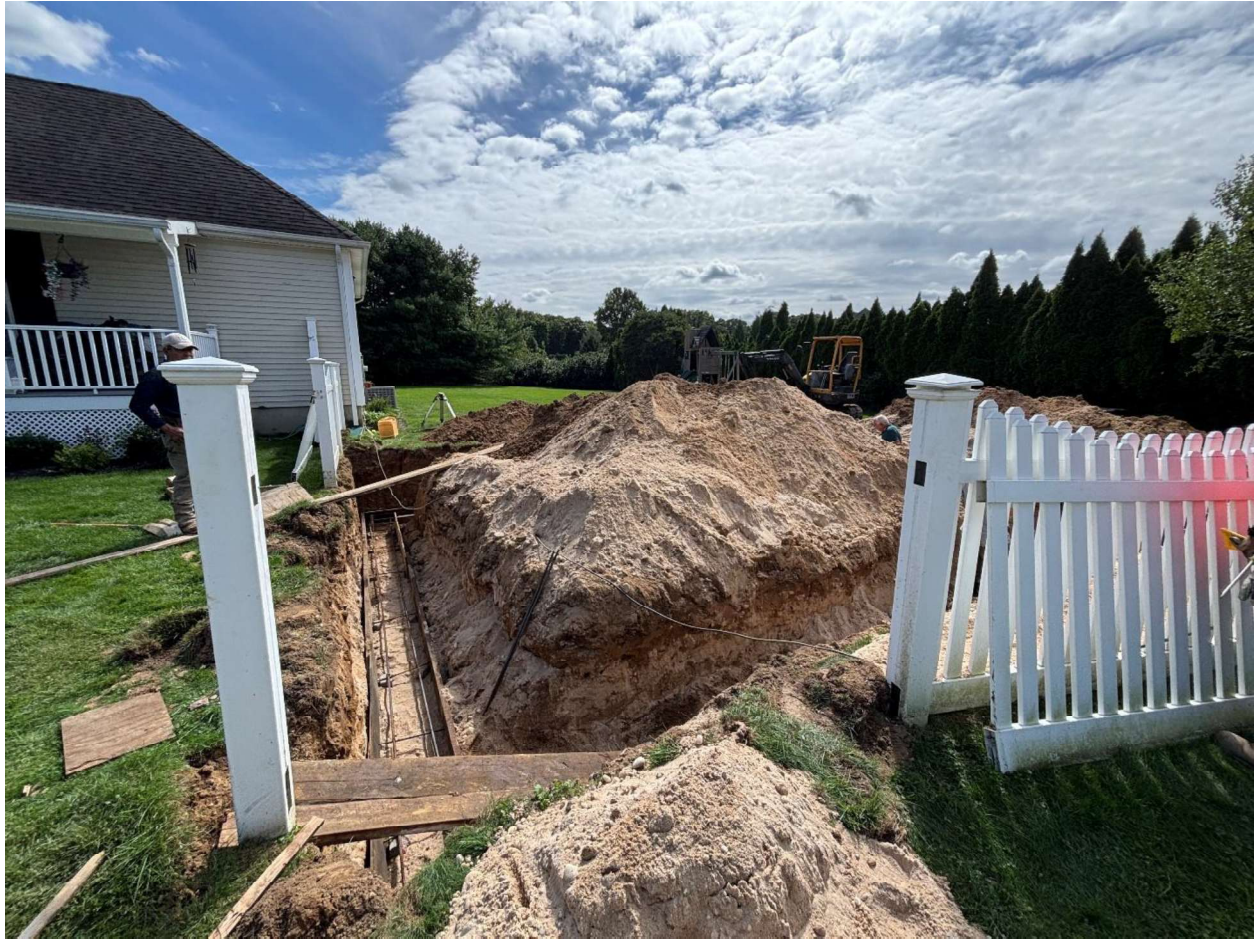
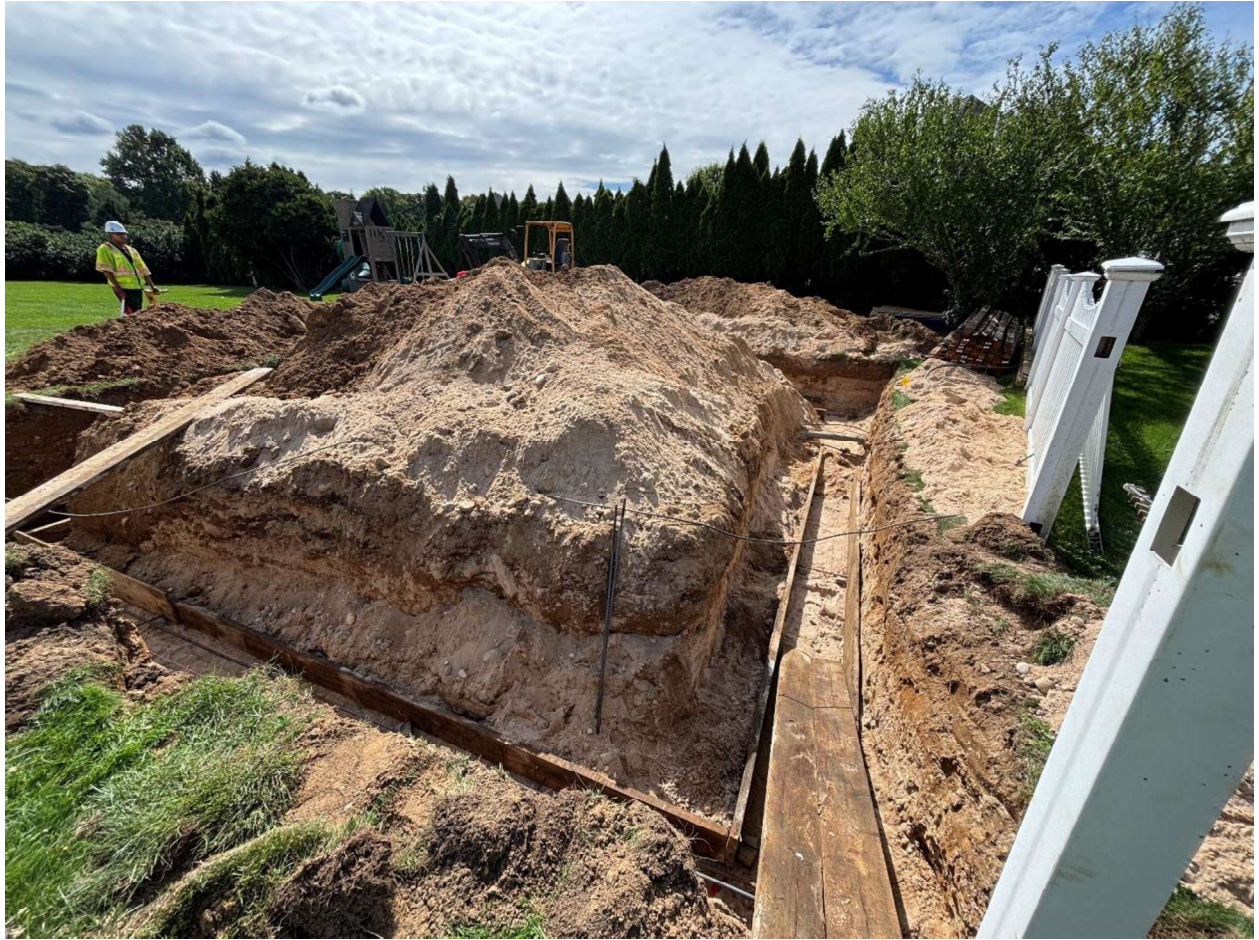
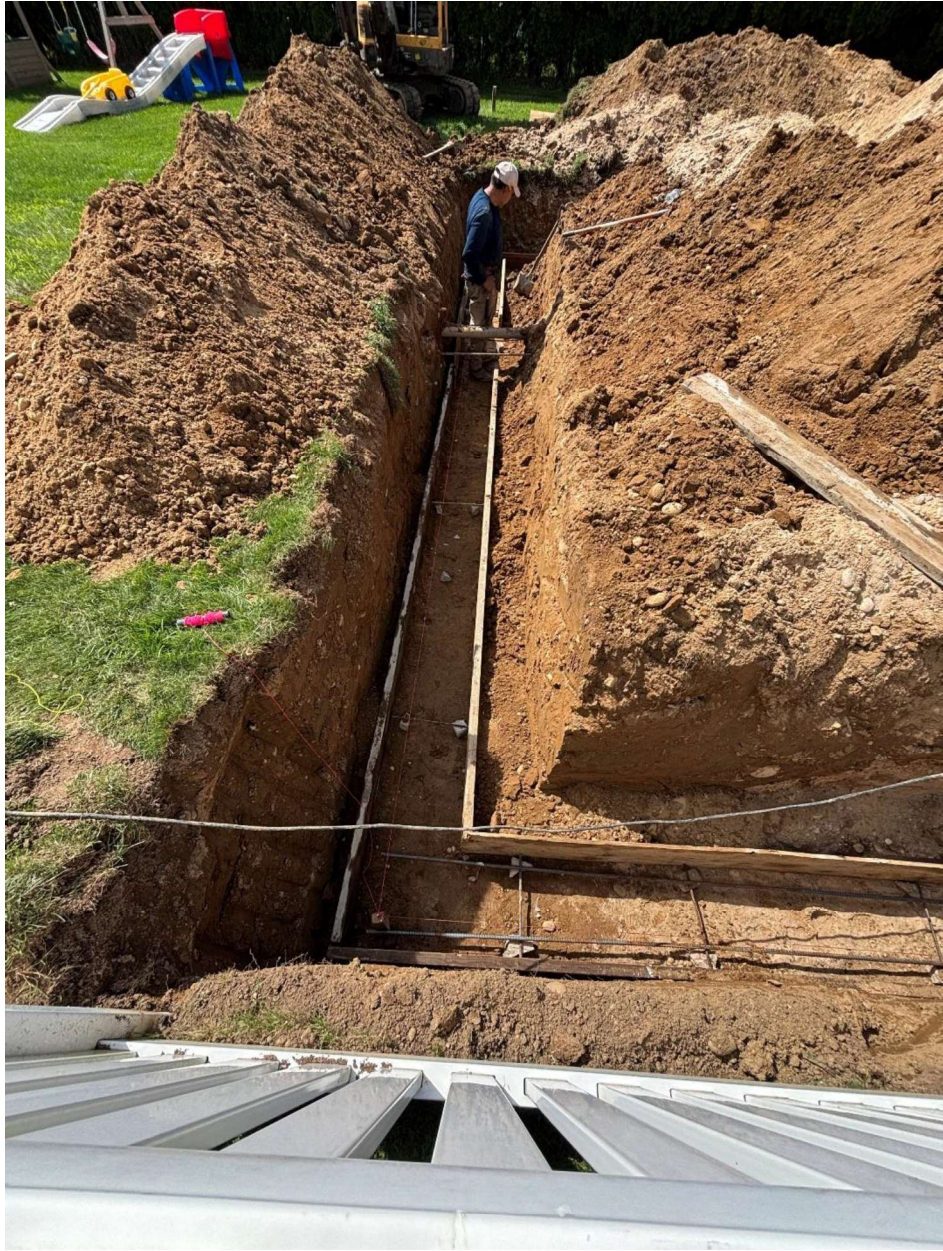
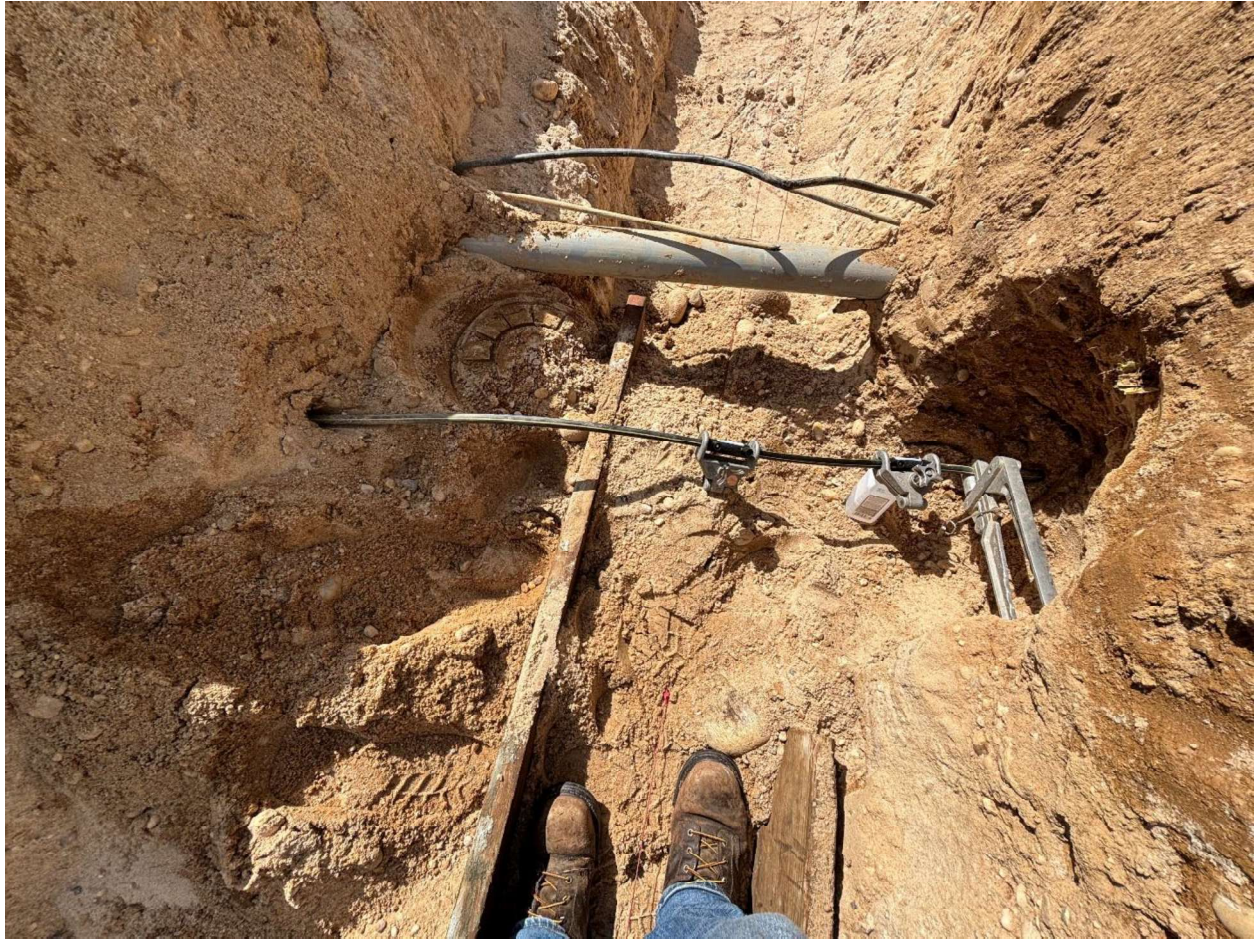
Photos attached and video (if available)

Type of Utility Damaged: **½” HD PE gas service**

Approx. Length of Utility to be repaired: **1’ of ½” HD PE gas service filler, (2) electro fused couplings**

The homeowner who claimed to work for LILCO prior was trying to take responsibility for the damage saying he did it with a shovel. After investigating and examining the damaged piece we determined this in fact was pulled with the excavator on site and not damaged with a shovel. He was advised of the 811 call-in requirements, Code 753, and the requirement that both contractors and homeowners obtain utility markouts before beginning any excavation. It is recommended that RECONN be sent to this address/location.
