## 21028 Hoffman Falls - Rapid Ordinary High Water Mark (OHWM) 1.1

Project	21028 Hoffman Falls Wetland Delineation
ID	364360
Survey Date	06/27/2023
User	Joseph Knight

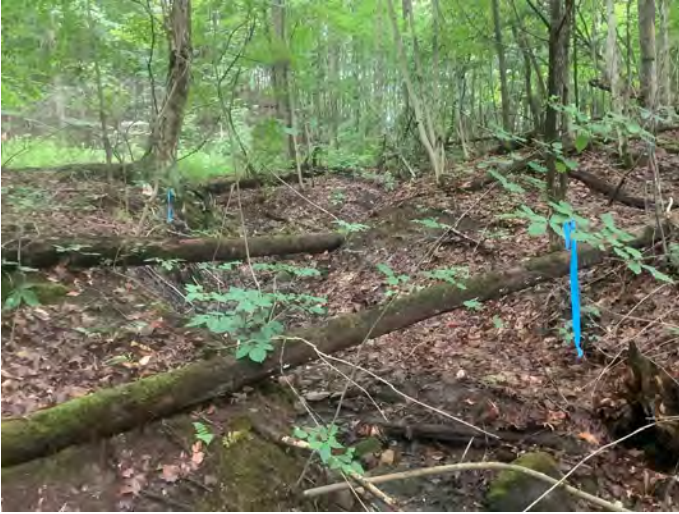
Presence of large wood, logs resting on the OHWM being suspended over the stream bed.

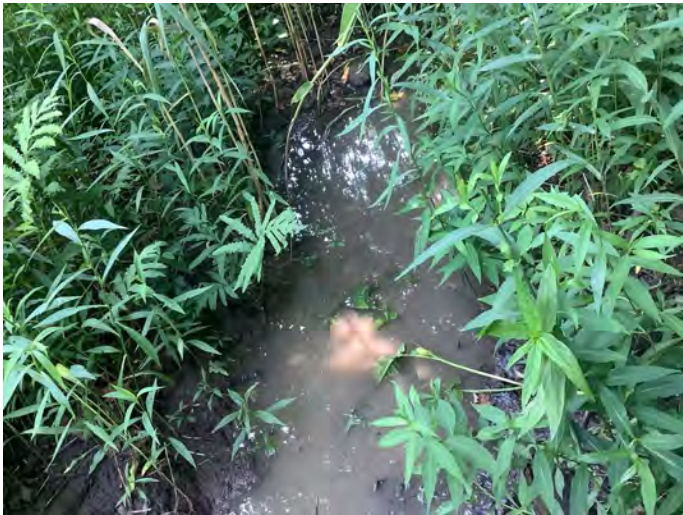
View of change in vegetation from absent to forbs within stream.

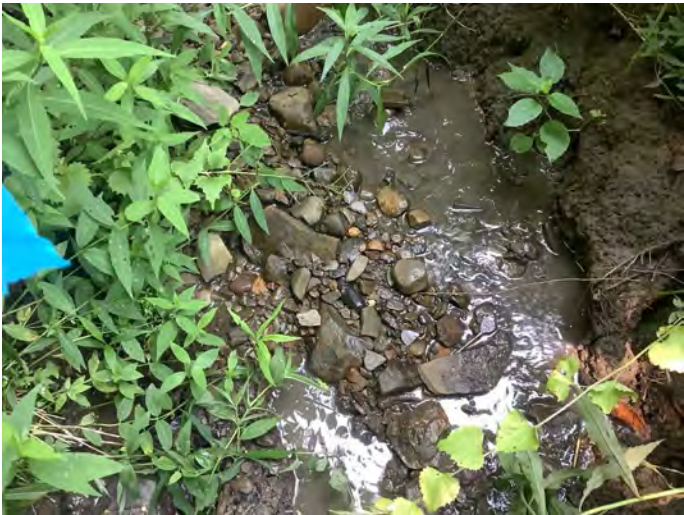
View of change in sediment from cobbles to silt. Change in vegetation density from absent to forbs

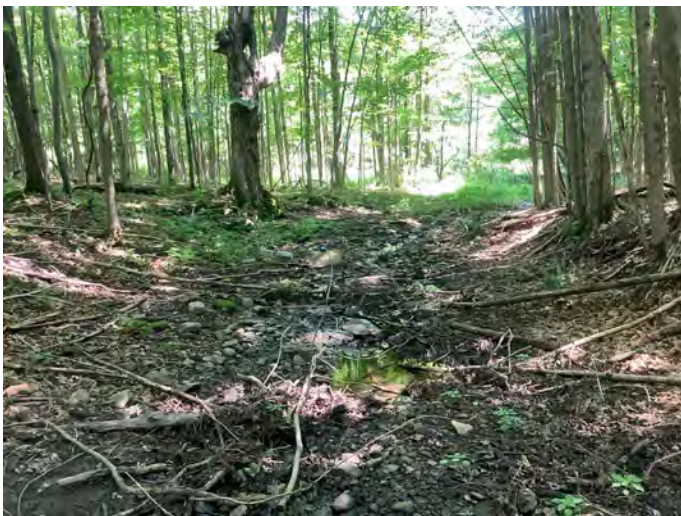
Break in slope, change in vegetation density, change in particle size distribution.

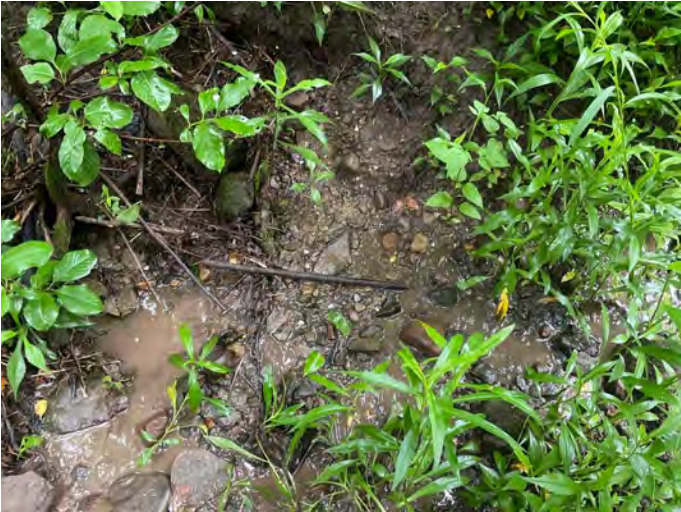
Stream substrate with absent vegetation transitioning to forbs.

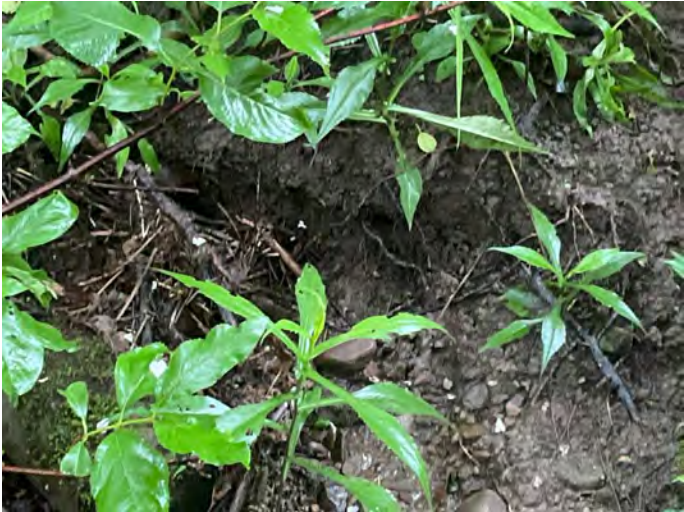
Exposed roots within the stream bank.

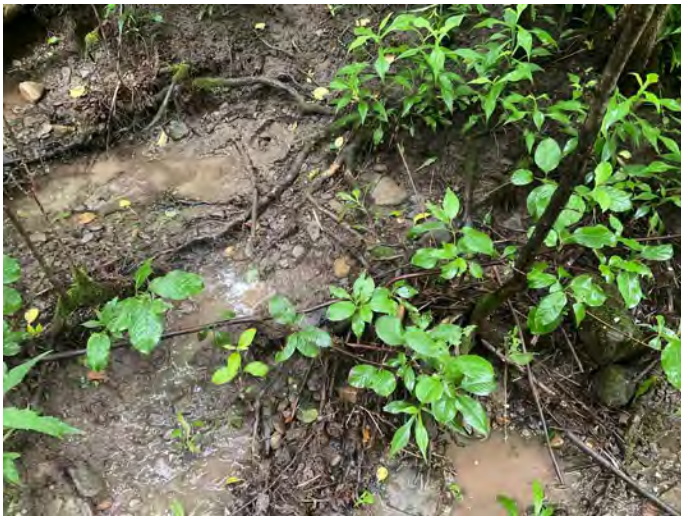
Wracking of organic material and exposed roots.

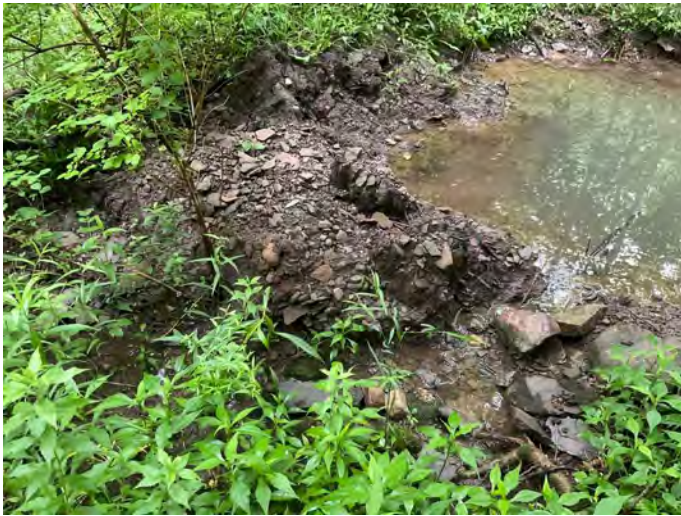
Outflow from excavated portion of stream.

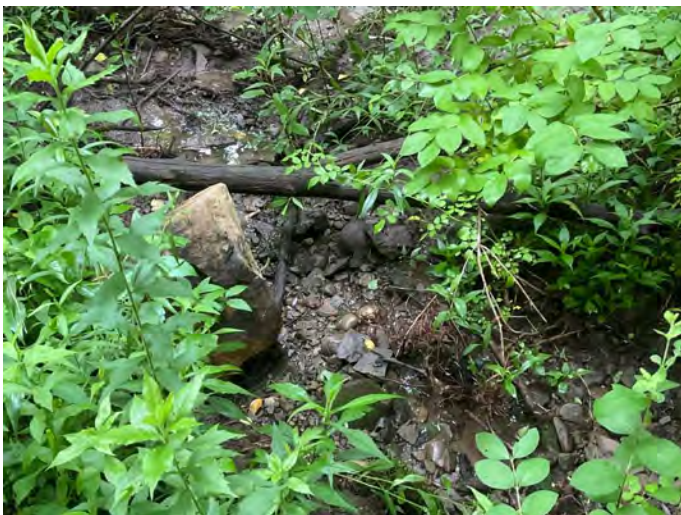
Vegetation transition present within stream bed.

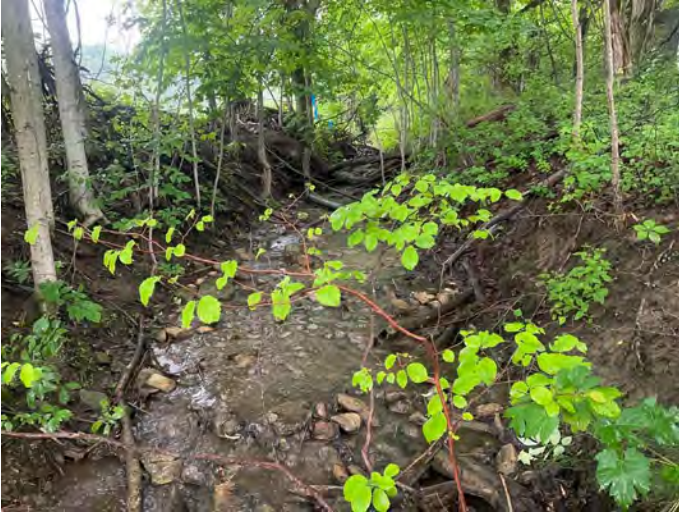
Indicators represented in this photo include a break in slope on the bank, shelving within the stream, instream bedforms (riffles), the presence of large wood, and disturbed leaf litter.

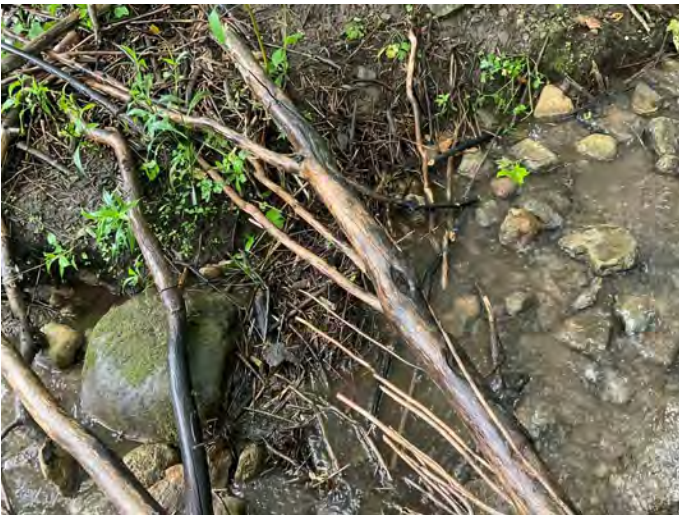
Indicators represented in this photo include changes in particle size distribution, wracking, exposed fibrous roots, disturbed leaf litter, and a break in slope on the bank.

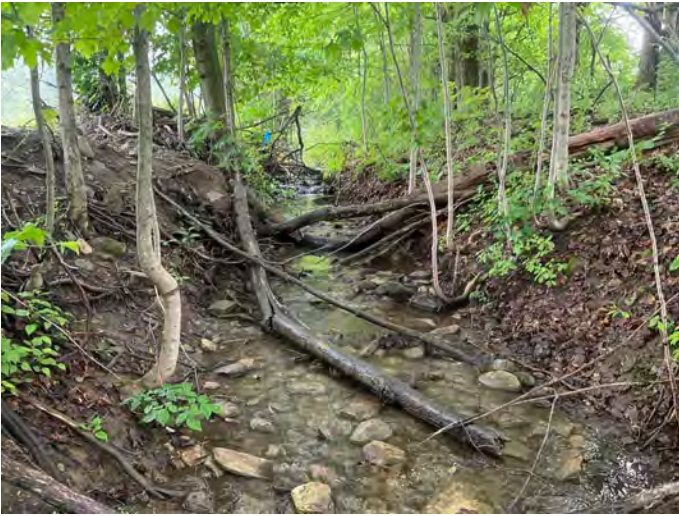
Indicators represented in this photo include a break in slope on the bank, shelving within the stream, instream bedforms (riffles), the presence of large wood, and disturbed leaf litter.

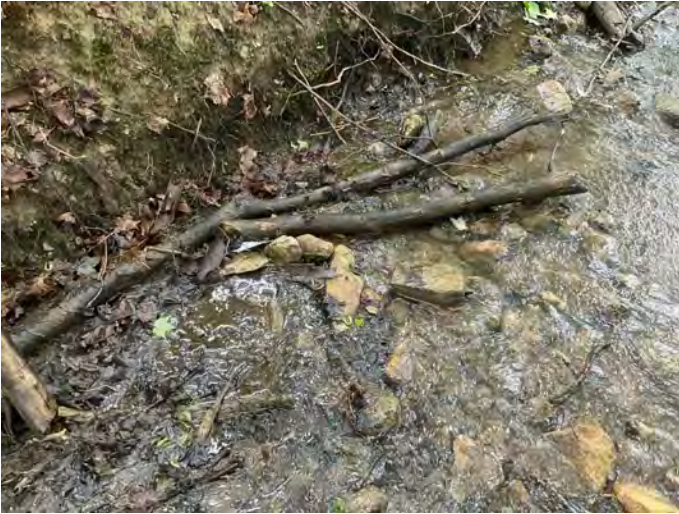
Indicators represented in this photo include a break in slope on the bank, disturbed leaf litter, changes in particle size distribution, exposed fibrous roots, and riffles.

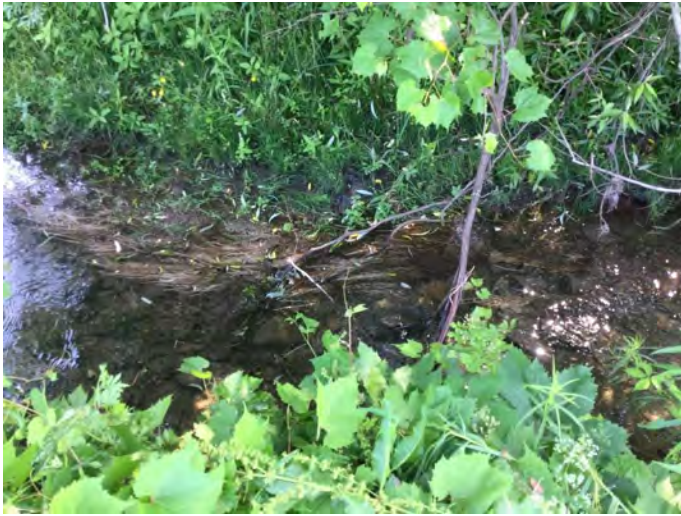
view across stream showing break in slope

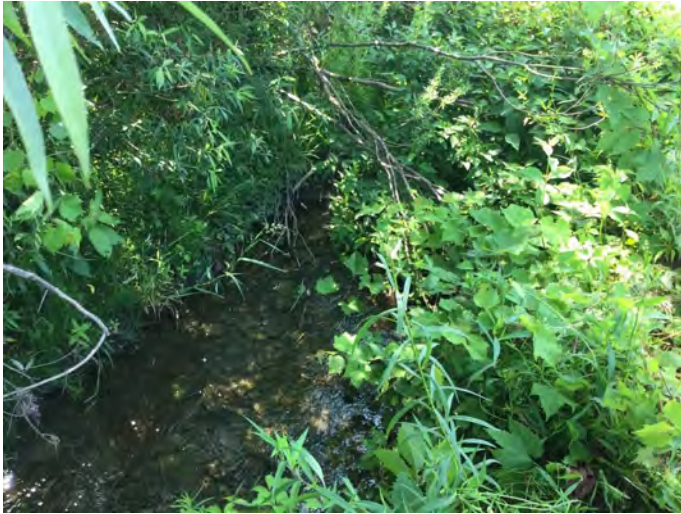
upstream, note the dense vegetation on the stream banks

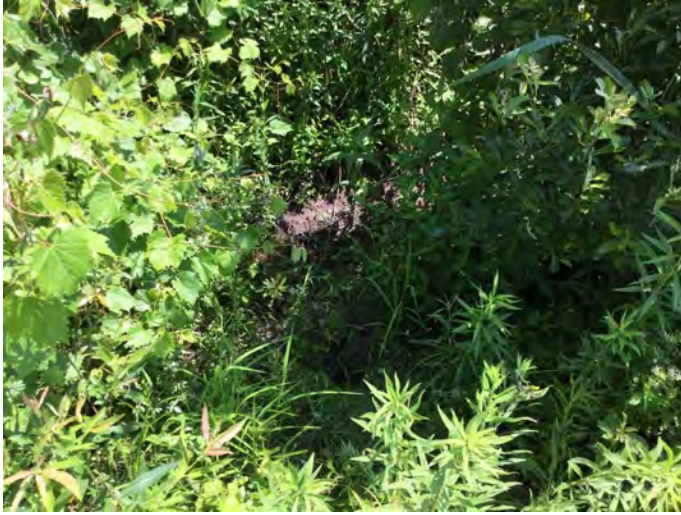
Dense vegetation begins at OHWM.

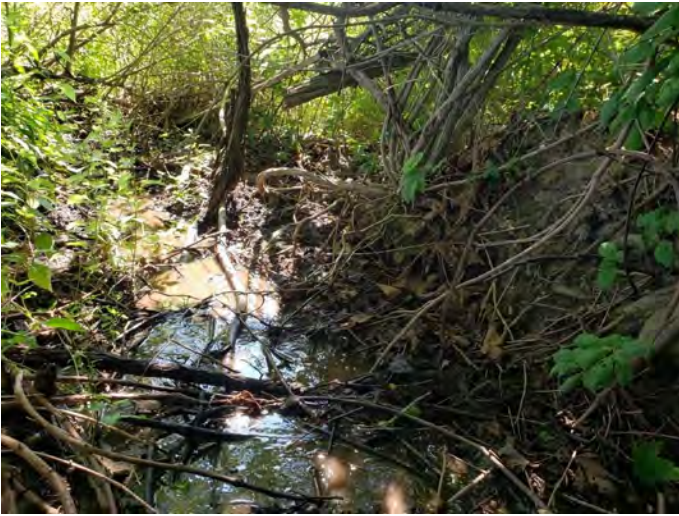
Downstream photograph with break in slope present, and a transition from absent vegetation to deciduous trees.

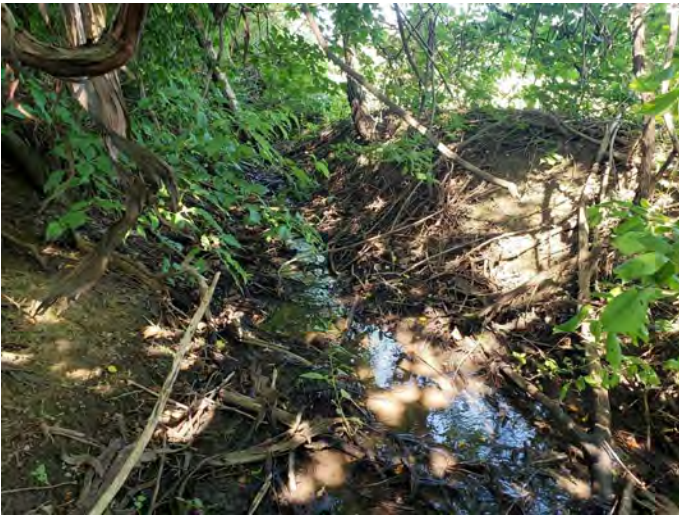
Upstream photograph with wracking present on stream banks.

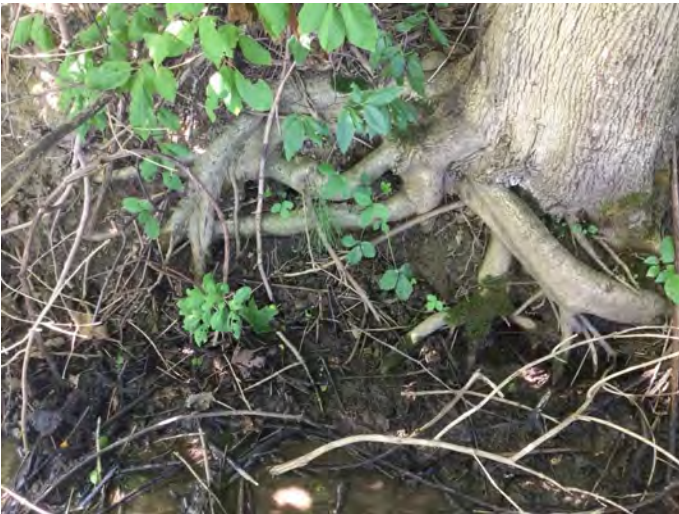
Exposed roots below intact soil layer.

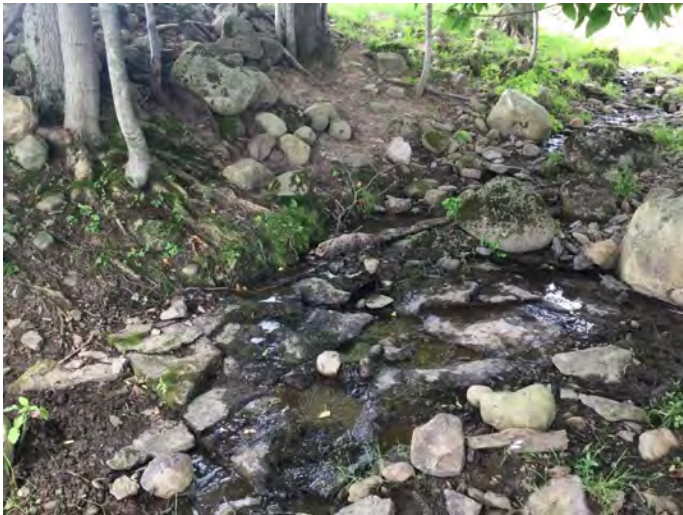
Break in slope clearly visible.

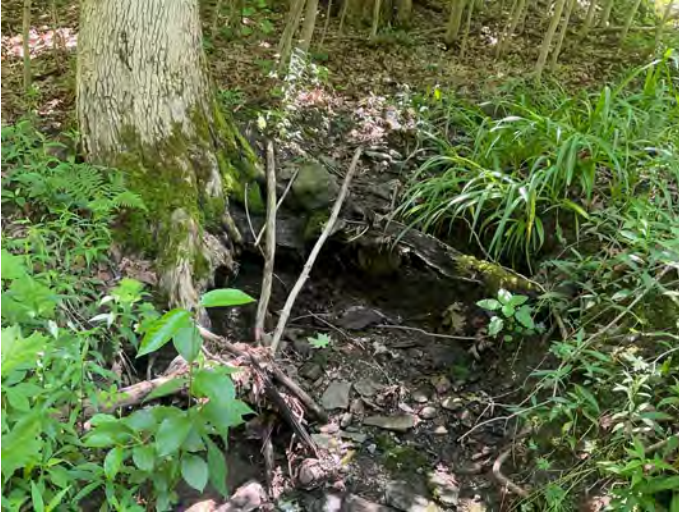
Shelving and upstream

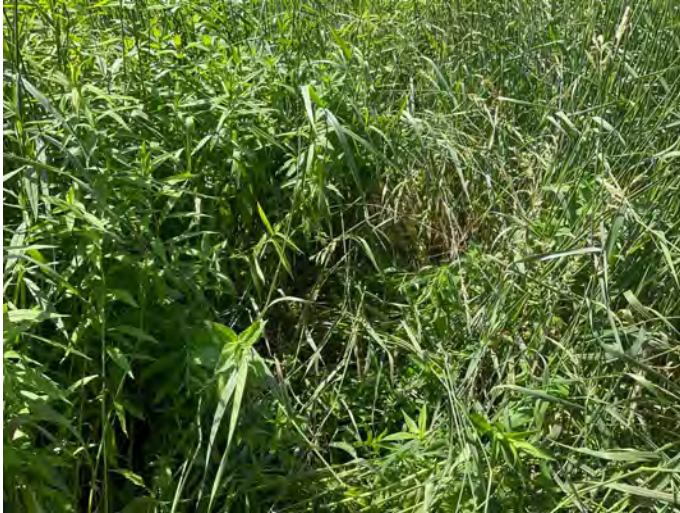
stream diffuses into wetland

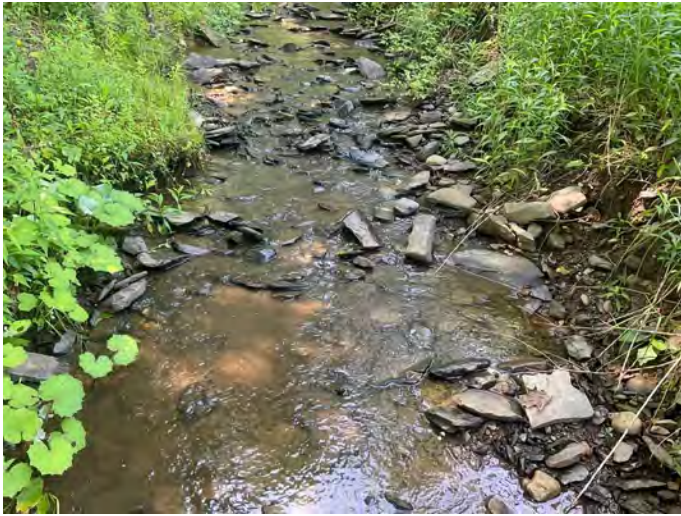
vegetation transition

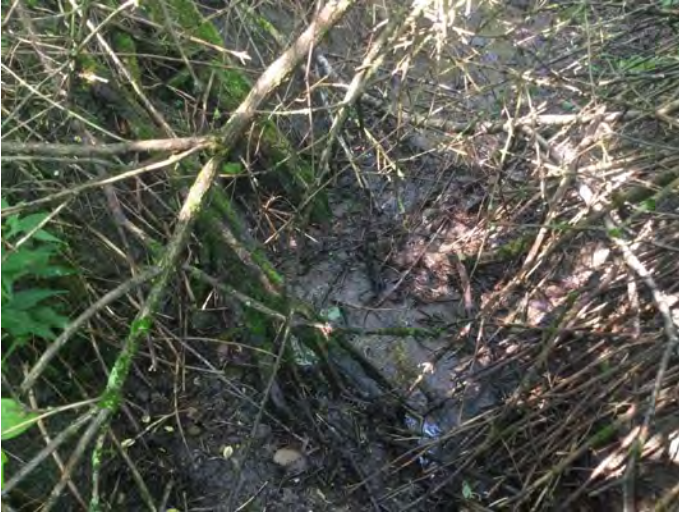
Break in slope and exposed roots.

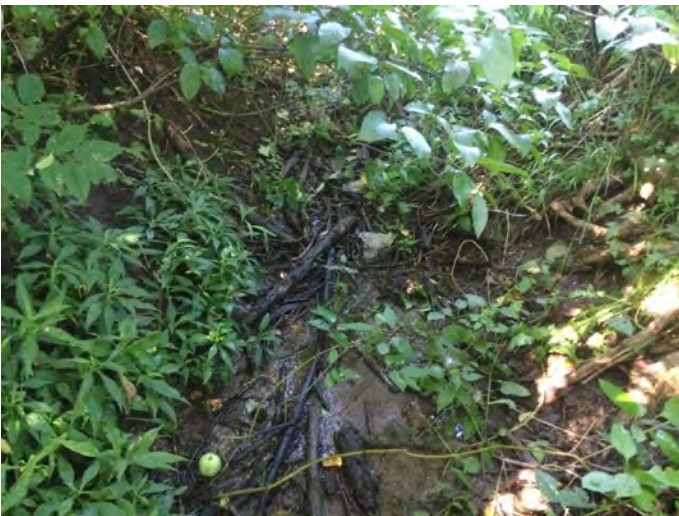
Stream channel.

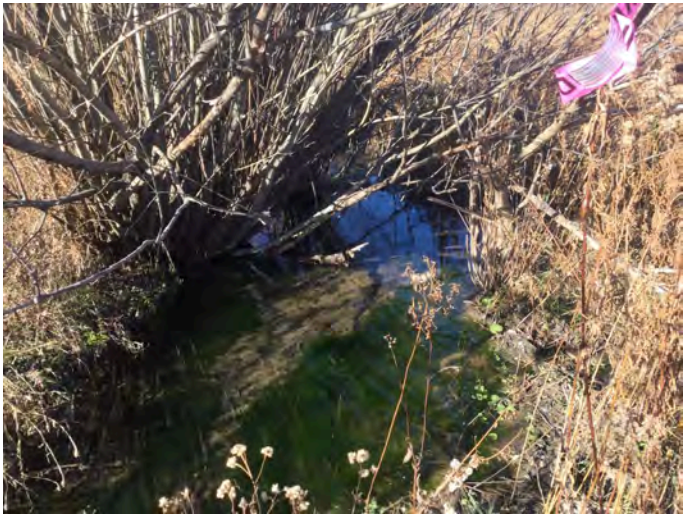
Downstream

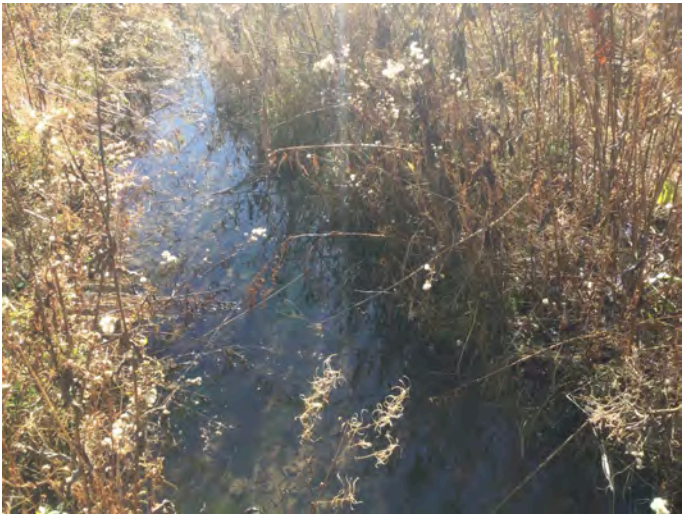
Upstream, shelf at top of bank, transition in vegetation.

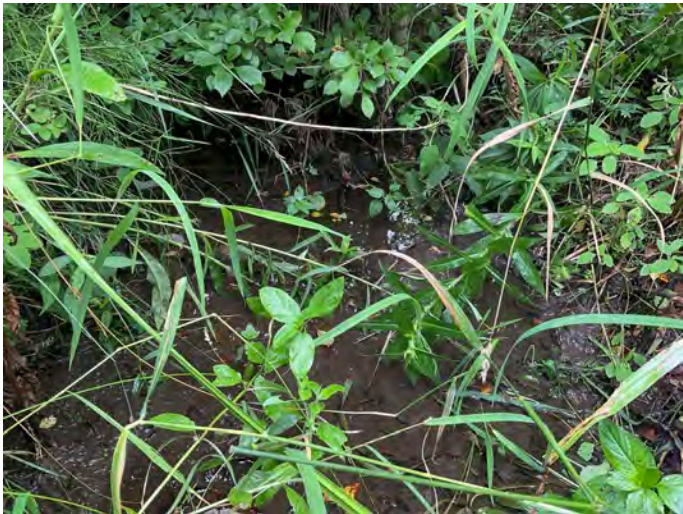
substrate in stream and undercut bank

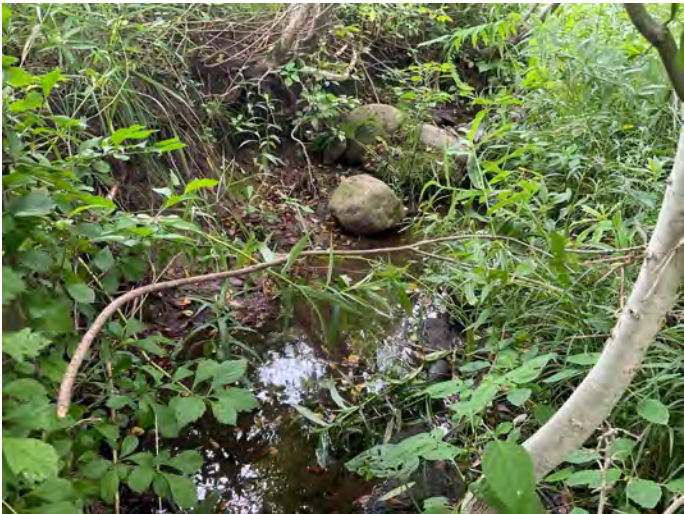
exposed roots below intact soil layer and upstream with cobbles and lack of vegetation in stream

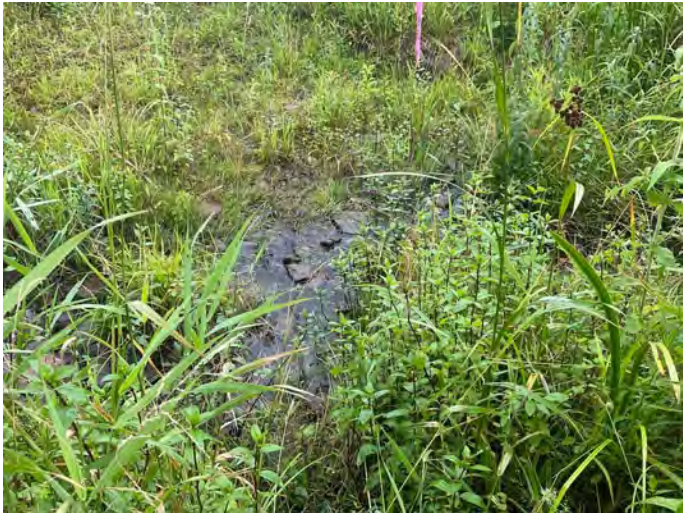
downstream where stream dissipates into PSS wetland

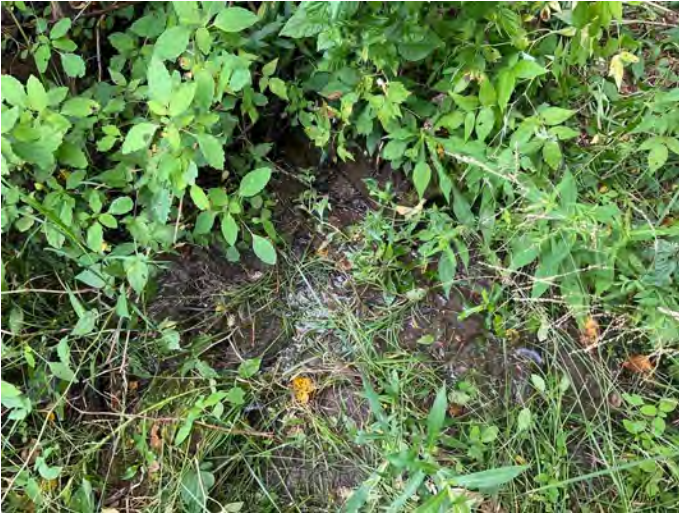
Stream substrate photograph, with a transition in vegetation density present.

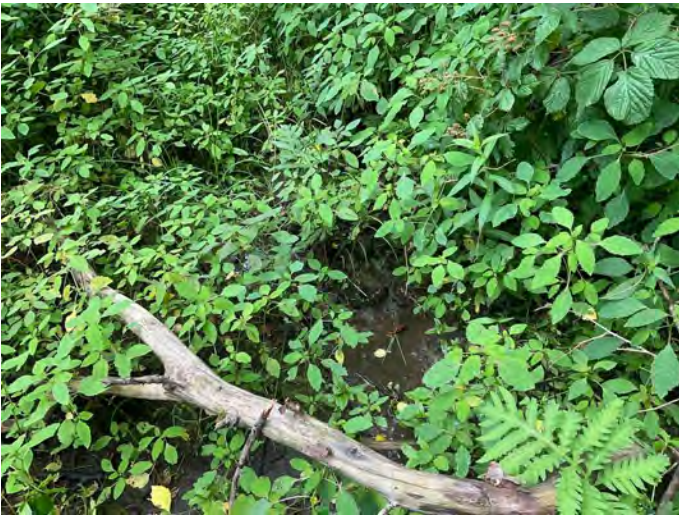
Upstream photograph with baseflow.

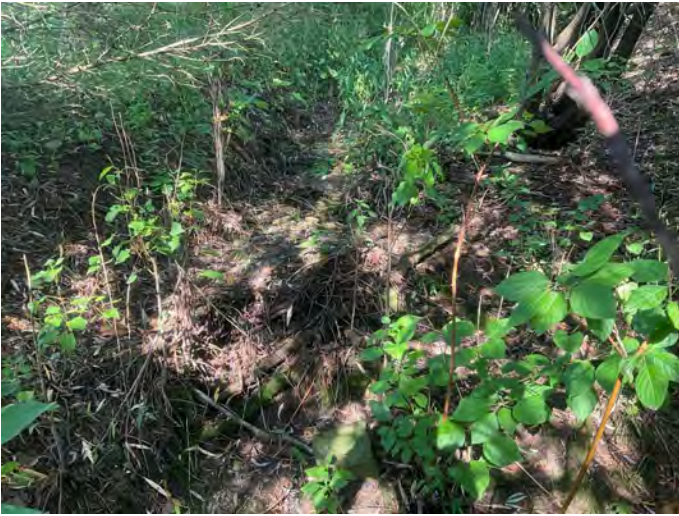
Upstream and wracking

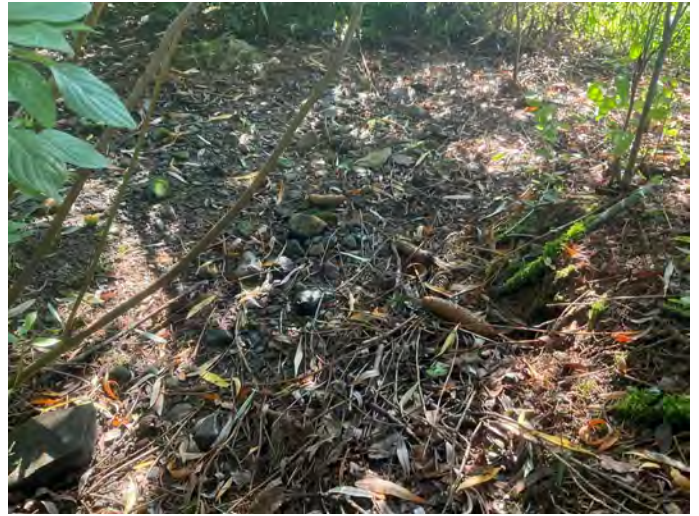
Downstream view.

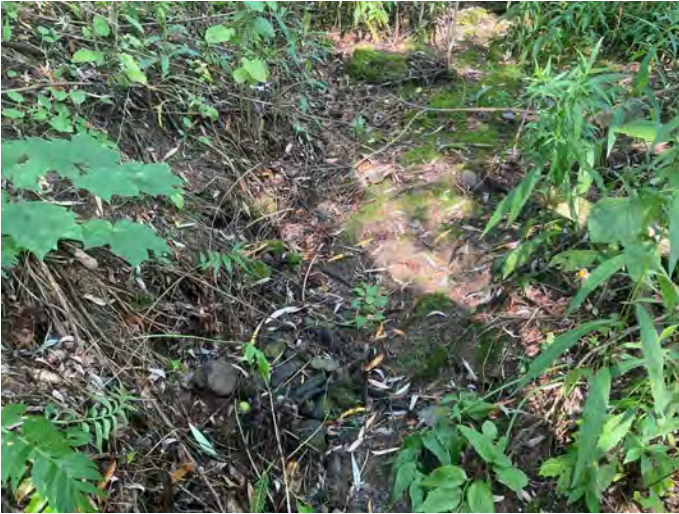
Photo of substrate, change from silt to cobble.

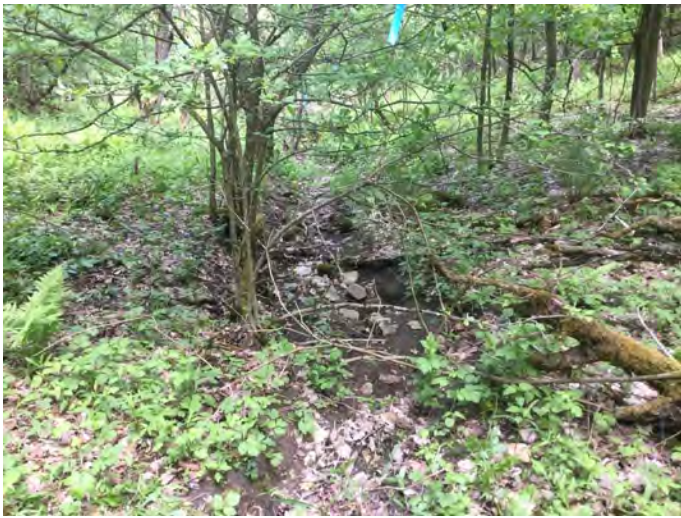
Transition in absent vegetation to forbs, facing downstream.

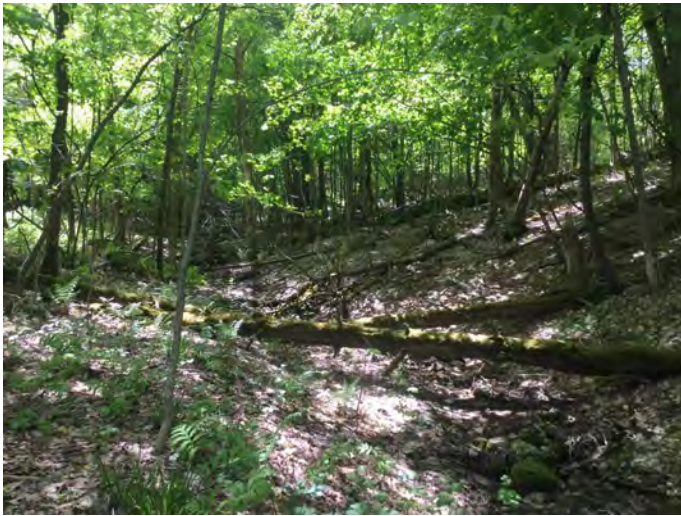
Break in slope and vegetation transition, facing upstream.

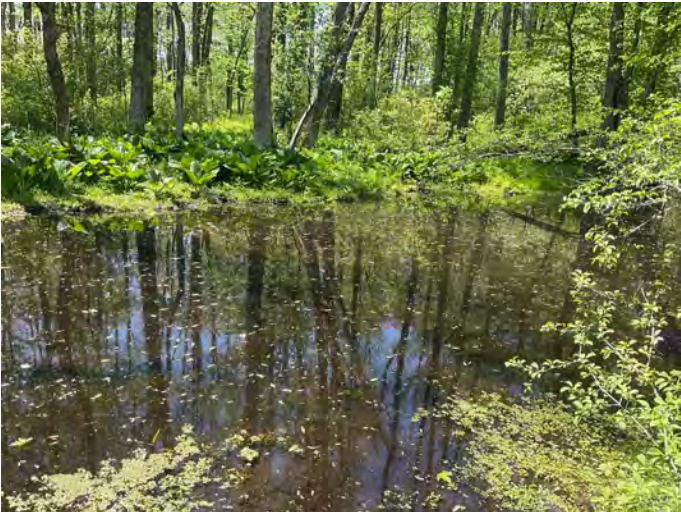
Transition from absent vegetation to forbs.

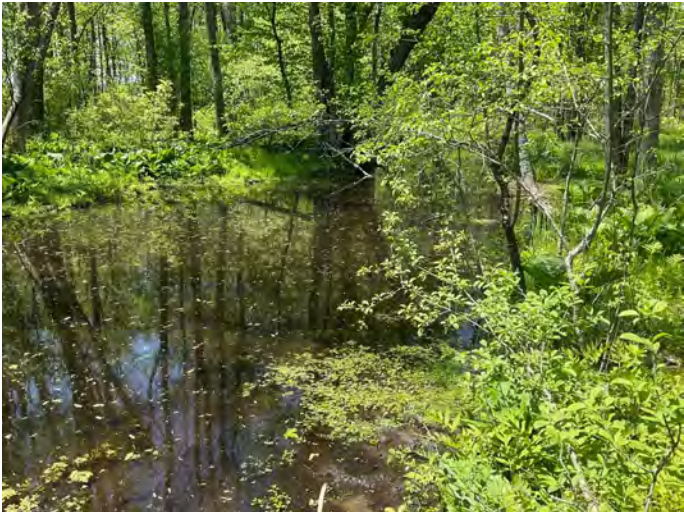
Upstream photograph.

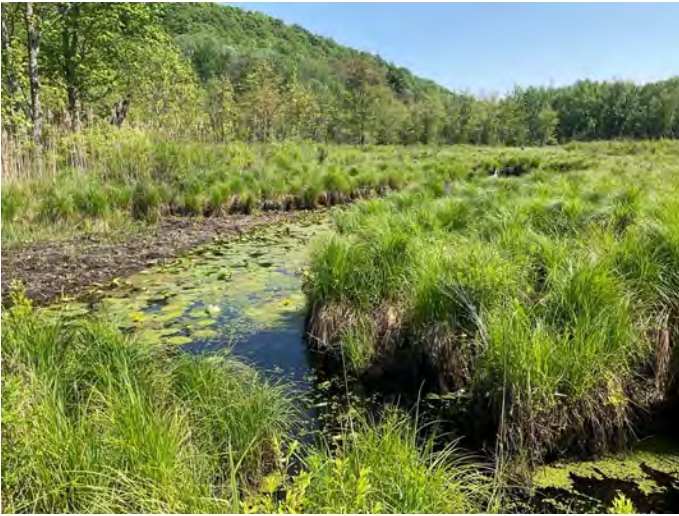
Photo of the confluence of streams 23-ST002 and 23-ST004, with a break in slope present, facing downstream.

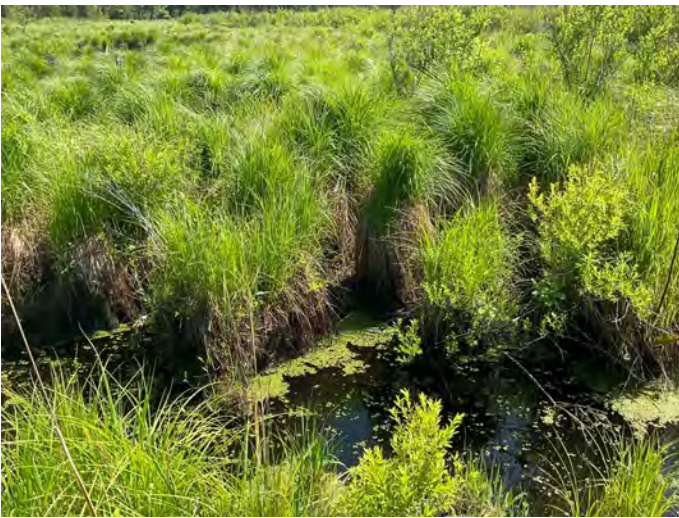
Photo facing across stream channel, exhibiting both a break in slope at the OHWM and a change in vegetation density above the OHWM.

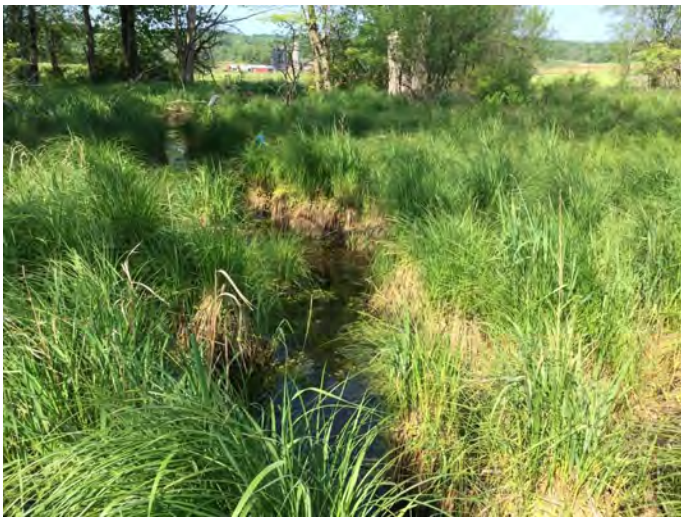
Downstream photograph, with break in slope and vegetation transition present.

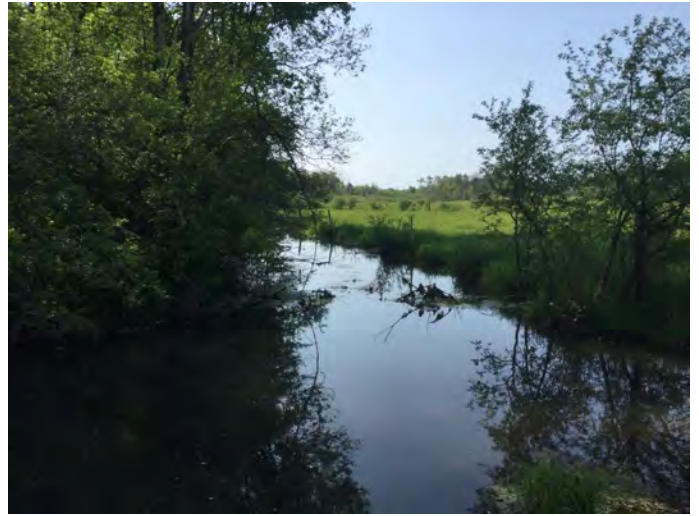
Downstream photograph.

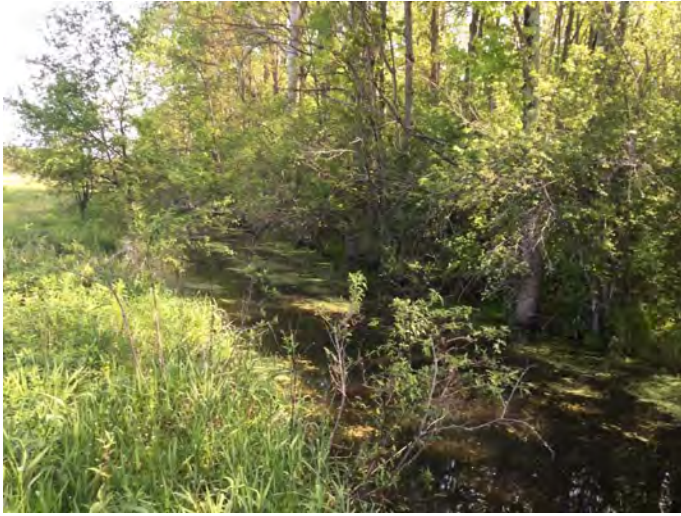
Upstream photograph.

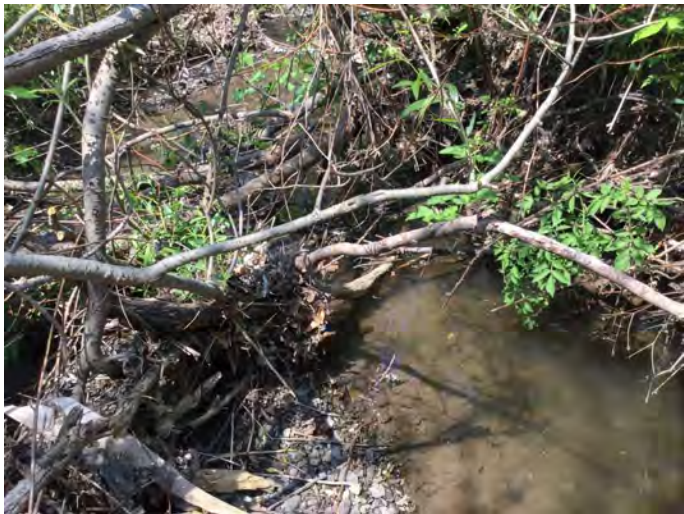
Photo of wracking, facing downstream.

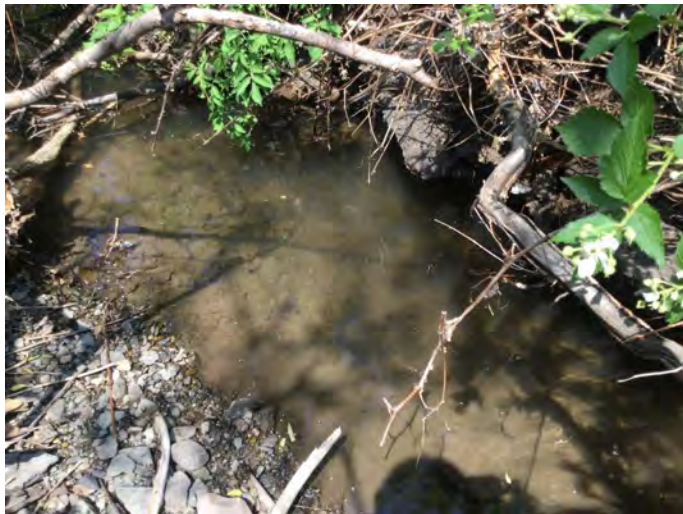
Photo of undercut bank and stream substrate.

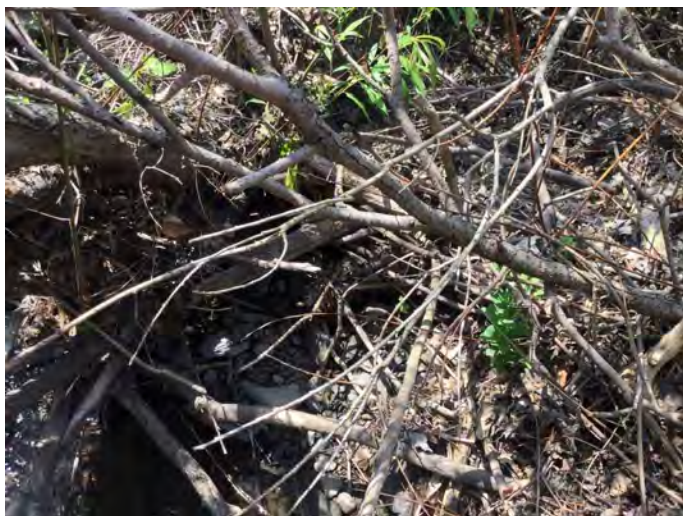
Additional wracking of organic material.

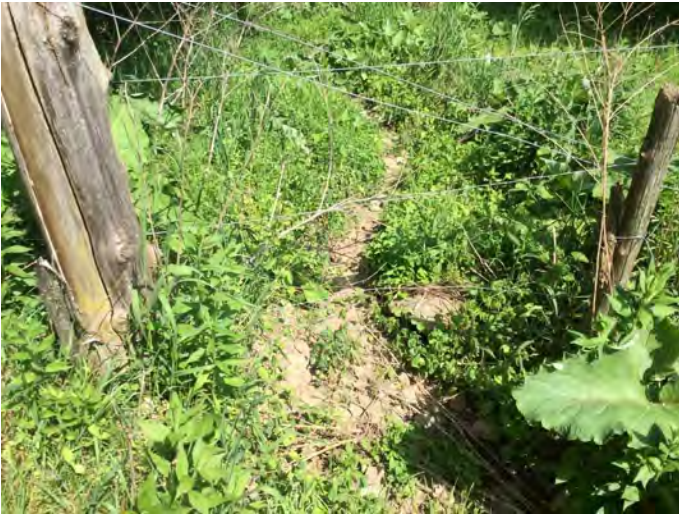
Downstream photograph.

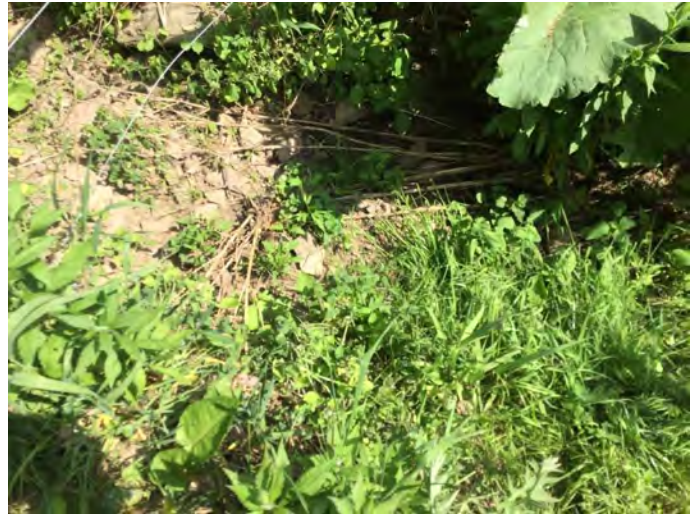
Stream substrate.

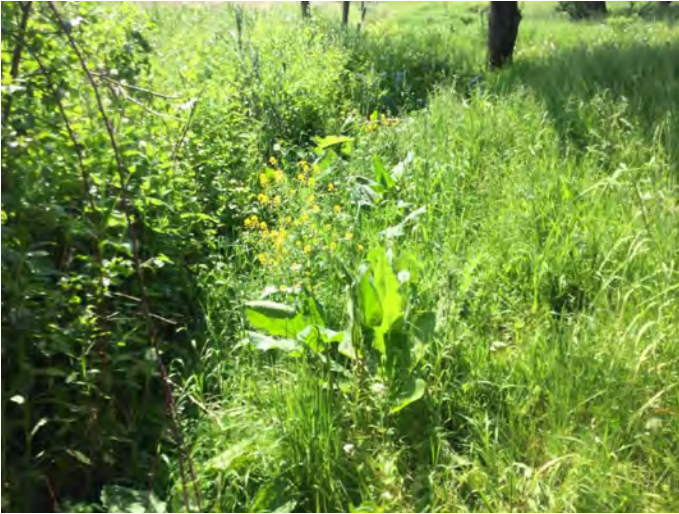
Upstream photograph, with man made berms.
